ESS weekly meeting (2022 W07)

A. Miyazaki et al

Part I: leak found in CM08 at cold

Part II: TH595A in DB stations

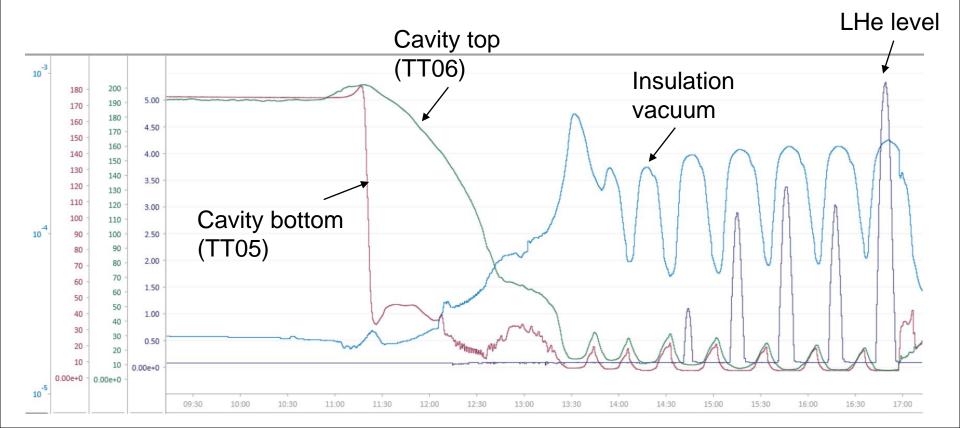
- Leak (1e-4 --1e-3 mbar) was observed in insulation vacuum
- The leak seems correlated to the bottom temperature and LHe level inside the cryomodule

helium signal by the leak detector (at cold)

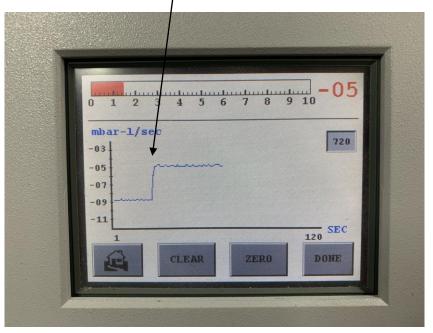
Open the angle valve between the leak detector and insulation vacuum

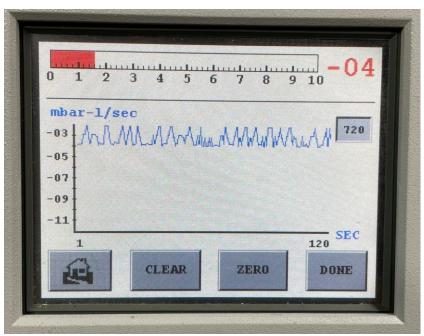
After while Max leak 1e-3 mbar*L/sec

(He circuit 1100 mbar; 4K cooling phase)

\rightarrow We decided to warm up the module

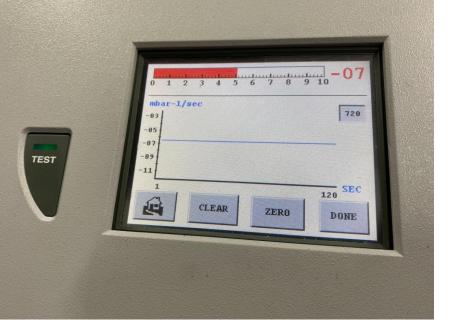
He circuit **30 mbar** insulation vacuum 1e-4 mbar

Leak 1e-7 mbar*L/sec

Leak rate is smaller (1e-3 \rightarrow 1e-5 mbar*L/sec) than at cold but it is proportional to the differential pressure \rightarrow Leak exists also at warm

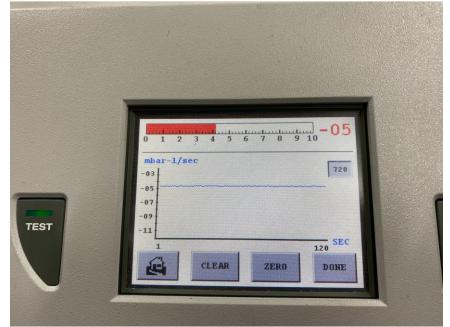
He circuit **1175 mbar** insulation vacuum 1e-4 mbar

Leak 1e-5 mbar*L/sec

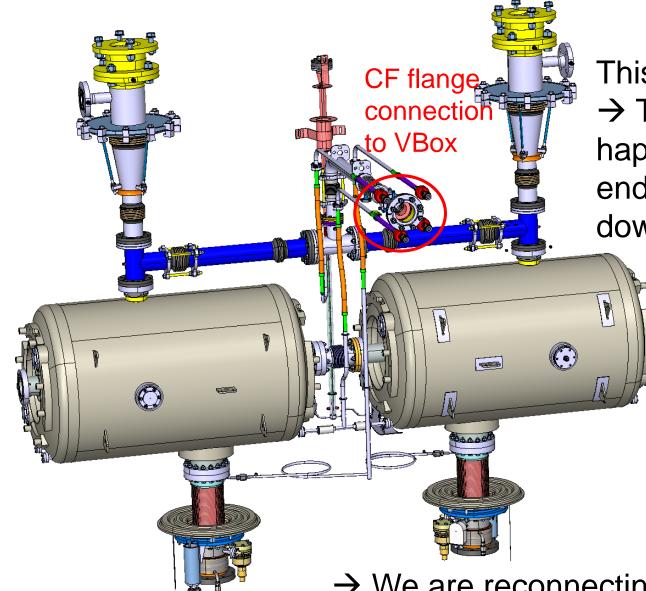
Where was the leak?

This is GHe exhaust → Thermal shrinkage happens at the very end of the cooling down process

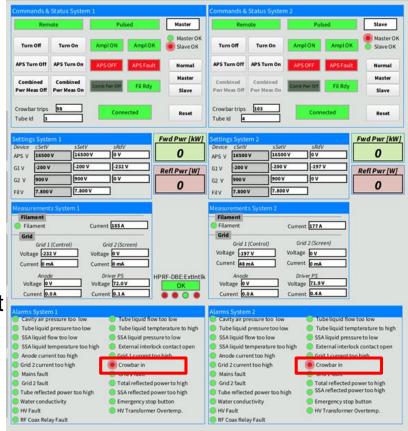
DB-B 595A 901204 4800 hours with filament ON Since September 2019

- Few crowbar events happened from the beginning of the series CM tests (Nov 2020)
- Crowbar became more and more frequent over time (typically after May 2021)
- Crowbar became permanent without RF only with HV (Sep 2021)
- Crowbar logic was shared by the sections and we could not identify which one was first
- We first replaced 901204 in DB-B with a virgin new spare 912223
 - \rightarrow Crowbar in was still there but less frequent
- We also replaced 907196 in DB-A with a virgin new spare 916278
 - \rightarrow Crowbar in has never happened again

\rightarrow Conclusion: both were dead

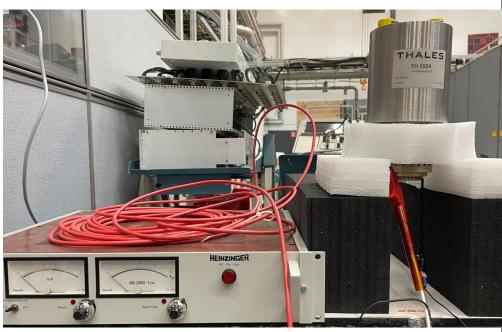
901204 test @ FREIA outside the station

THALES*		This test	
	HV	current	HV	current
K+/G1-	2 kV	<1 uA	2 kV	0
G1+/G2-	1.5 kV	< 6 uA	1 kV	> 400 uA
G2+/A-	20 kV	12 uA	20 kV	0

Several cycles of applying HV in G1-G2 max 1.5 kV for 3 hours

- → Dark current in G1-G2 disappeared (<10 uA)</p>
- → The tube was sent back THALES

- THALES reproduced our results after the conditioning
- We did not have a chance to check if the conditioning was also effective with filament ON + HV + RF
- The conditioning might just hide the issue only at cold
- \rightarrow Systematic and careful test is required

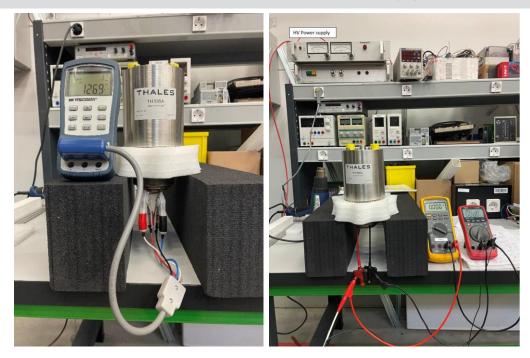
907196 test @ FREIA outside the station

THALES*		This test	
	HV	current	HV	current
K+/G1-	2 kV	<1 uA	800 V	0.5 uA
G1+/G2-	1.5 kV	< 6 uA	600 V	58.3 uA
G1-/G2+	-	-	800 V	0

- Polarity dependence observed
- Dark current slowly decreased with constant HV
- We stopped the test to avoid conditioning of this tube
- \rightarrow The tube still preserves the problematic status

- We have not applied extensive conditioning yet because it might just hide the issues at cold
- However, we could also perform the conditioning and mount the tube back to DB station and see what happens

- If the crowbar issue does not happen, this conditioning can be a solution
- \rightarrow We need a strategical decision making among ESS, THALES, and FREIA
