Motor intervention at ESS

4th and 5th July

Motor intervention

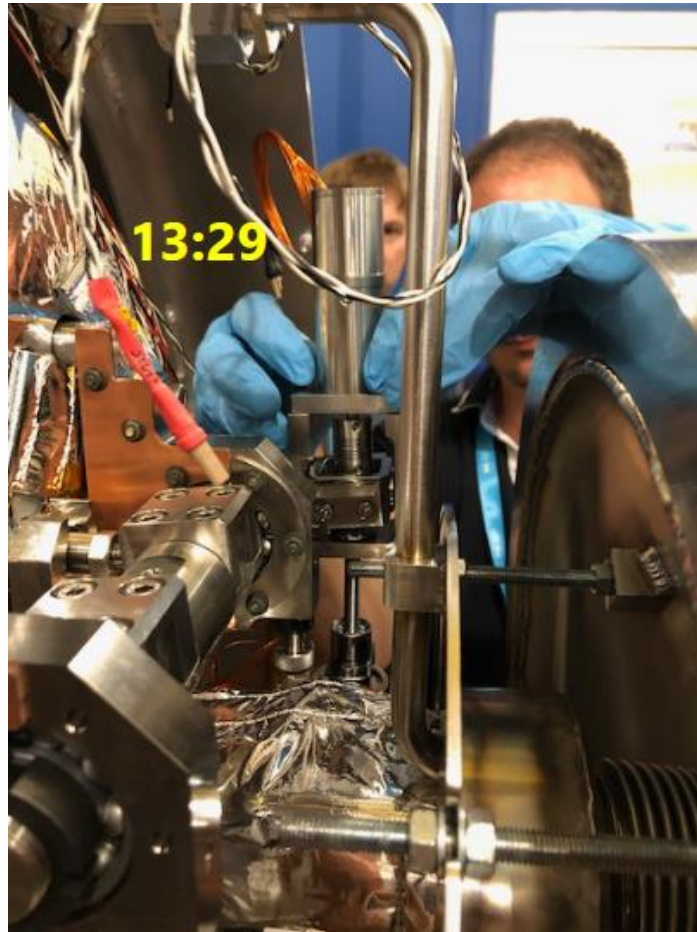
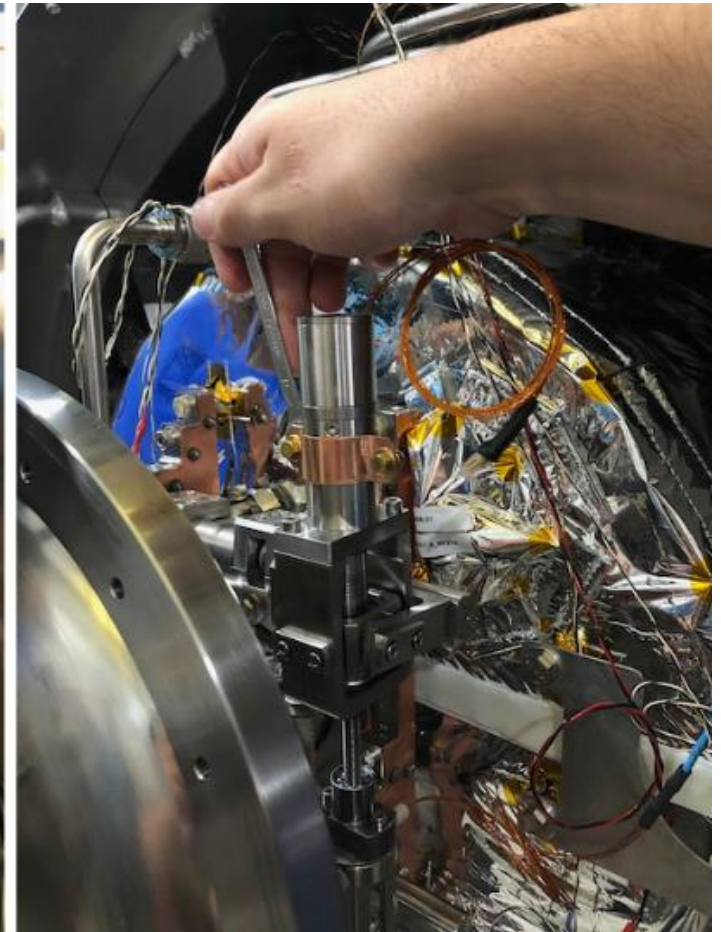
Motor replacement

➔ OK

Note that we now put the copper collar of the PT100 sensor on the gearhead body, just by precaution.

- ➔ Will have slight incidence on temperature response
- ➔ True on CM12, and CM10 CTS2 then.

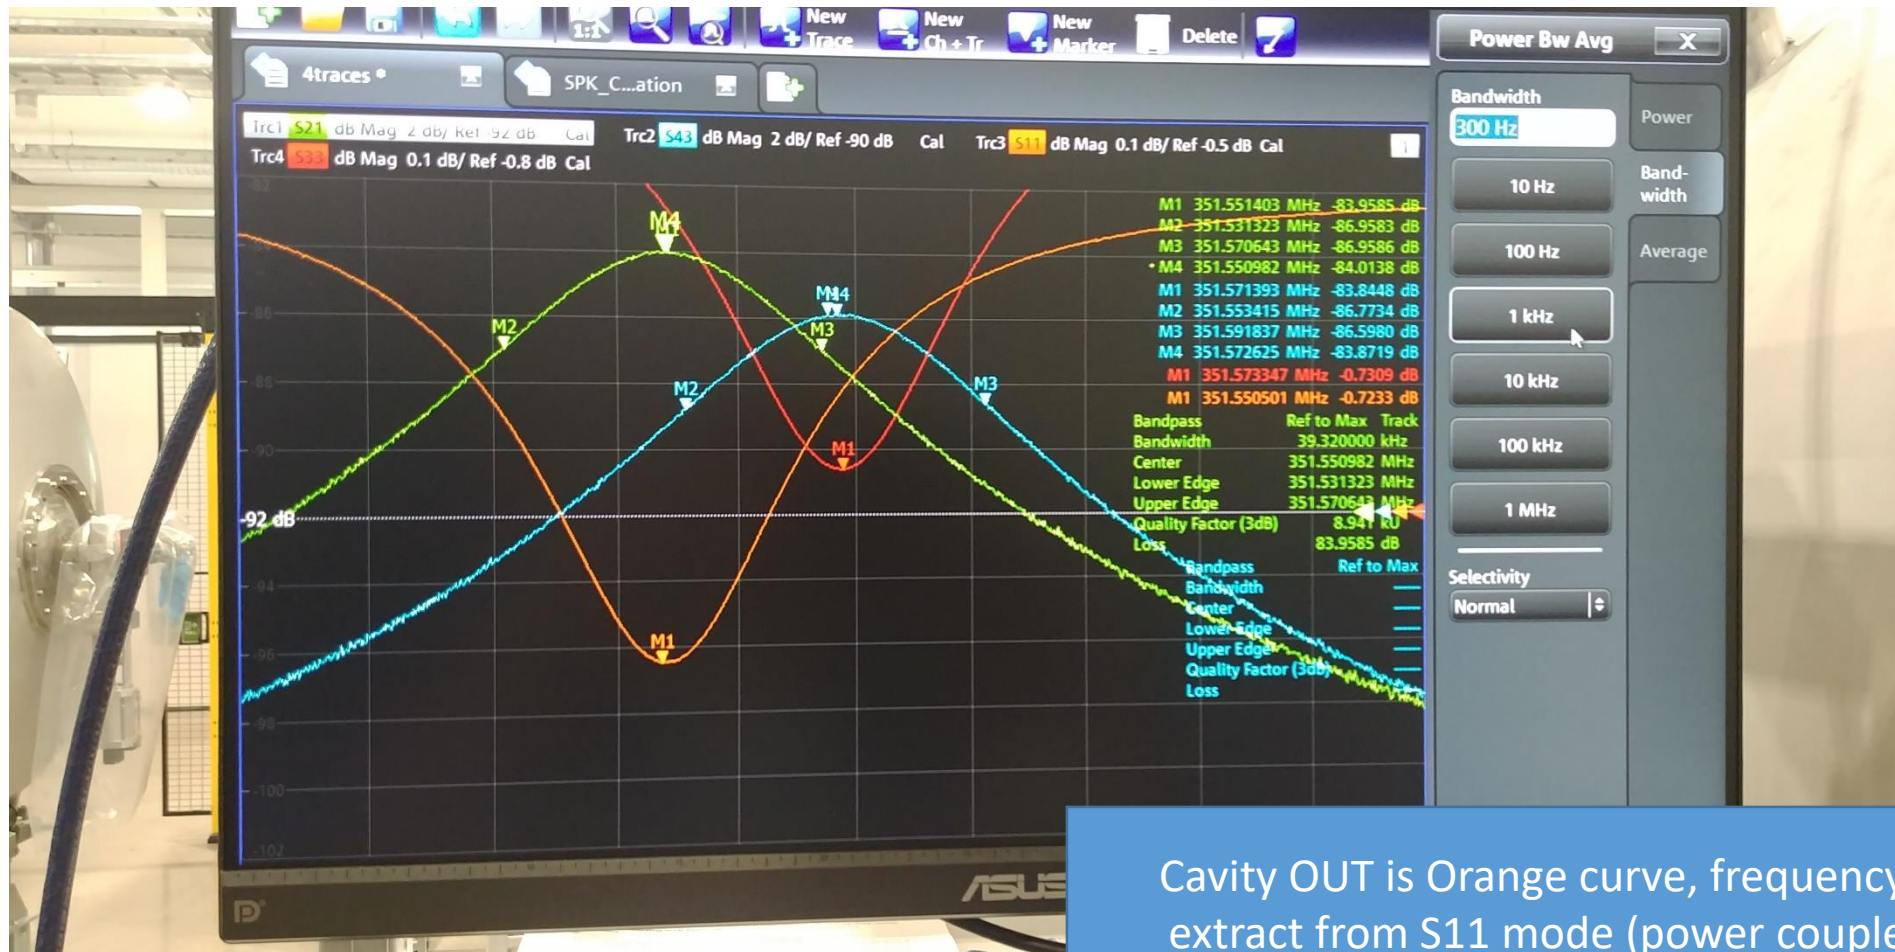
VNA Measurement

Cavity OUT is Orange curve, frequency is extract from S11 mode (power coupler)

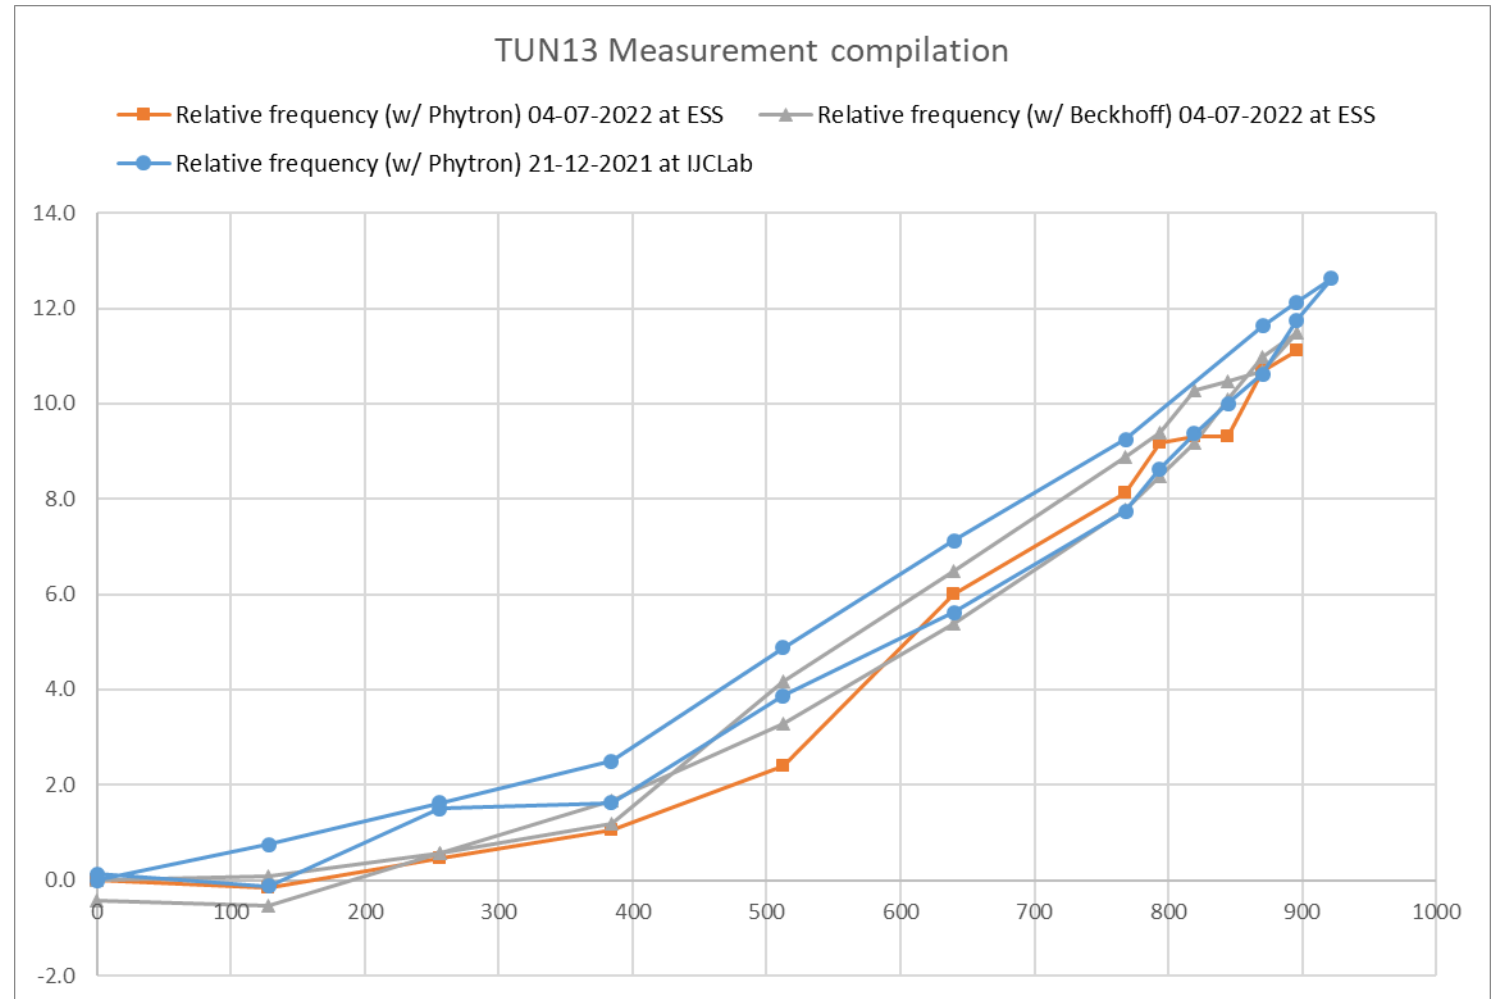
Frequency measurement at warm

Those measurement can be done thx a blocker part on the disengage system, and we must not exceed 13 kHz relative frequency to stay in elastic limit of Niobium (40 MPa)

1/ Frequency measurement with **Phytron MCC2** → **OK**

2/ Frequency measurement with **Beckhoff EL7041** → **OK**

Nice reproducibility from measurement made **at IJCLab** before sending de cryomodule.
