ESS weekly meeting (2022 W44)

CM10_2: General planning update

CM10 2nd CTS tests

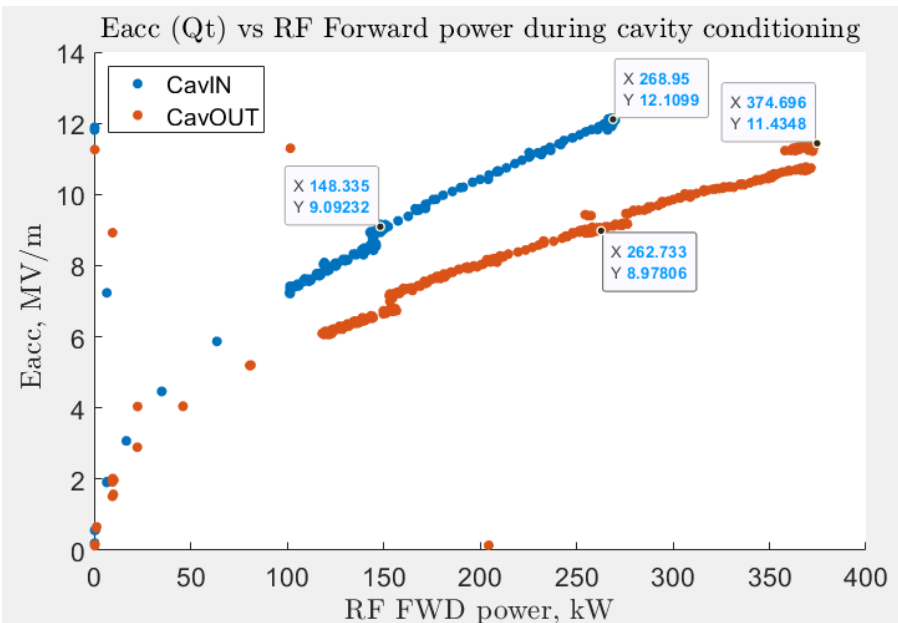
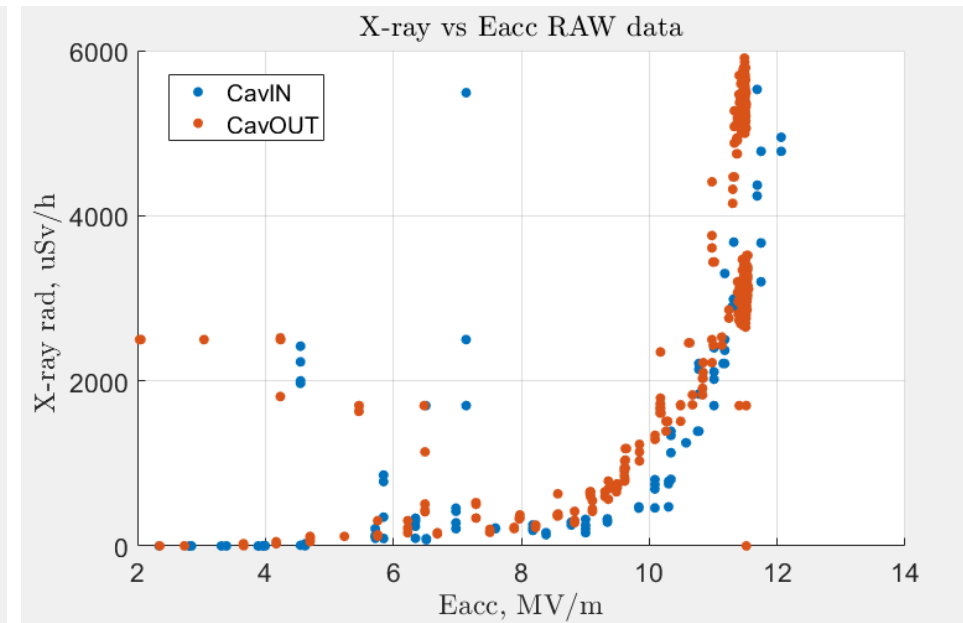
- Both cavities reach 9 MV/m.
- Cav1 max tested field is 12 MV/m. Cav2 max tested field is 11.5 MV/m.
- “OK level” field emission founded in both cavities with ~8 MV/m offset.

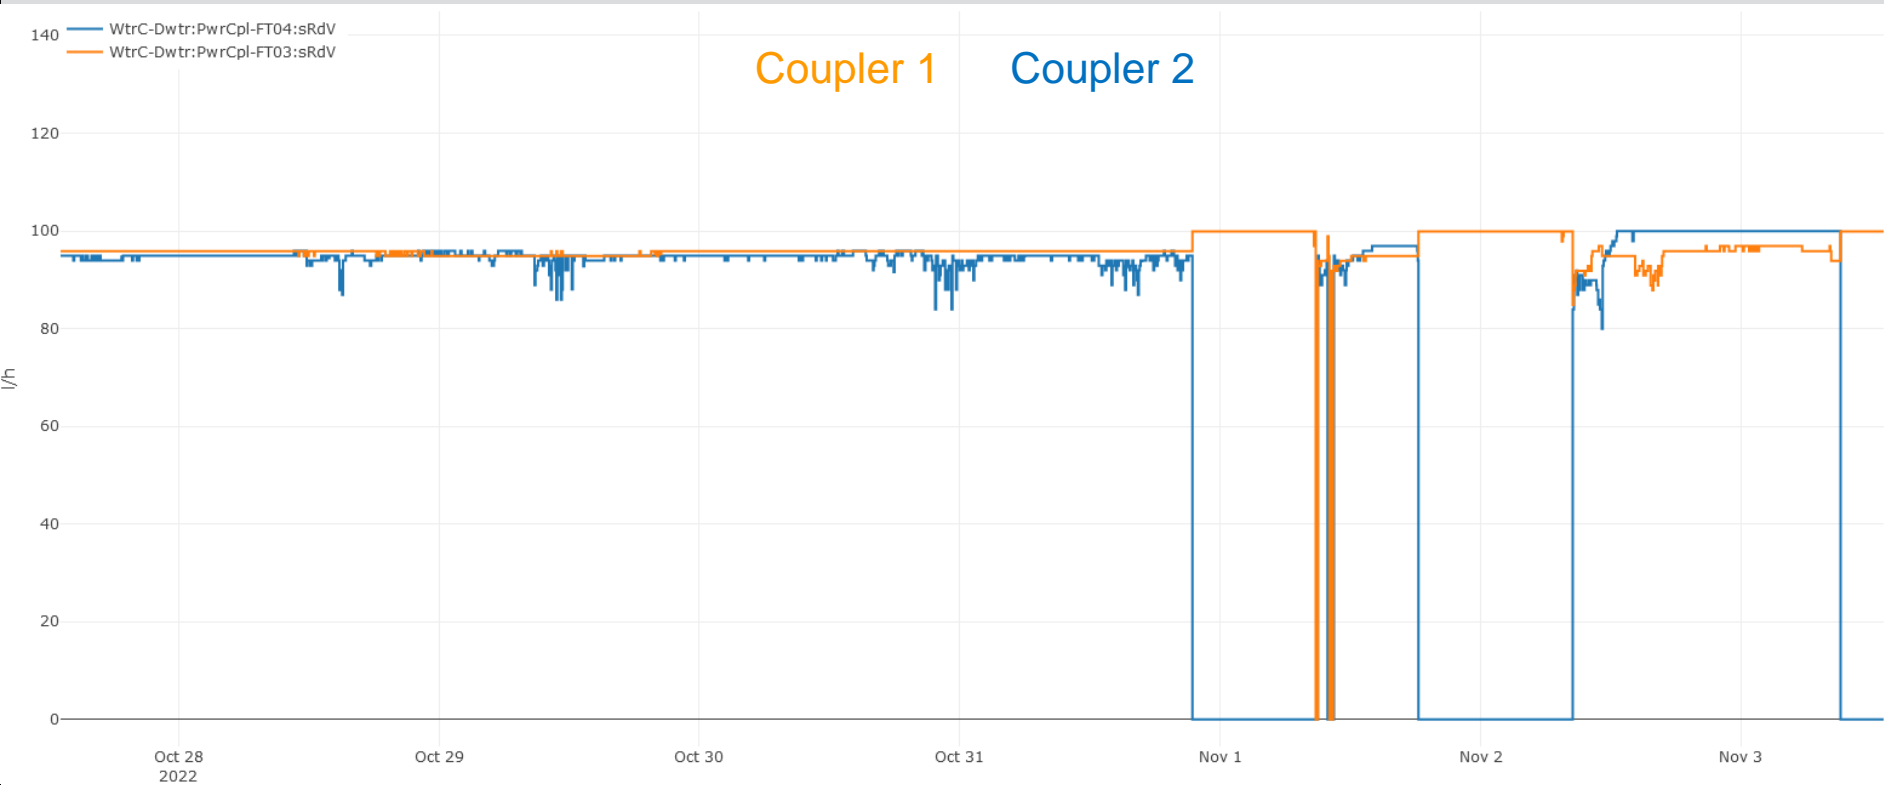
- We start often detect a absence of water flow in **Couple 2** cooling line.
- To fix this we several times drain water from cooling line.
- Expected caus: Contamination by products of corrosion from coupler side.

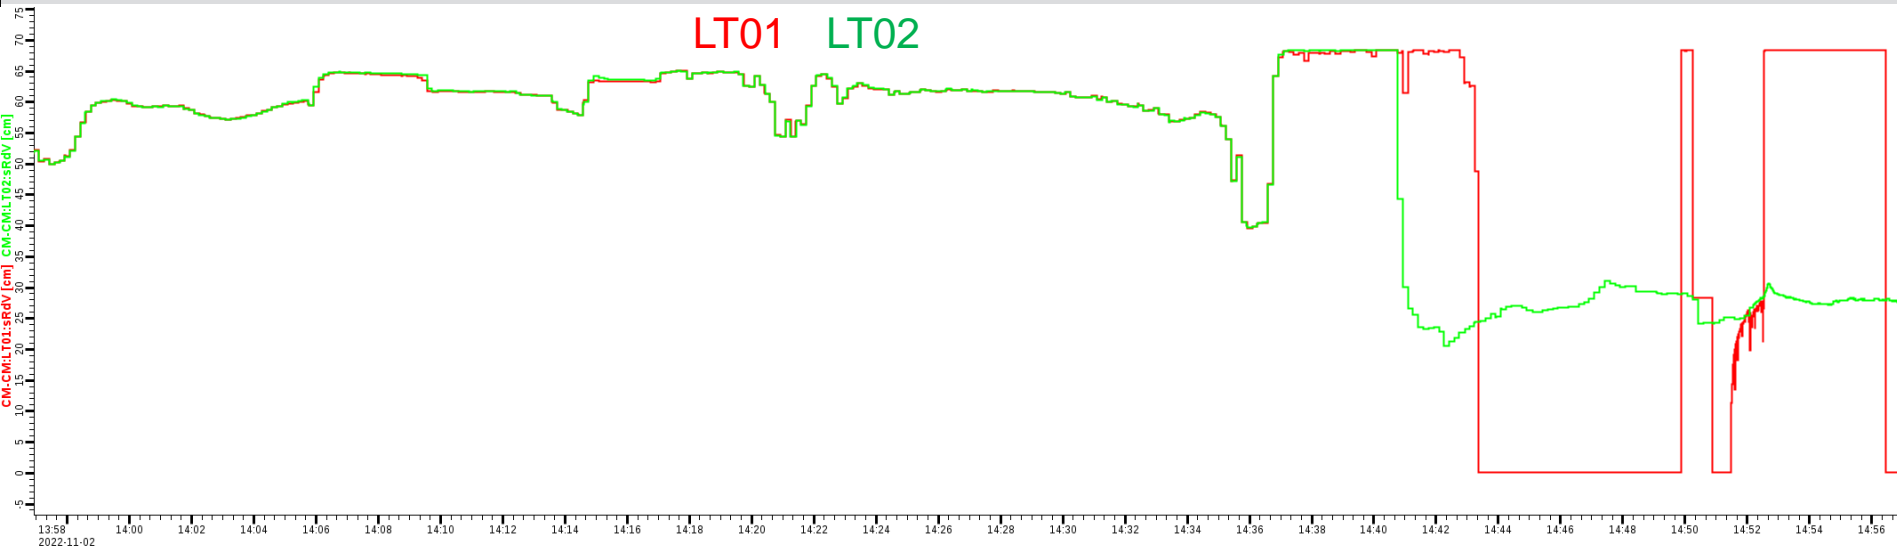
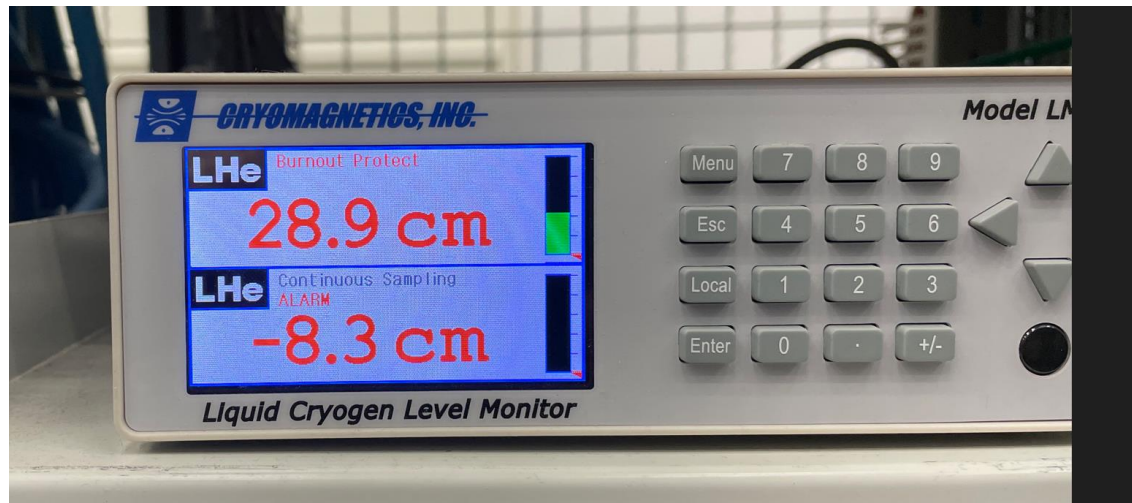
- When we start warm-up LT01 start bouncing 0 and max level value.
- Controller switched to **Burnout Protect** mode.
- Electrical continuity will be check after warm-up

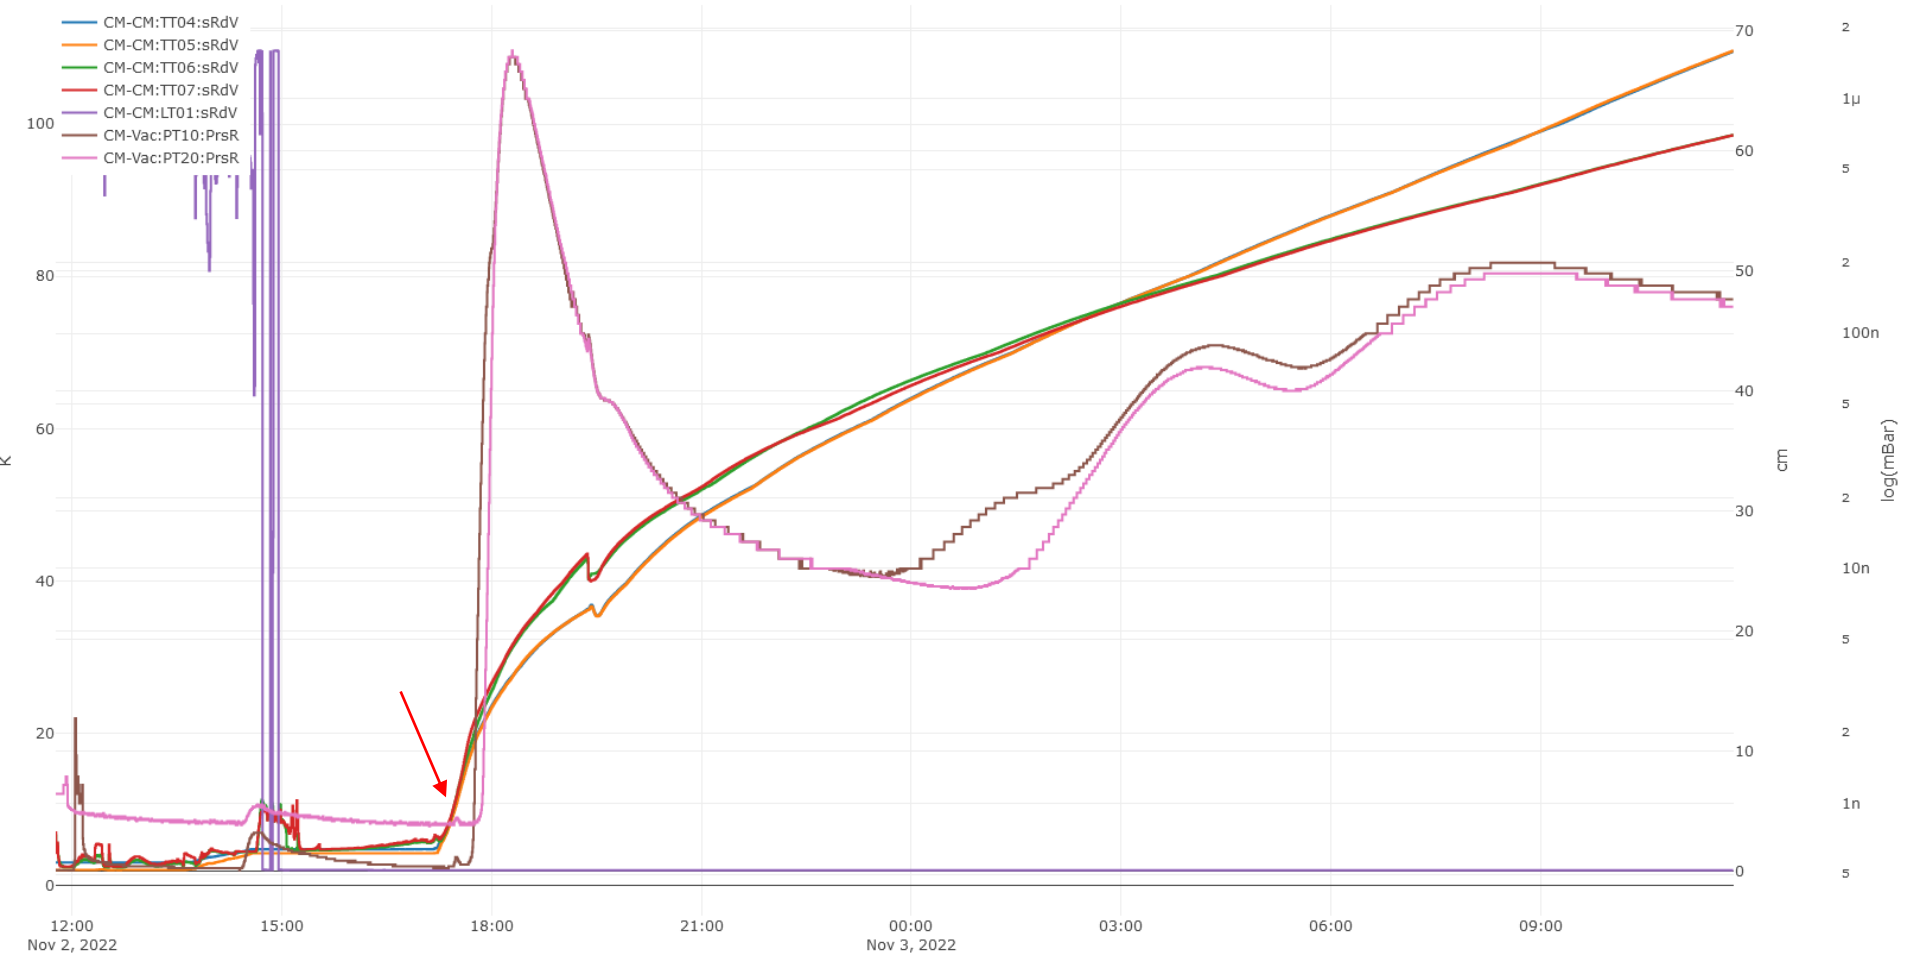
- Small bump in beam vacuum detected around 11K at 17:30.

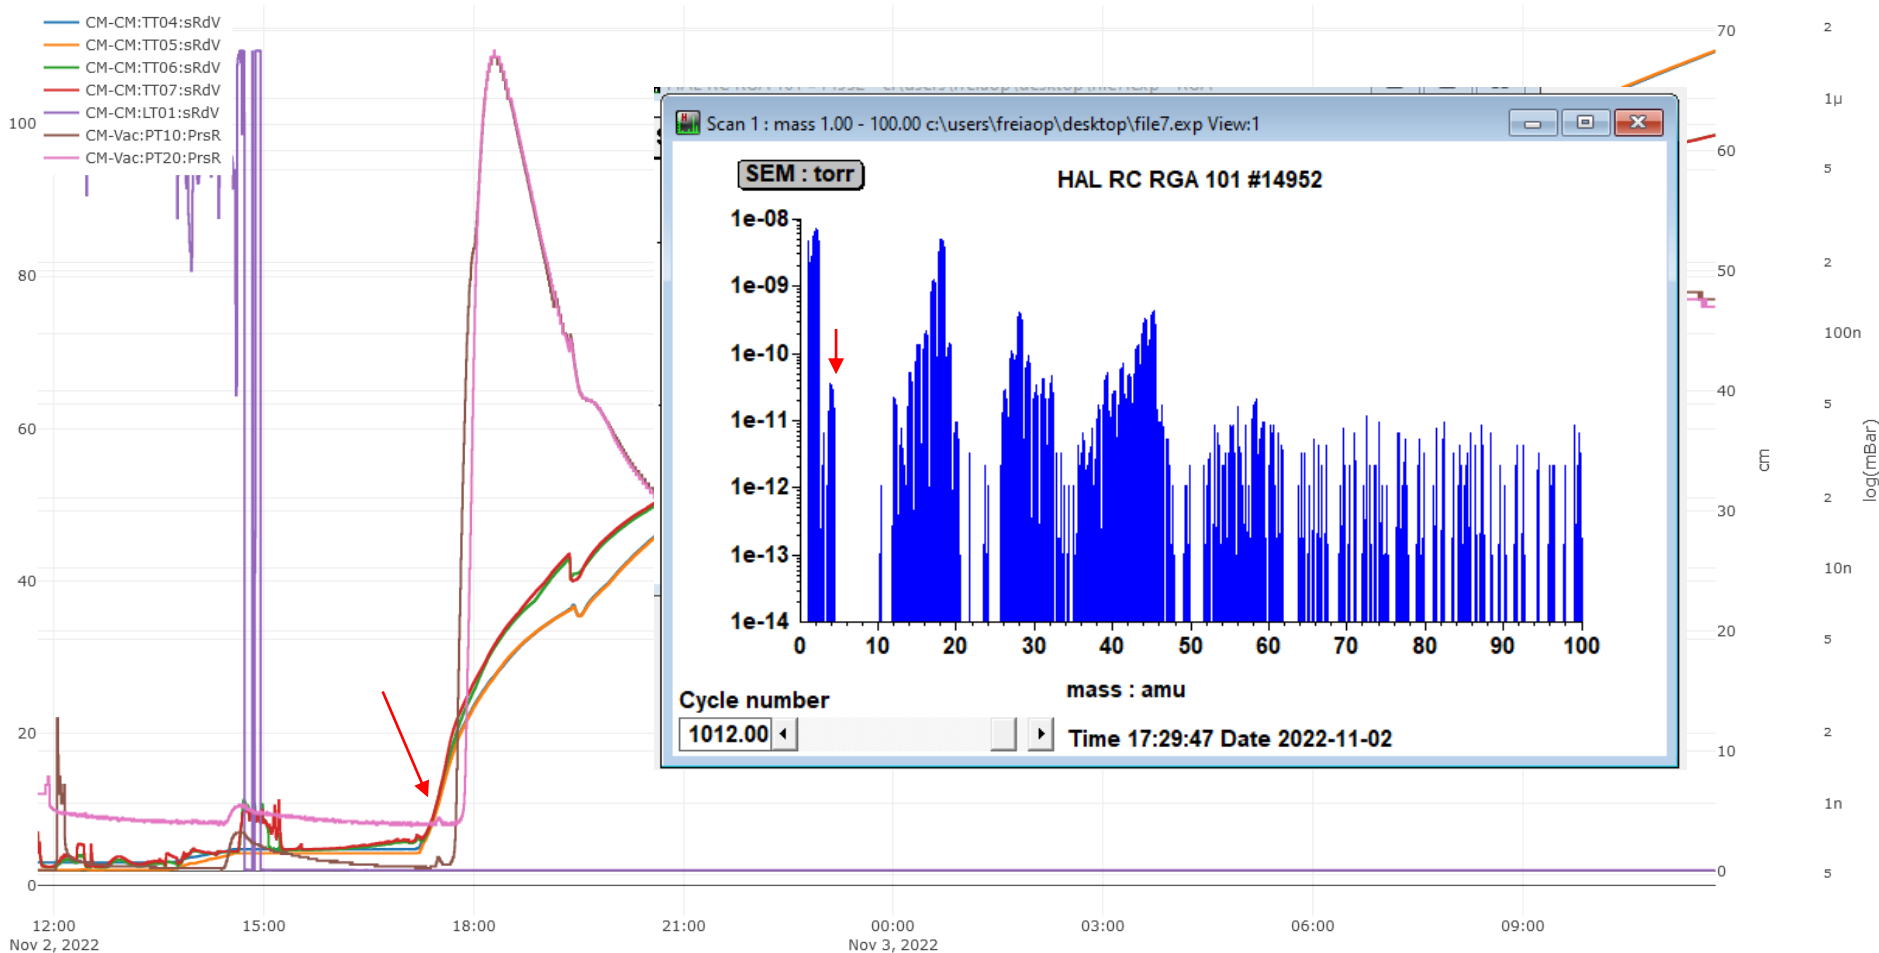
- Small bump in beam vacuum detected around 11K at 17:30.
- He signal (2E-11 torr) observed in same time by RGA

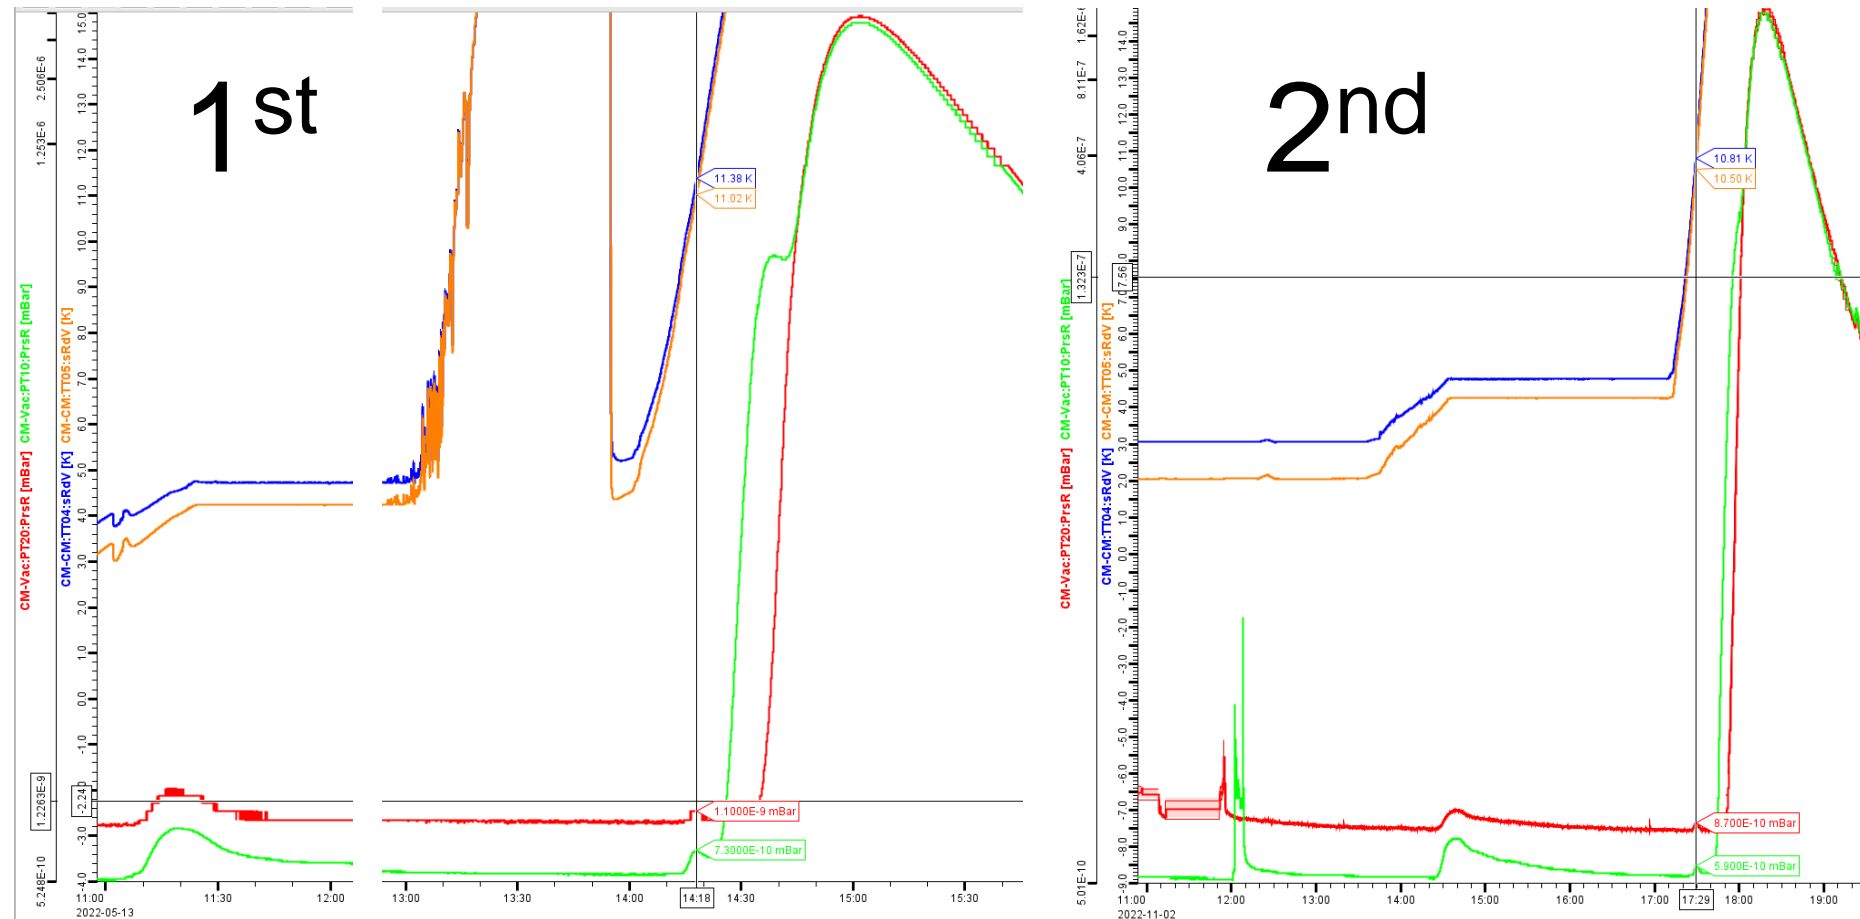
- Same behavior observed also during 1st run of CM10.
- We cant exclude (for now) that: This can be common behavior for all CMs.
