Motor issues update

N. Gandolfo – IJCLab - 10/11/2022

CM10 Motor reminders

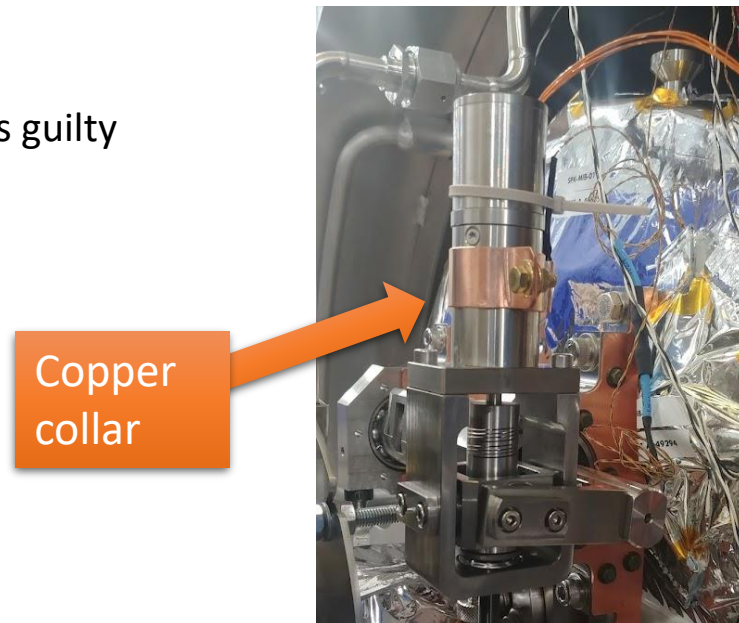
- Done : Motor failed very quickly, only at LT
- Done BUT... large axial play found on the shaft...

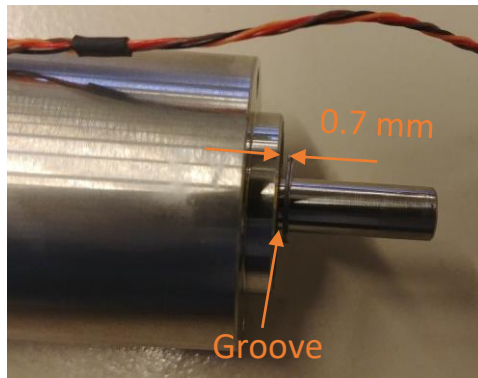
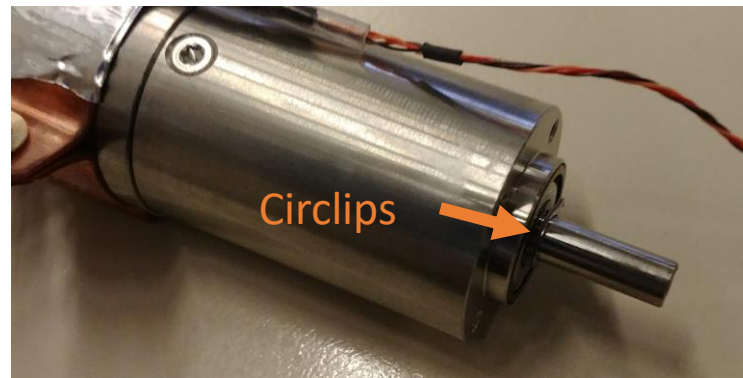
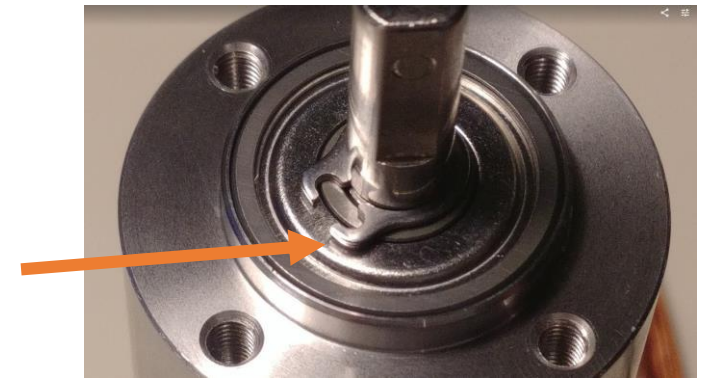
After removing the motor support, the gearhead circlips has been found out of its groove, allowing then an axial displacement of the shaft of about 0.7 mm.

There is no clear explanation of when and why did it happened, two ideas :

- A. Wrong assembling from Phytron : should have been seen when cabling, testing and assembling the motor to the tuner.
- B. Undesirable force pushing toward the motor : not possible in nominal operation, still possible in weird configuration. For instance : if the disengage system is moved and then closed at non home position and the motor is not at home position and it goes back in negative direction, then it could be possible... but no probable.

Since we are doubting of the cause and consequences of this, we just replaced the circlips by « new » one (borrowed on another motor), and go for retesting in same condition.

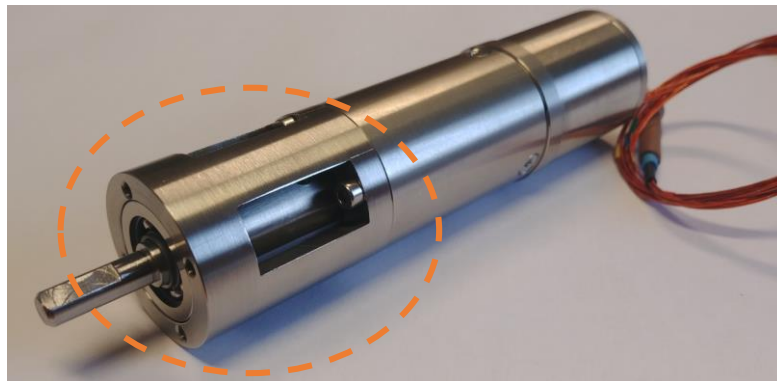
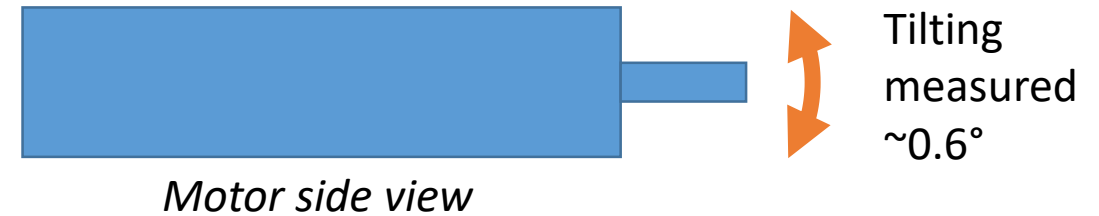
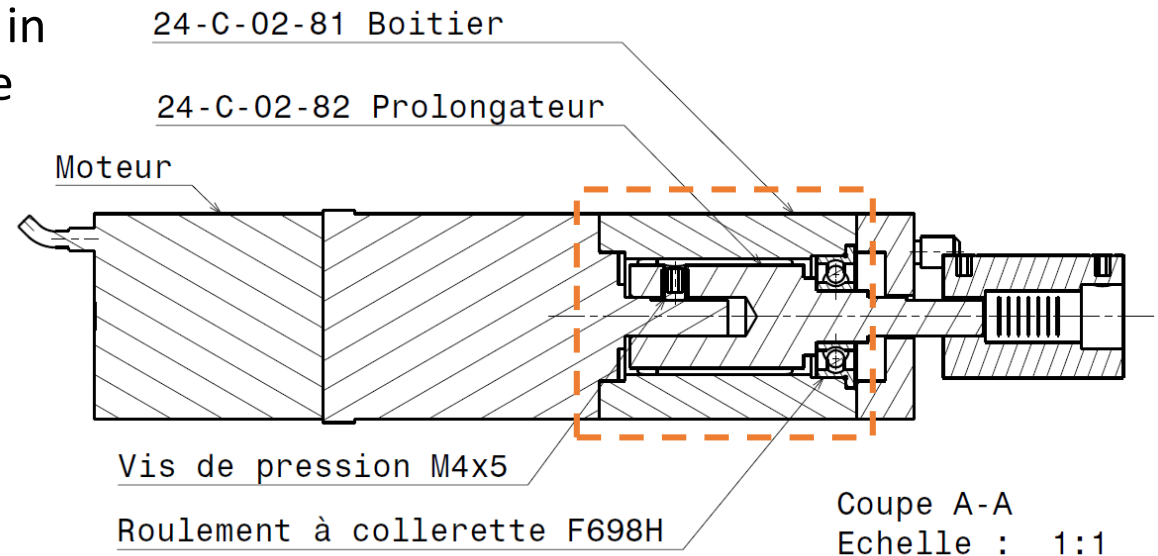
There are serious doubt about the shaft tilting possibility that could damage the internal pinions (dry coating).

There are some discrepancies about the adjustment arrangement between shaft, bearing and housing around the front of the motor (gearbox bearing) from proto to serie, but also from batch to batch.

New set of parts have been designed and fabricated in order to mitigate the tilting possibilities, and validate this theory.
