CM10 motor LN2 test report

N. Gandolfo - 01/12/2022

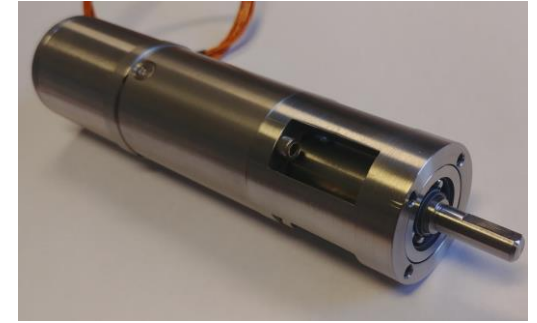
VSS32 Motor with elongated shaft

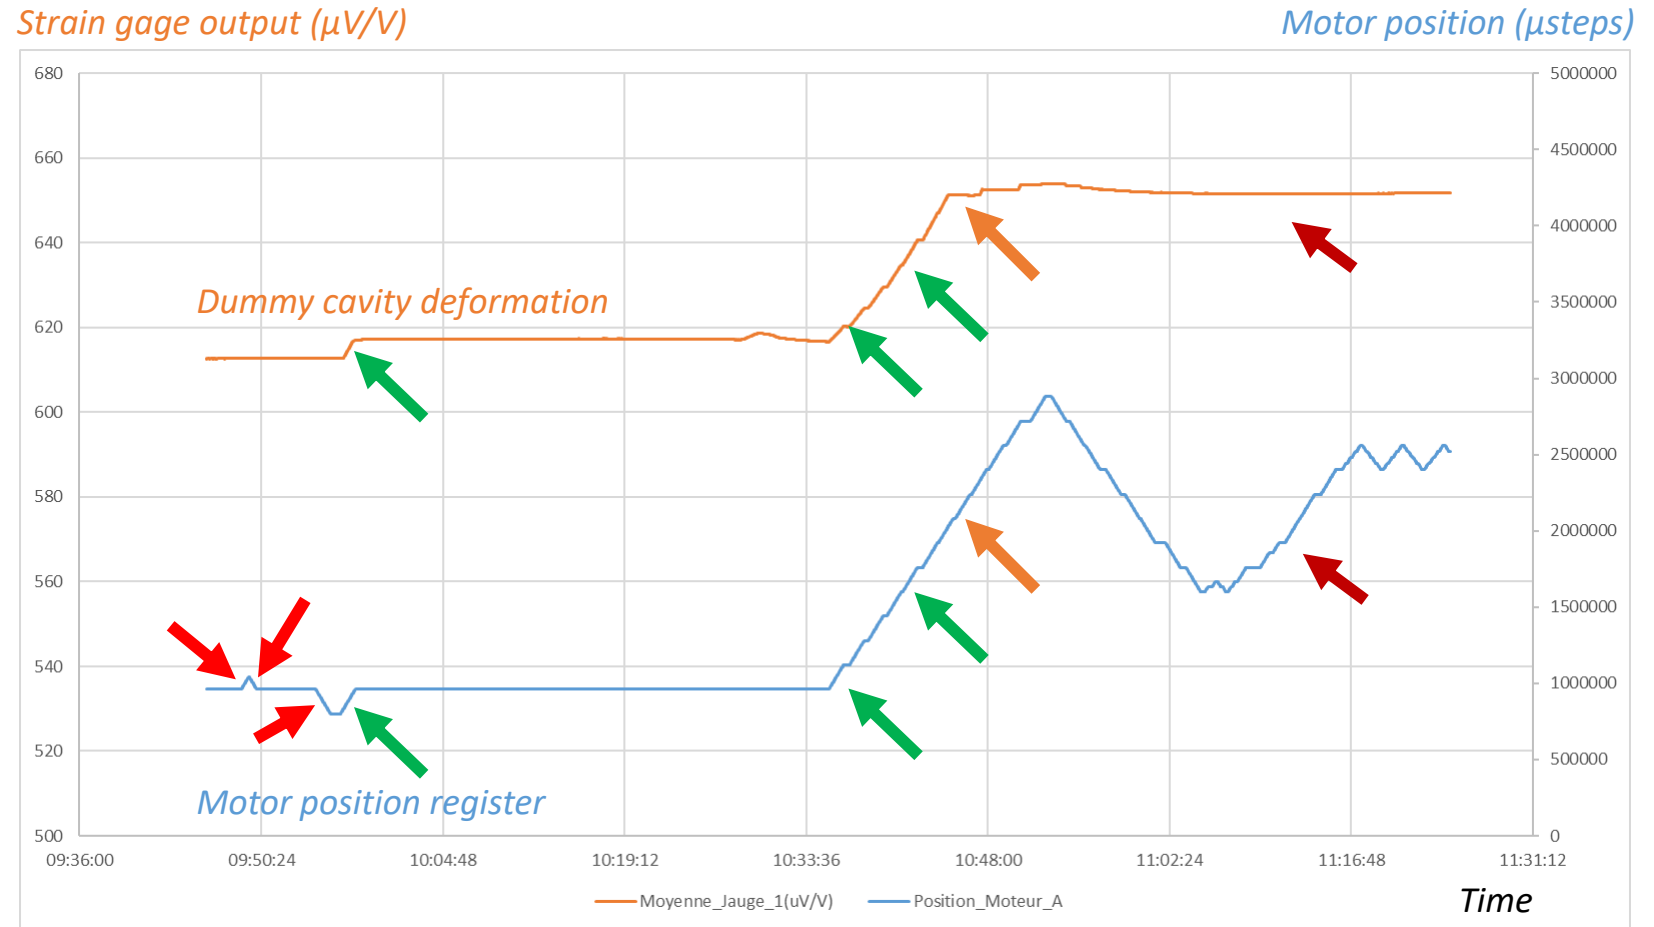
1. Very first attempts failed
2. Then it started to move properly
3. And then quickly started to get stuck more and more
4. Finally stuck again

...we were about to warm-up and change the configuration, we tested to rise the current to 1.0 A, and the motor finally seemed to work very properly !!

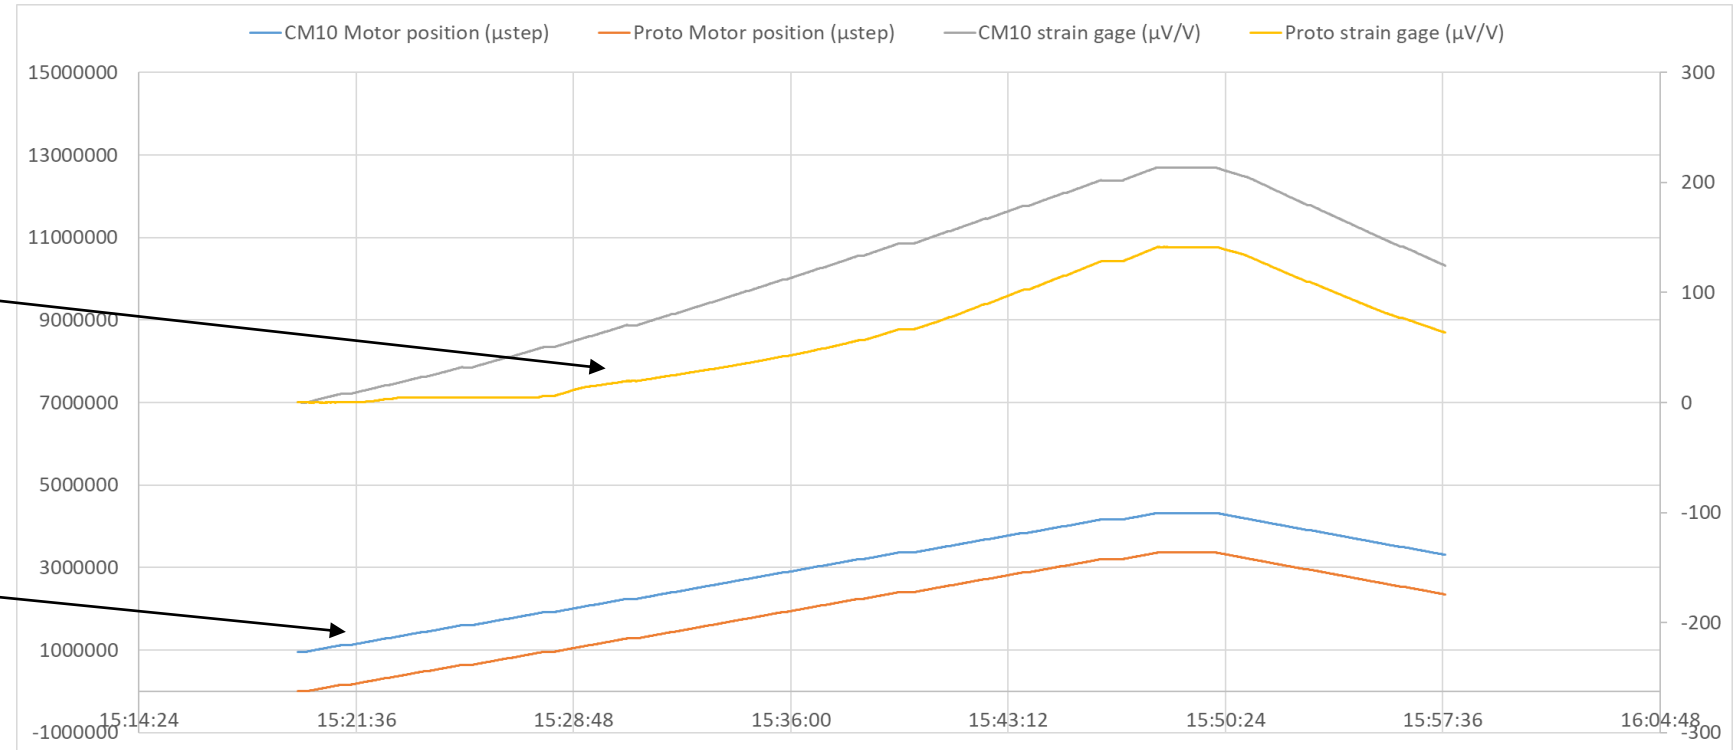
Non linearity issue due to proximity from home position. OK, not a concern. (proto motor only)

Offset due to wrong initialization, not a concern.

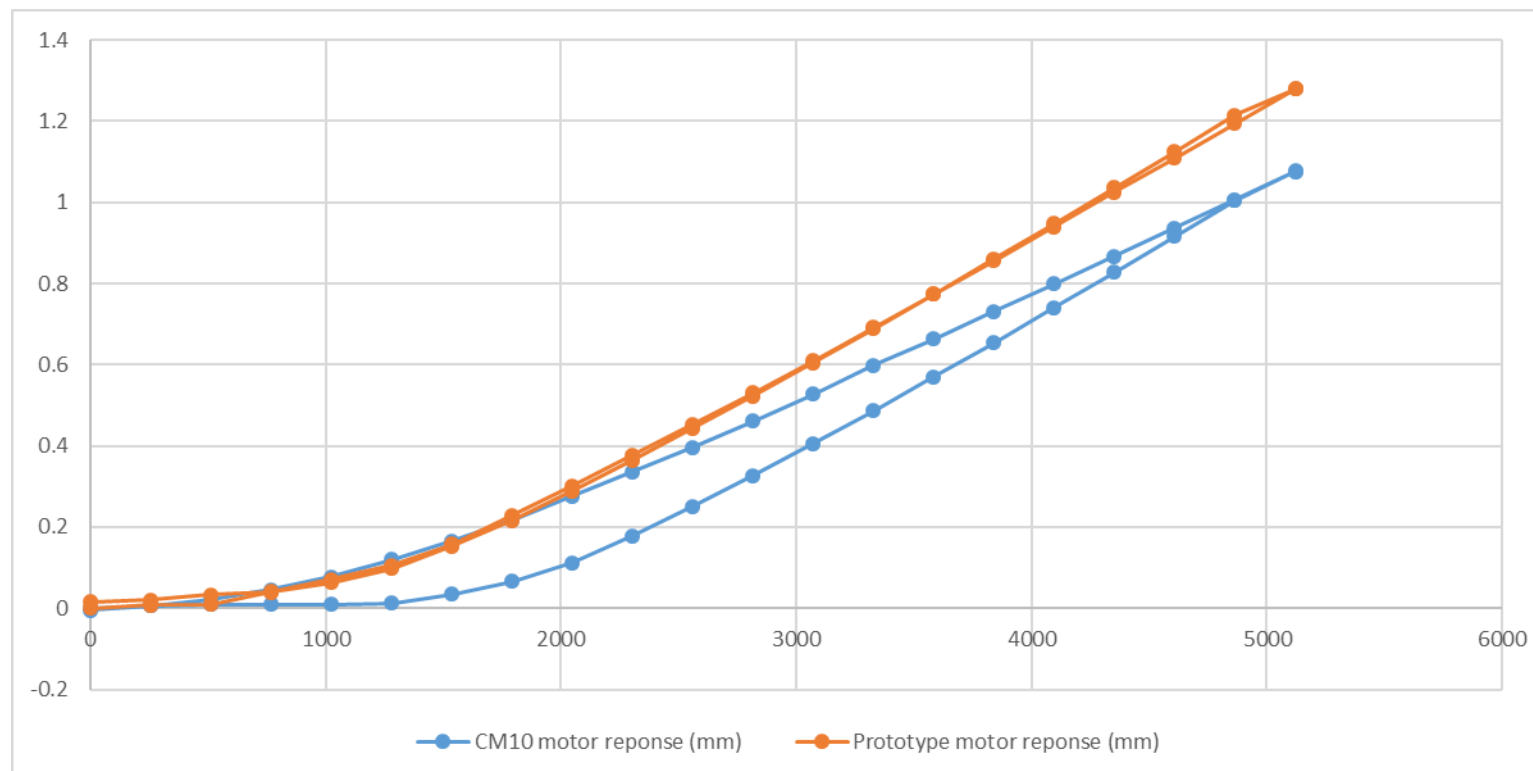
- Large stroke testing (1.0 A), round trip

➔ No issue

➔ Hysteresis on CM10 motor tuner mostly imputed to mechanical slight issue, sometimes observed on some tuner testing. Not motor related.

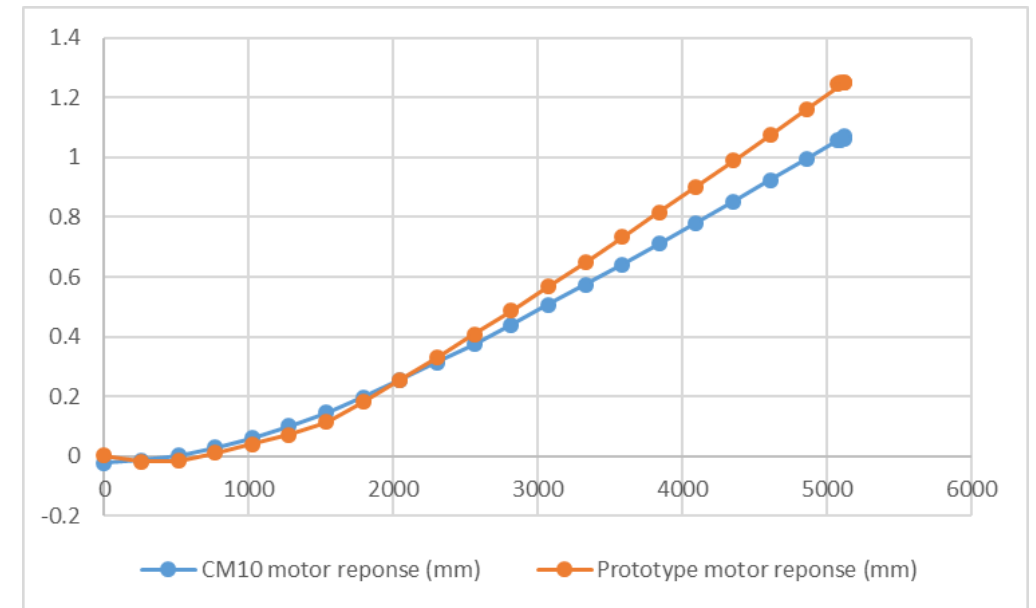
Day 3 single way

- Single way to 5,120 rev (1.0 A)
- ➔ No issue, good correlation with round trip of the day before

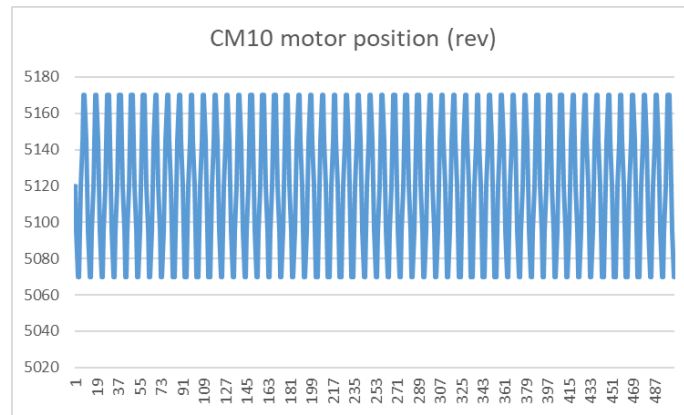
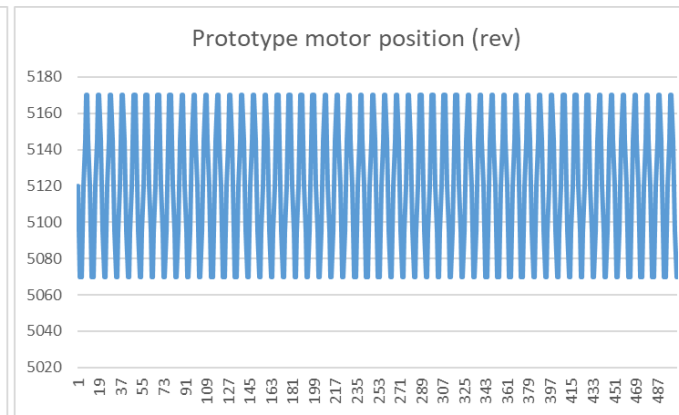
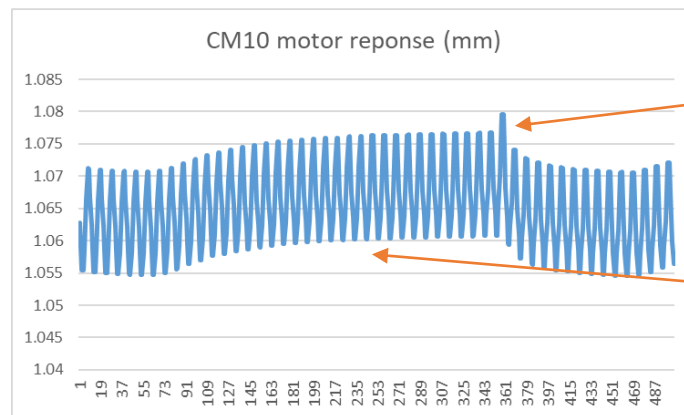
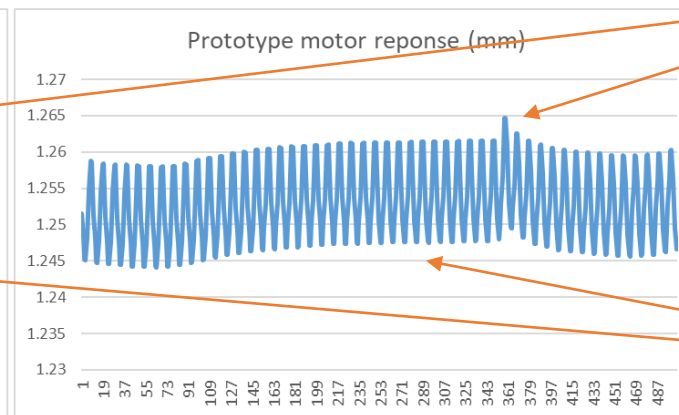
- Evaluation of motor start current from 1.0 A down to 0.32 A → OK (!!)
- Stress test 10,000 motor rev. (input of gearbox, not output), at 0.4 A → OK (!!)

Thermal
instabilities due
to LN2 refilling

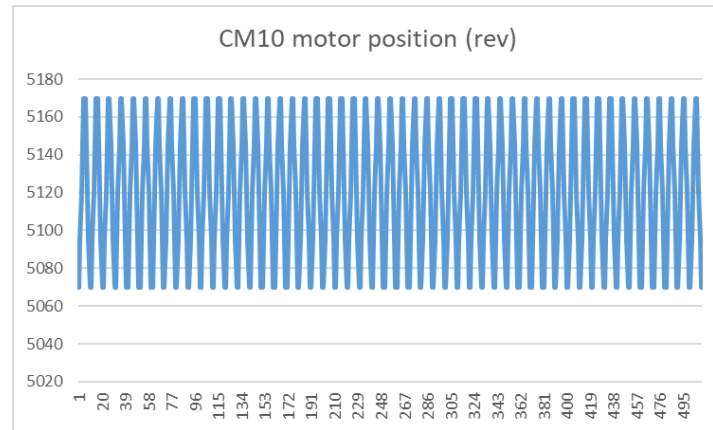
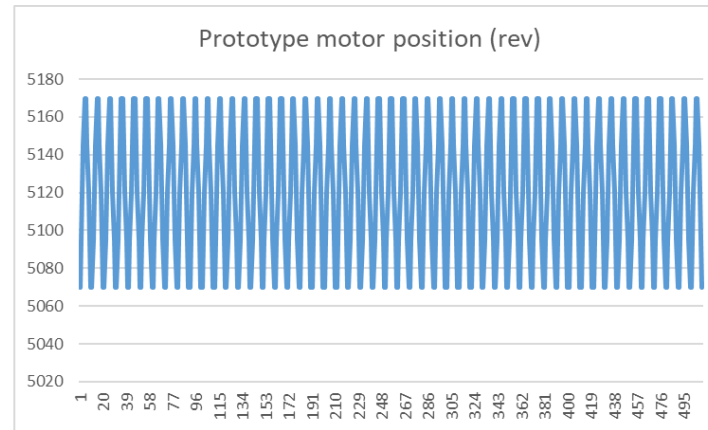
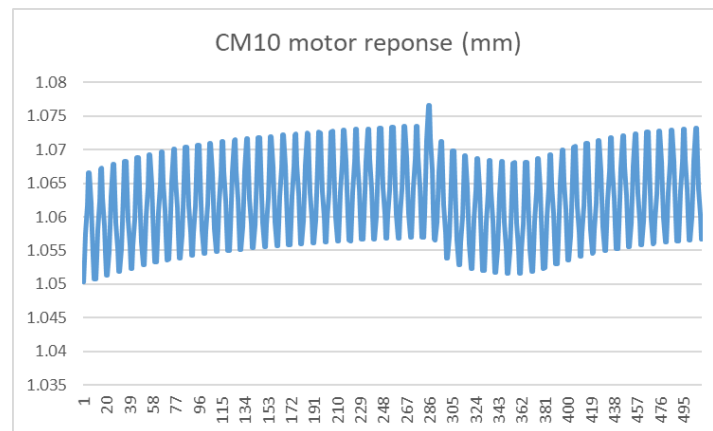
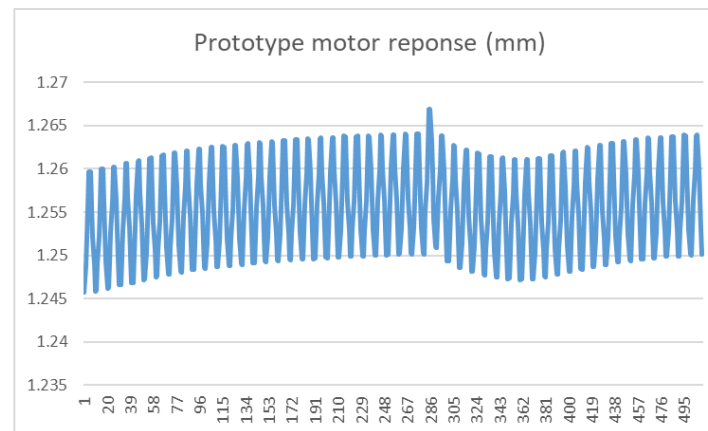
- Again, stress test 10,000 motor rev. (input of gearbox, not output), at 0.4 A → OK

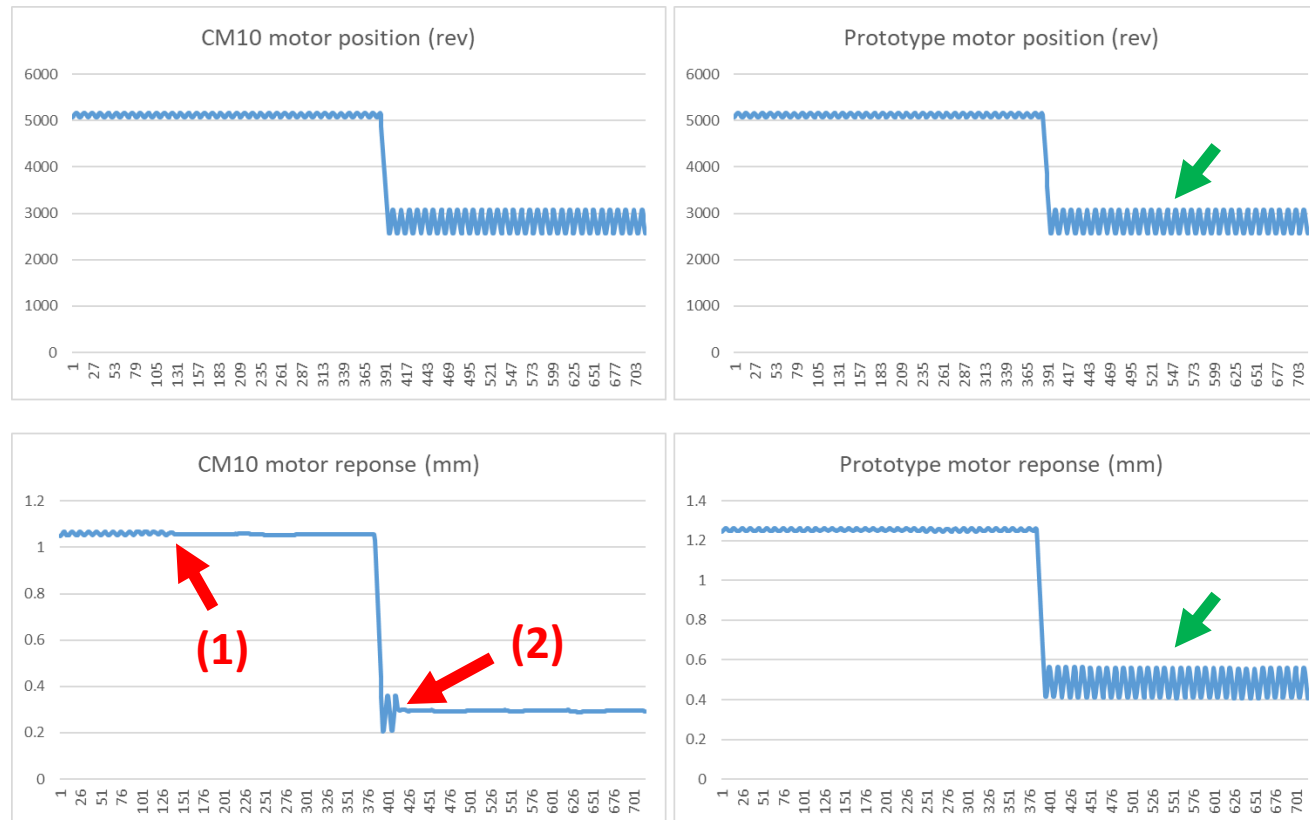
- Again, stress test 10,000 motor rev. (input of gearbox, not output), at 0.4 A → **NOK (1)**
- Put tuner at 2,560 rev (1.0 A) → **OK**
- Evaluation of motor start current from 1.0 A down to 0.32 A → **OK (!!)**
- Again, stress test 10,000 motor rev. (input of gearbox, not output), at 0.4 A → **NOK (2)**

Carefull, Y scale is larger than previous slides
