# 1. Visual inspection from TL012 upper bellow into VB

### **OUTCOME of TESTS**

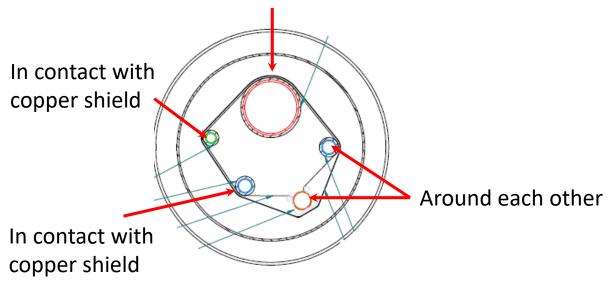
There does not seem to be anything in contact with this line...

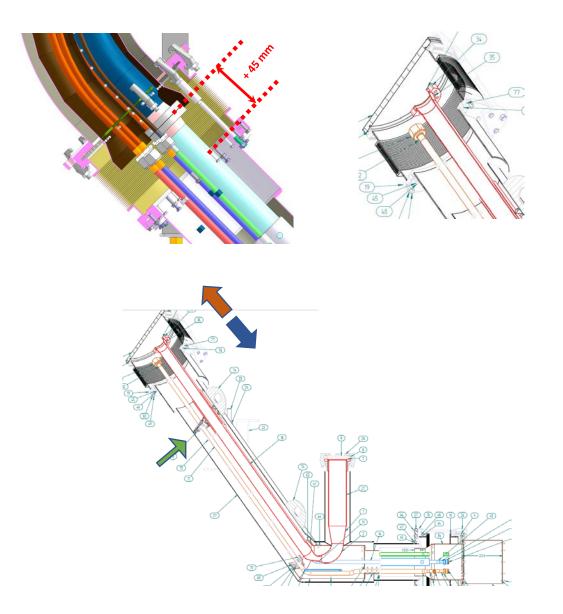
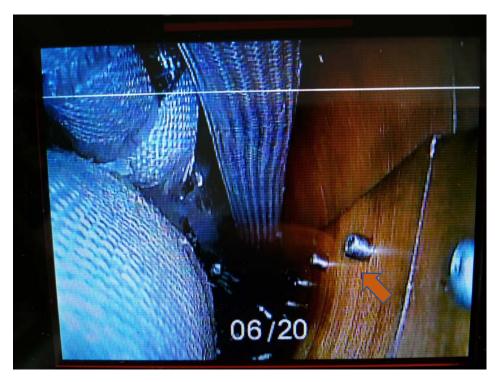
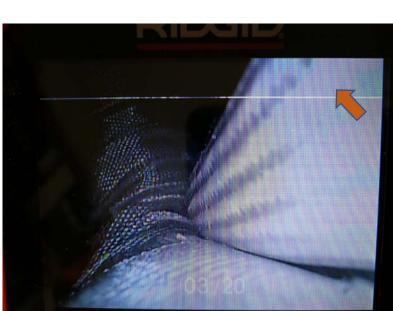
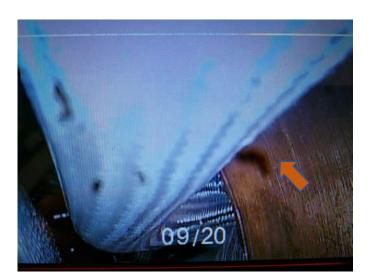
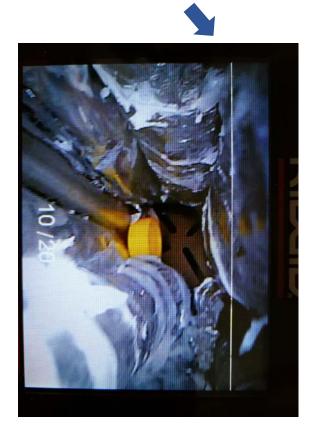
2. Visual inspection from TL012 upper bellow into VCS 💙

- No copper shield on this part
- Cannot see past the G10 separator (camera does not fit)

- **3.** Distance measurement from CF flange to bellow flange
- 45 mm displacement towards VB wrt drawing

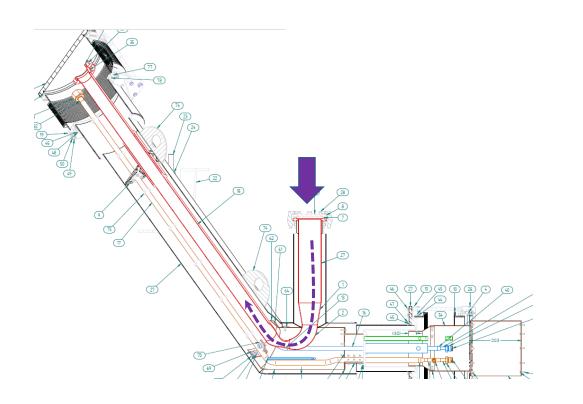
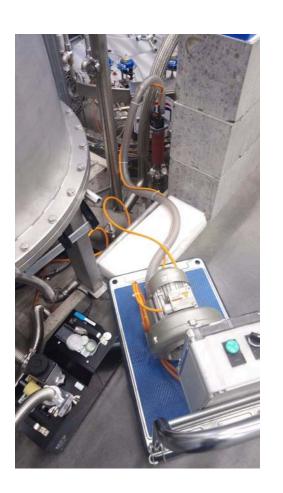
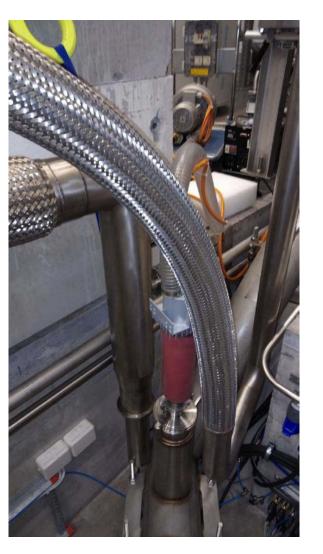
## 4. Blow hot air (ca. 50C) through bayonnet and let air out after TL016 outlet in VB (see graph next page)

- Pumping circuit at ca. 330 K
- Other LHe circuit at ca. 300 K
- Thermal shield TTs at ca. 300 K
- Did not see any hot spot on the joints where the bayonet meets the TL

#### VB, VCS and TL012 NOT under vacuum

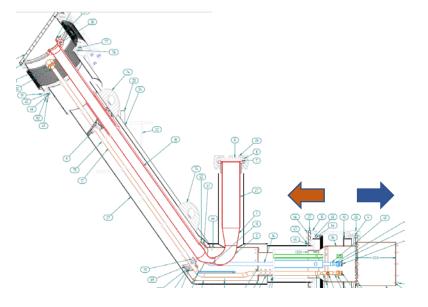
## 5. Visual inspection from TL012 lower bellow into VB

- Lines are separated thanks to the spacer, but
- Between the spacer and the bayonnet
  - One seems to be in contact with the copper shield
  - They are round each other, not sure if in contact

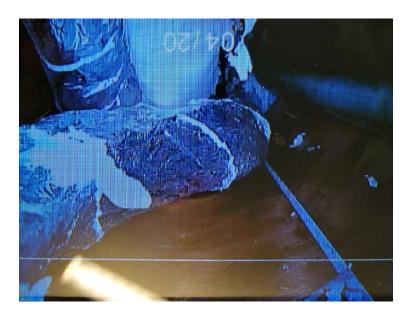
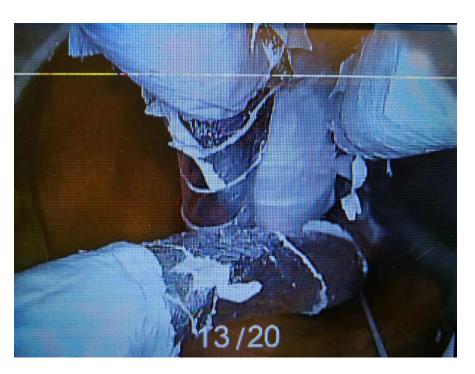
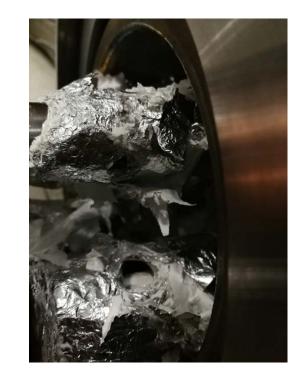
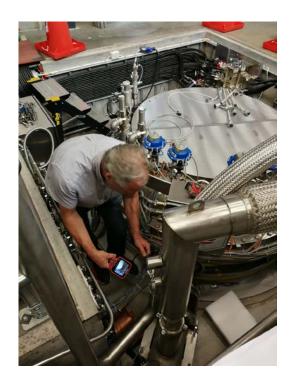
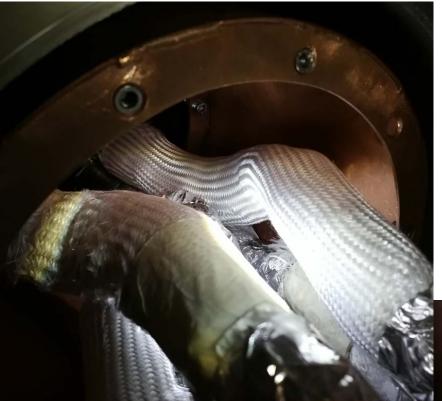
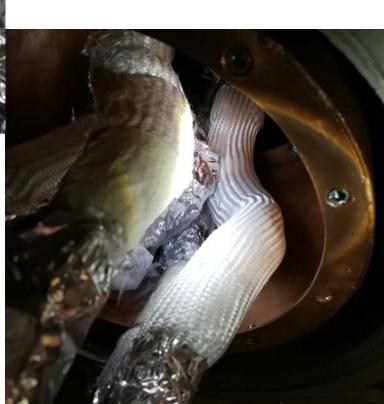
- 6. Visual inspection from TL012 lower bellow into VCS
- SCHe line touches a bit the thermal shield
- Both Lhe lines are touching LN2 lines

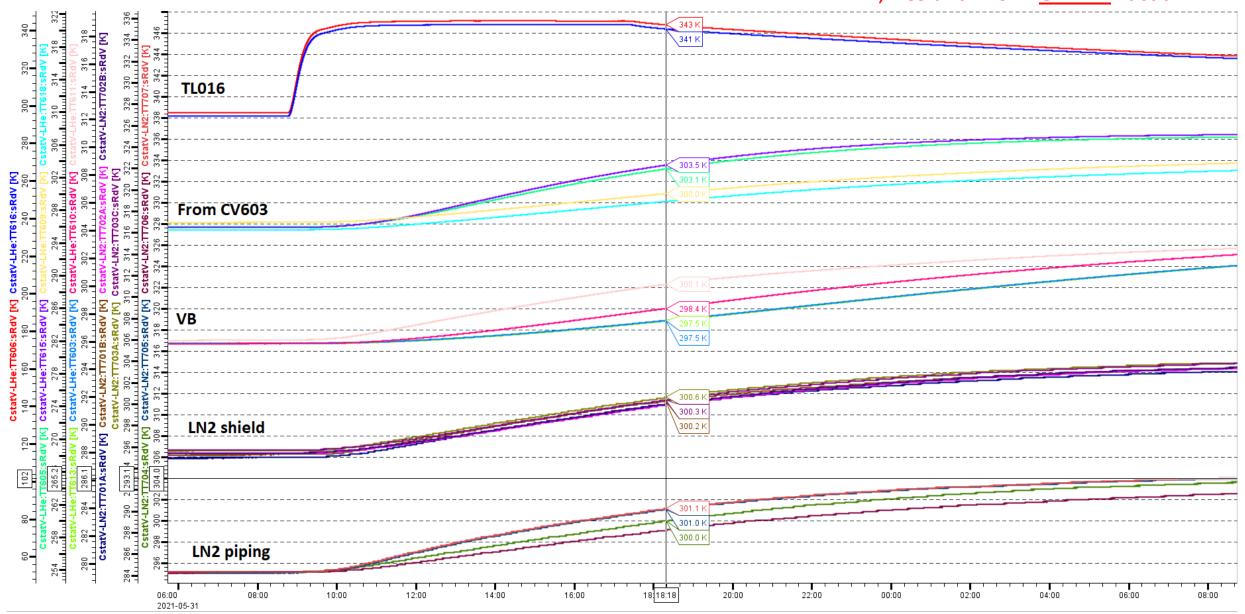
### VB, VCS and TL012 UNDER vacuum

- Pumping circuit at 347 K
- Other LHe circuit at 303 K
- 4K tank at 297 K
- LN2 shield TTs at 300 K
- LN2 piping at 301 K

Stopped after a few hours. Did not want to leave the hot air running through the night.
