Issues in DB station and TH595A

A. Miyazaki, M. Zhovner, T. Peterson and R. Wedberg

Issues in DB station

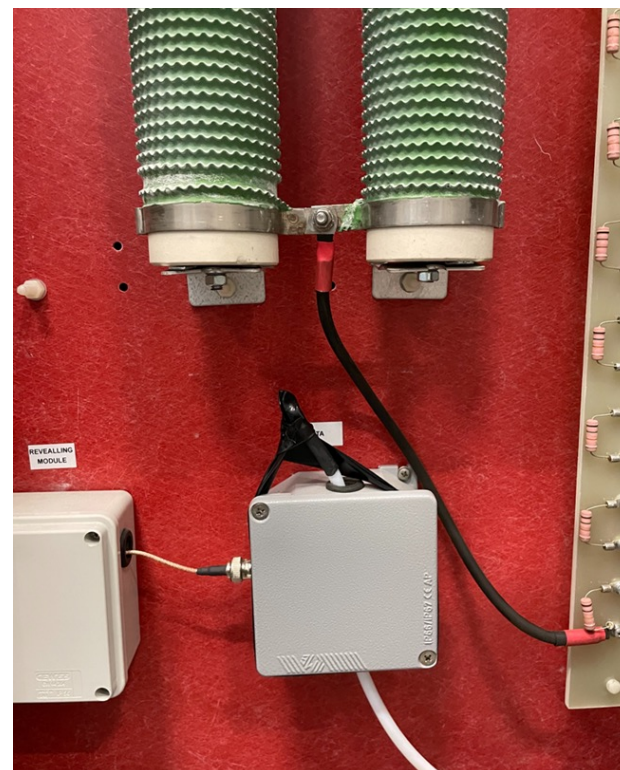
Cavity passed the HV test

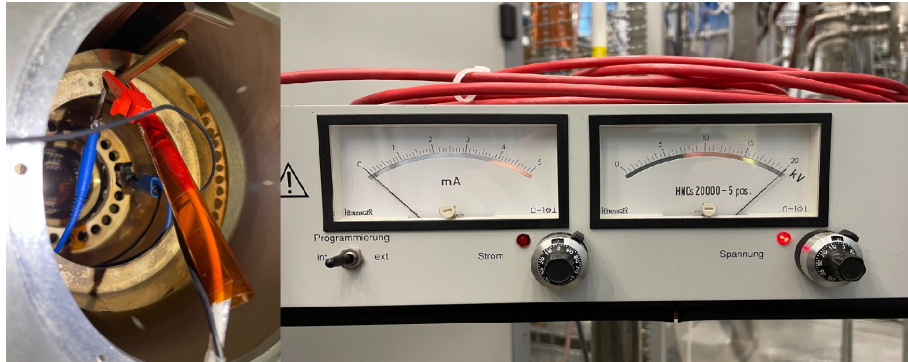
Tube did NOT

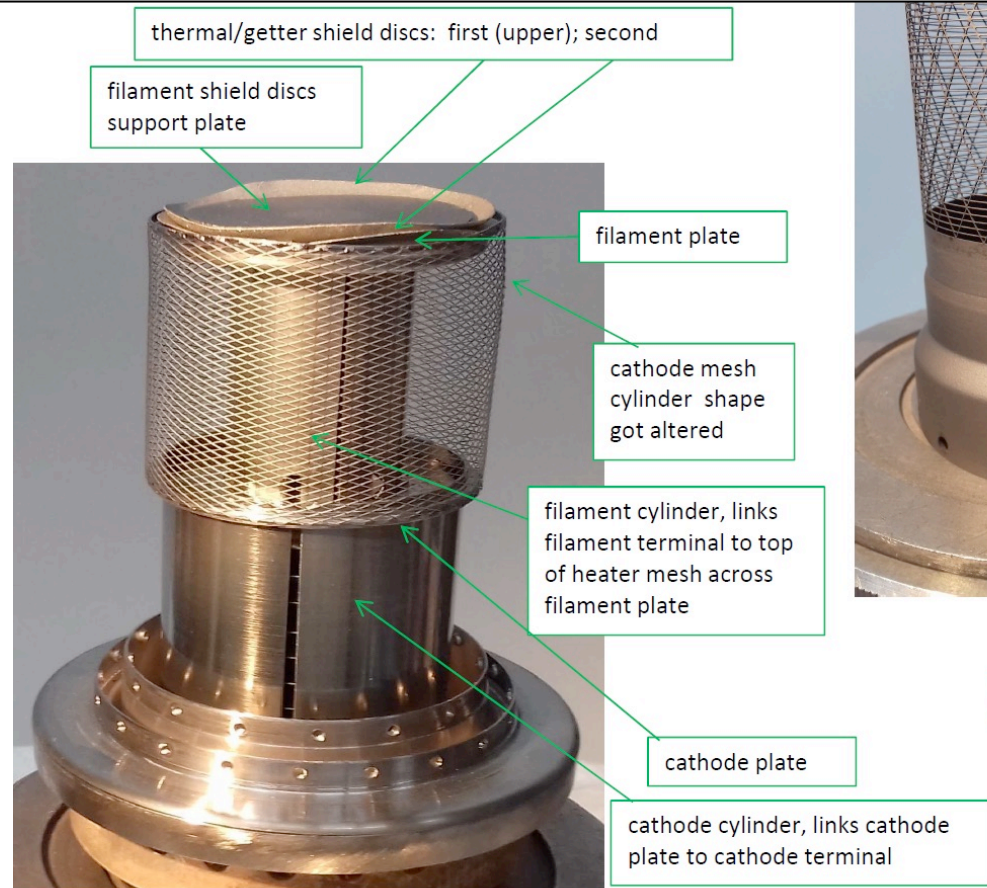
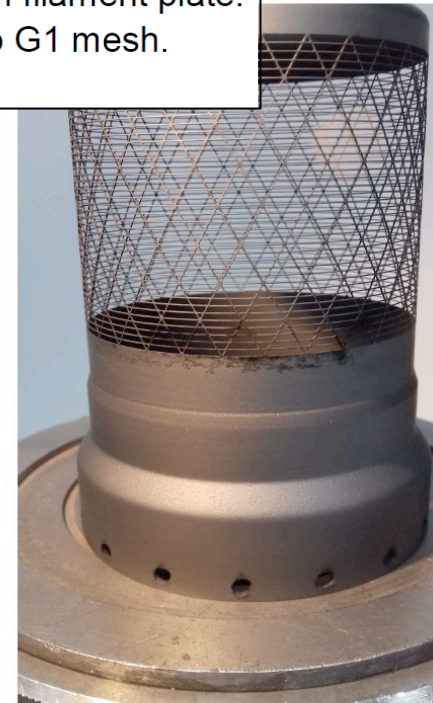
The upper (first) thermal/getter shield got deformed. The second one got partially stuck with filament plate. Filament plate deformed, resulting in cathode deformed, and cathode eventually in touch to G1 mesh. Marks of severe arcs, G1 to G2, at the bottom of grid mesh. (see picture of G1)

several arc marks
below the bottom end of
G1 mesh

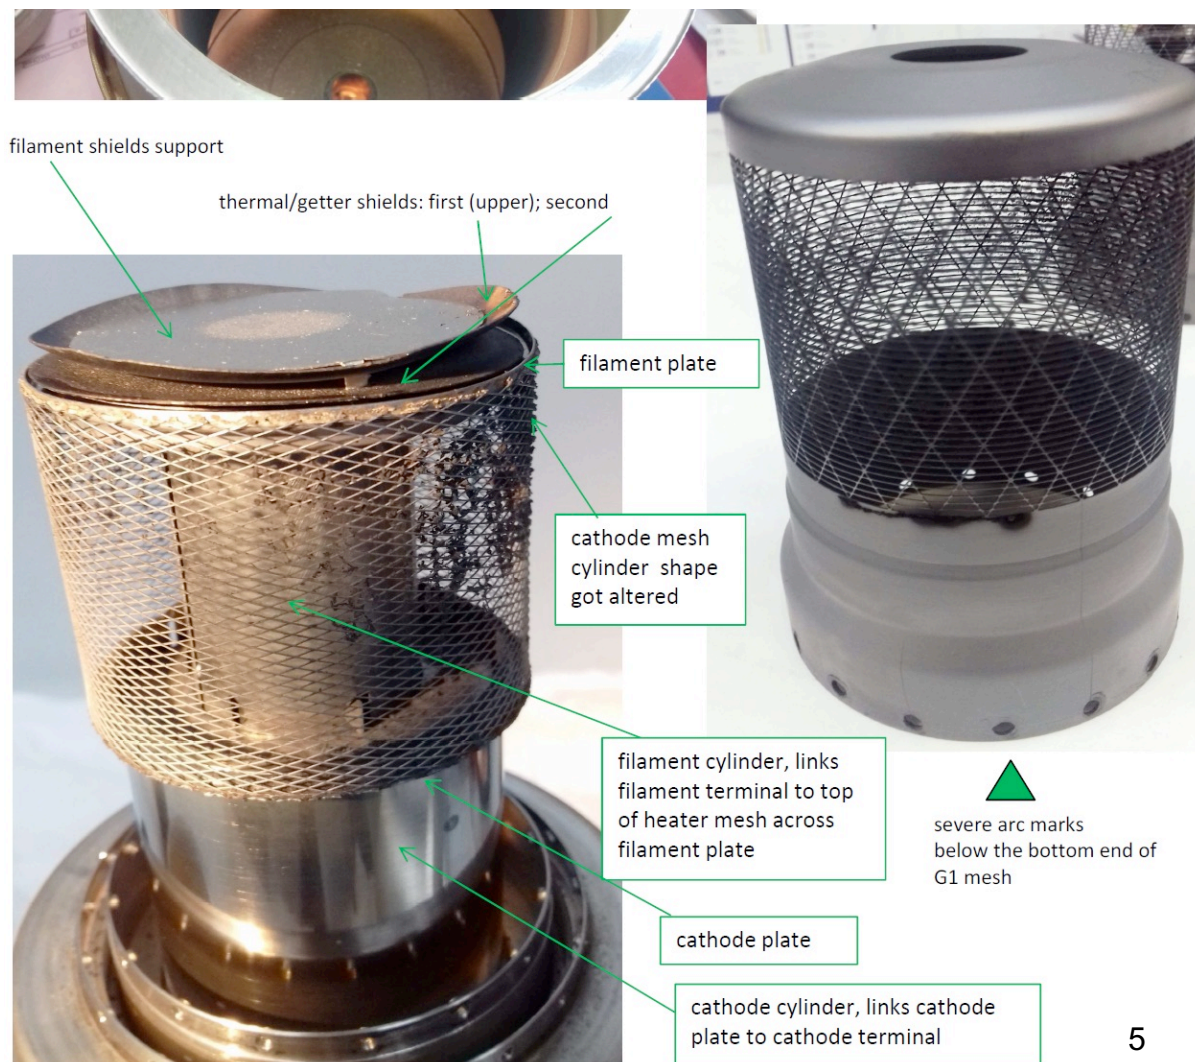
- Anode inner surface got blackened. Main insulator got darkened (see picture)
- Marks of severe arcs, G1 to G2, at the bottom of grid mesh. (see picture of G1)
- The upper (first) thermal/getter shield got deformed, which fostered electrical arc with G1 top inner surface
- The second thermal/getter shield got stuck with filament plate.
- Inside the heater cylindrical inner structure, the upper thermal shield got rolled in shape, and brittle.
- Cathode got deformed. Also, the tantalum belts, onto which cathode mesh ends are welded, got partly crushed into powder, resulting in **snow crystal-shaped particles** in-between cathode-to-G1 gap.

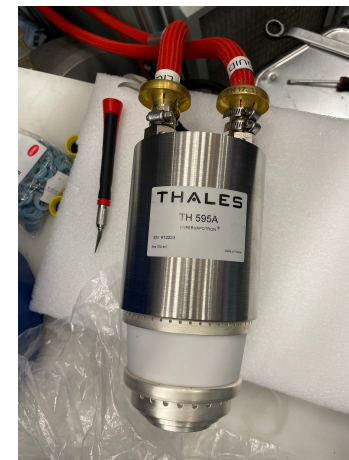
Section A 120kW

Section B 120kW

Tripped before taking
data point above 120kW

- The tube 595A 901204 was replaced to a **virgin new spare 912223**
- The new filament was flushed over one night
- OK with HV test **without RF**
- RF test with a dummy load was performed
 - Up to 120kW in section A & 120kW in section B (total 240kW)
- CROWBAR IN above 240kW
 - Not clear yet if it is from section A (with TH595A S/N907196; filament 4800 hours since 2020 March 6th) or B
 - **The issue could be from section A** → to be tested more
