# TH595A SN907196 testing

## DB Electronica 200 kWp RF station

Section A  
TH595A SN907196

Section B  
TH595A SN901204

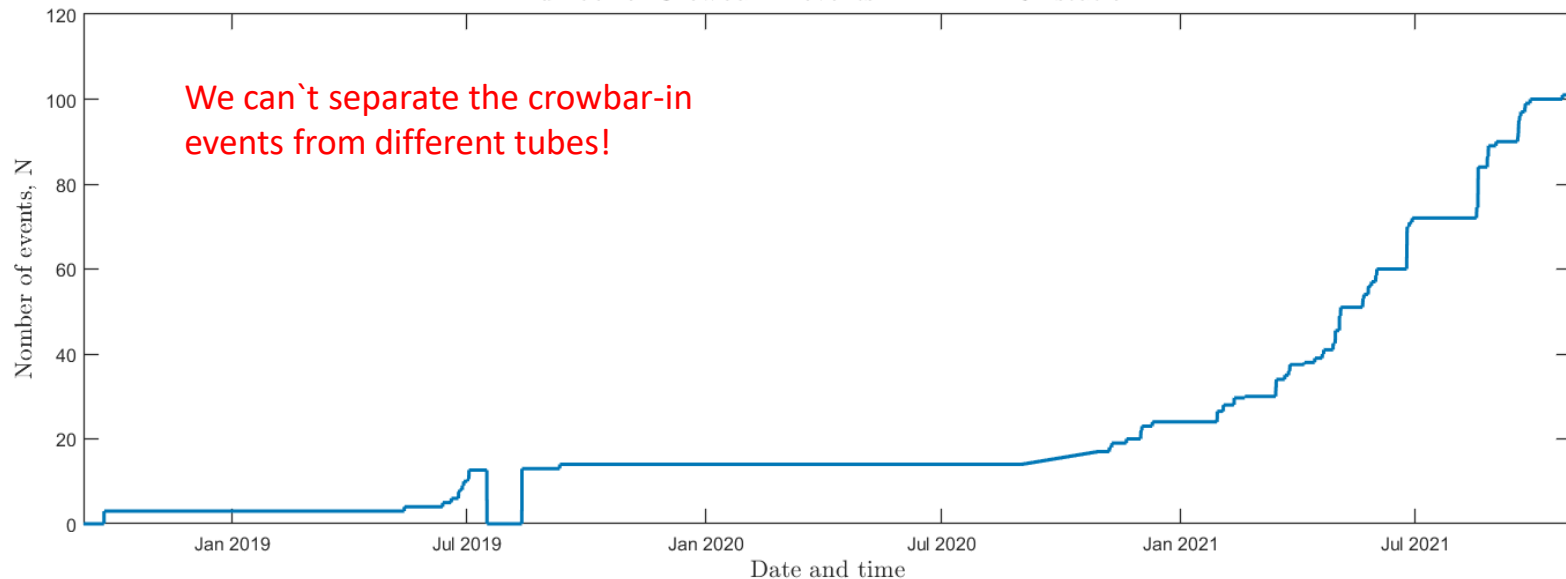
Total number of crowbars

# 100

Number of Crowbar-in events in DB HPRF station

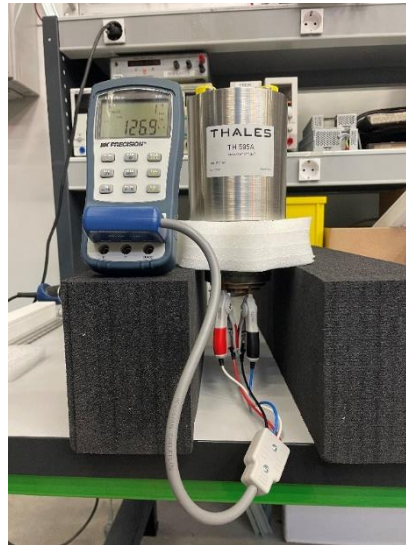
#### Interelectrode Insulation Test.

Before test. pF	After test. pF	Test report (63062854). pF
K-G1	126.9		128 ✓
K-G2	86.8		
G1-G2	244.9		243 ✓
G1-A	20		
G2-A	22.5		20.5 ✓

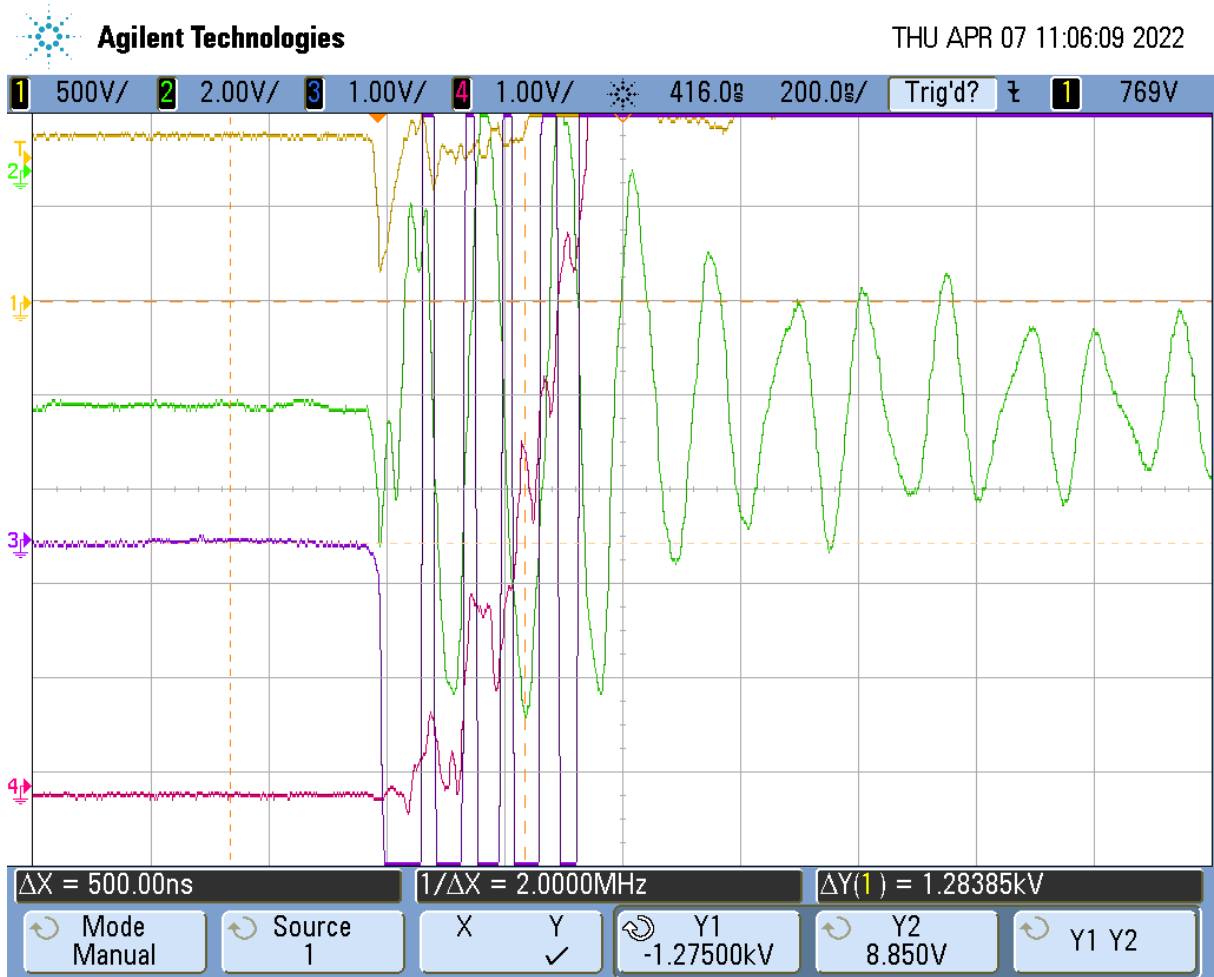
N2 – Crowbar-in at 200kW

All Crowbar-in events happened outside of RF pulse:

- Blanking time bigger than pulse duration (68ms vs 3.2ms).
- During blanking time the  $V_{g2-g1}$  is maximum.
- No influence of RF pulse to Crowbar-in events

- Ch1 - VG2
- Ch2 - IG1
- Ch3 - IG2 (Neg)
- Ch4 - Ia

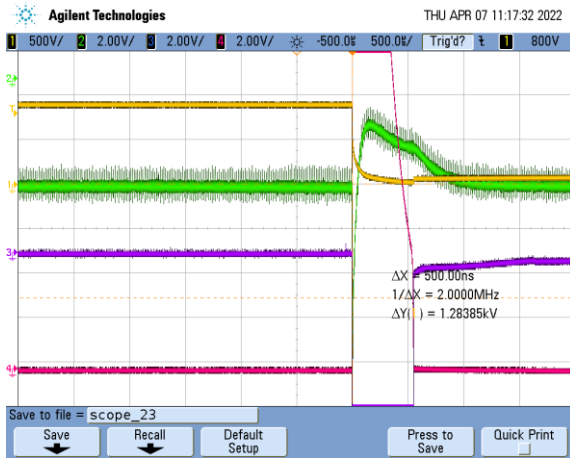
# Tripp N3

Crowbar-in at HV ON, No RF  
Just next to N2

Ch1 - VG2

Ch2 - IG1

Ch3 - IG2 (Neg)

Ch4 - Ia
