ESS weekly meeting (2022 W41)

CM10_2: General planning update

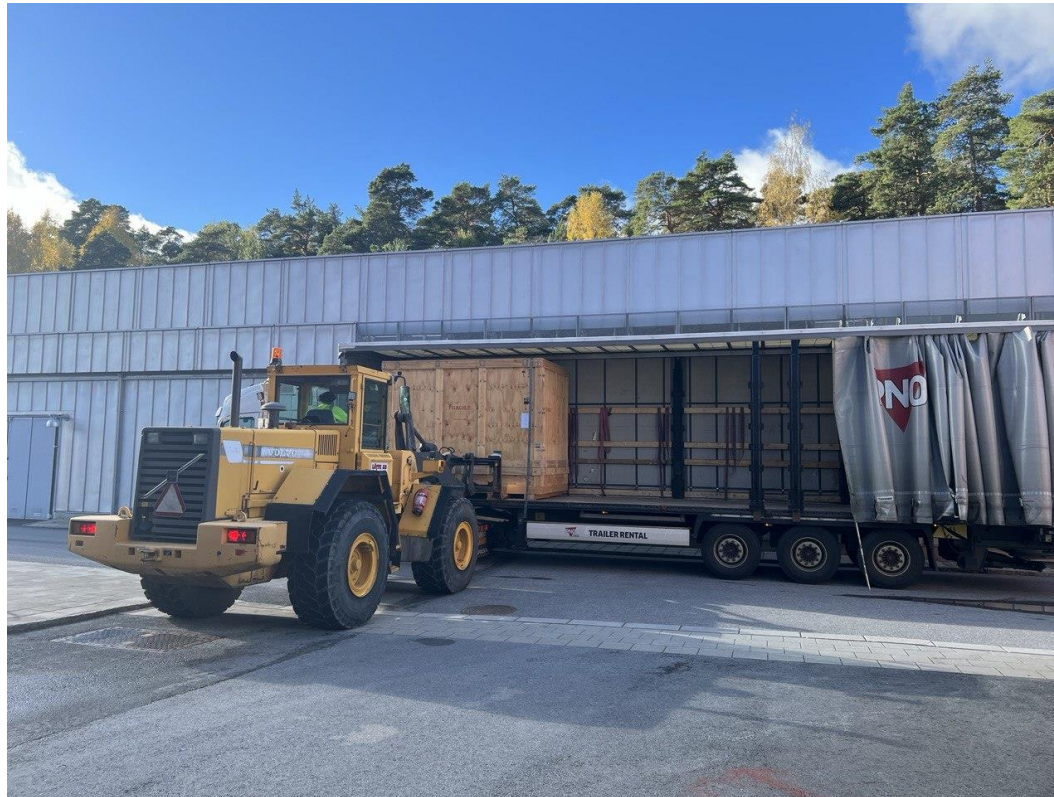
CM12 was departure to ESS

- Firstly only CM box was loaded (was only one box in transport declaration).
- ESS called the transport company and decided that the driver should come back to FREIA and pick up the pallet as well.
- Totally CM box and one pallet shipped to ESS.

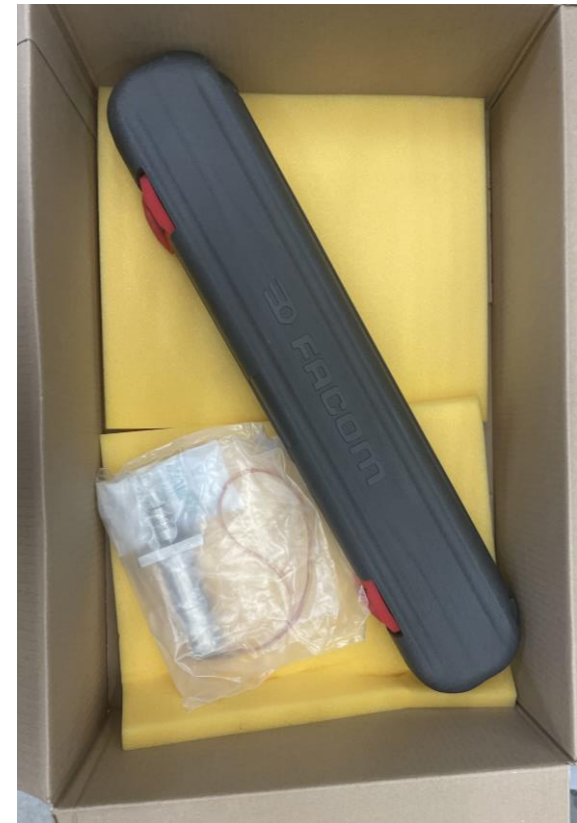
* Additional foam was added later

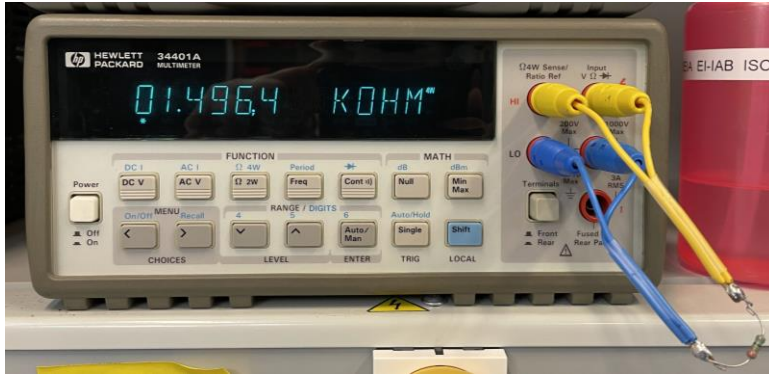
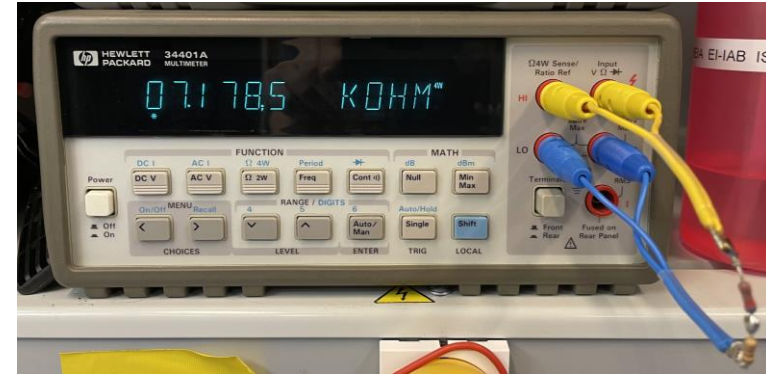
Resistance measured by 4W multimeter

1.5 kOhm

7.2 kOhm

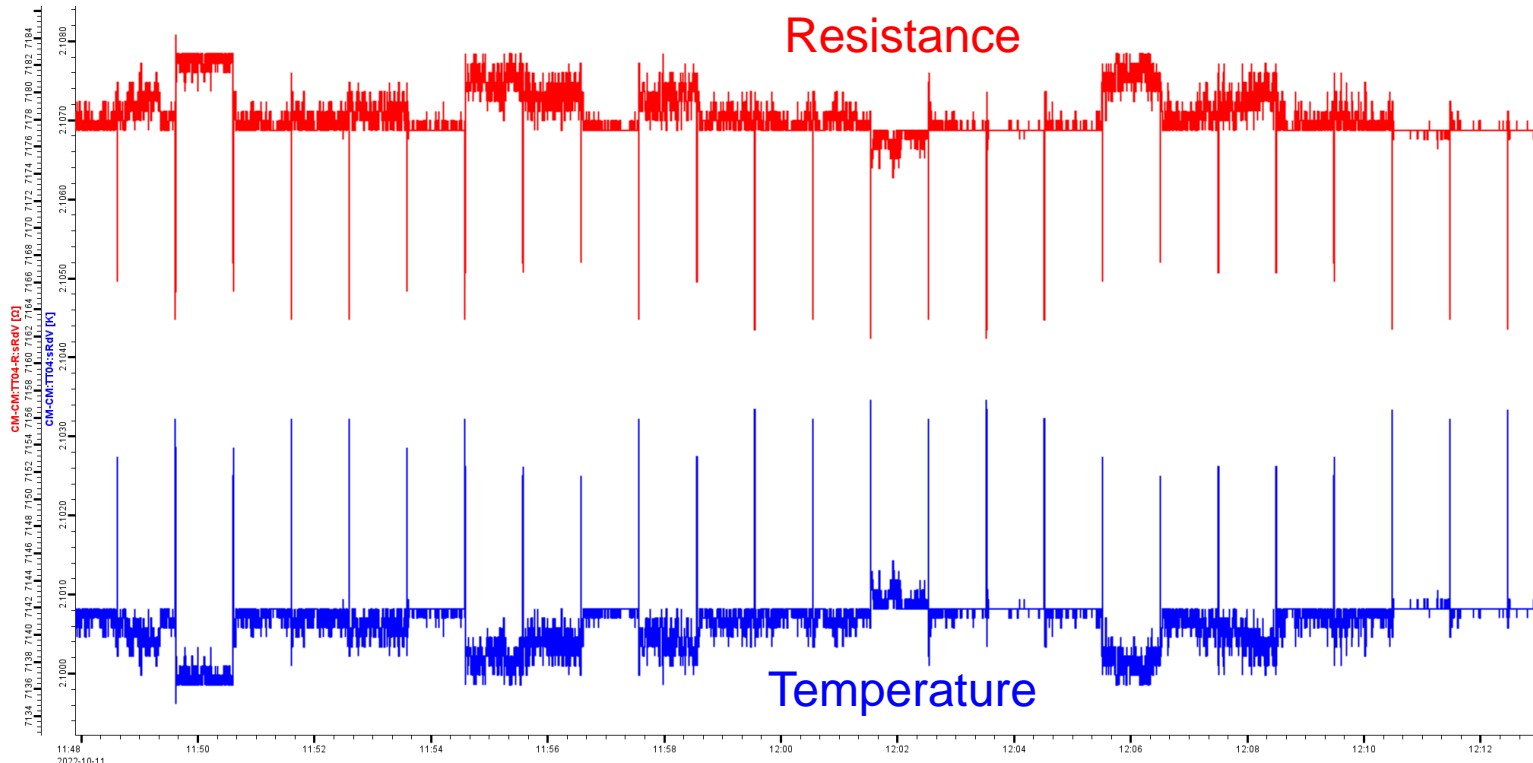
CM10_2: Constant resistors connected to CABTF (TT04 channel 7.2kOhm)

Display Name	Sample Count	Mean	Median	Standard Deviation	Min Value	Max Value	Sum
CM-CM:TT04-R:sRdV	3565	7178.681210143101	7178.61865234375	2.225961158422342	7161.81591796875	7184.23730468...	2.55919985141...
CM-CM:TT04:sRdV	3565	2.1005675583298387	2.100578295171748	3.8195129303475196...	2.09961414169862...	2.10346148983...	7488.52334544...

- Only one “sensor” connected to CABTF.
- Every minute the drops in resistance are visible.
- No clear visible spikes in archive data

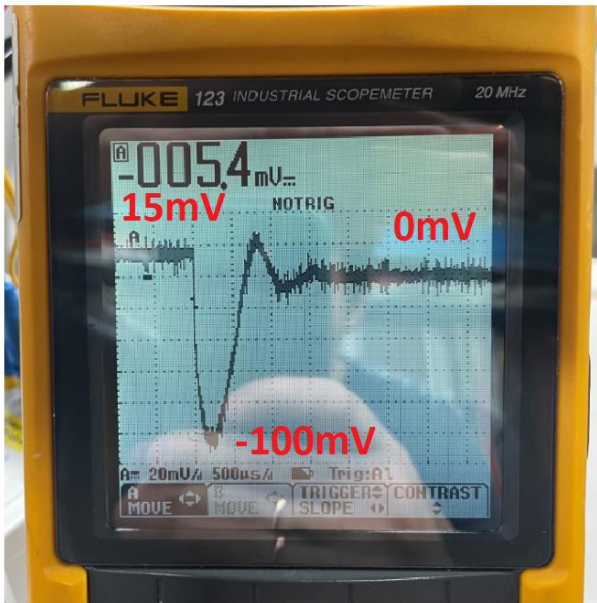
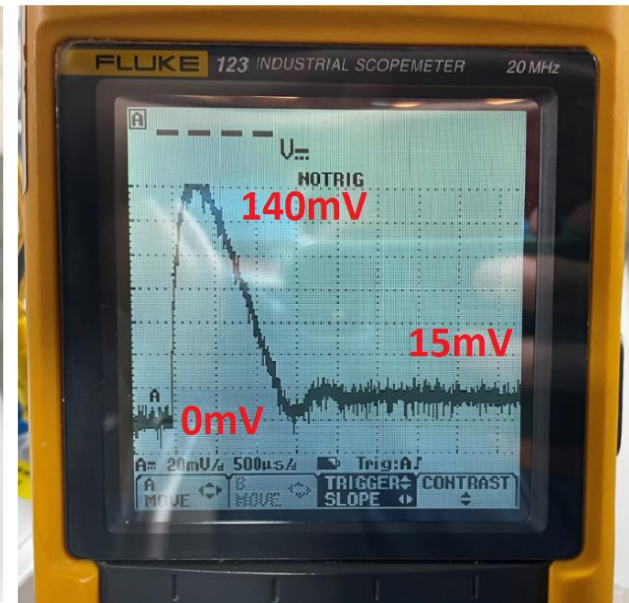
Closer looks to change of voltage across resistor

- Voltage across resistor drop drop down +15mV → 0mV for 160ms with 1Hz repetition.
- Visible transient effect: +15mV → -100mV → 0mV; 0mV → +140mV → +15mV.

Goal: Compare measurement result with another CABTF unit. More carefully look to resistance value at real operation.

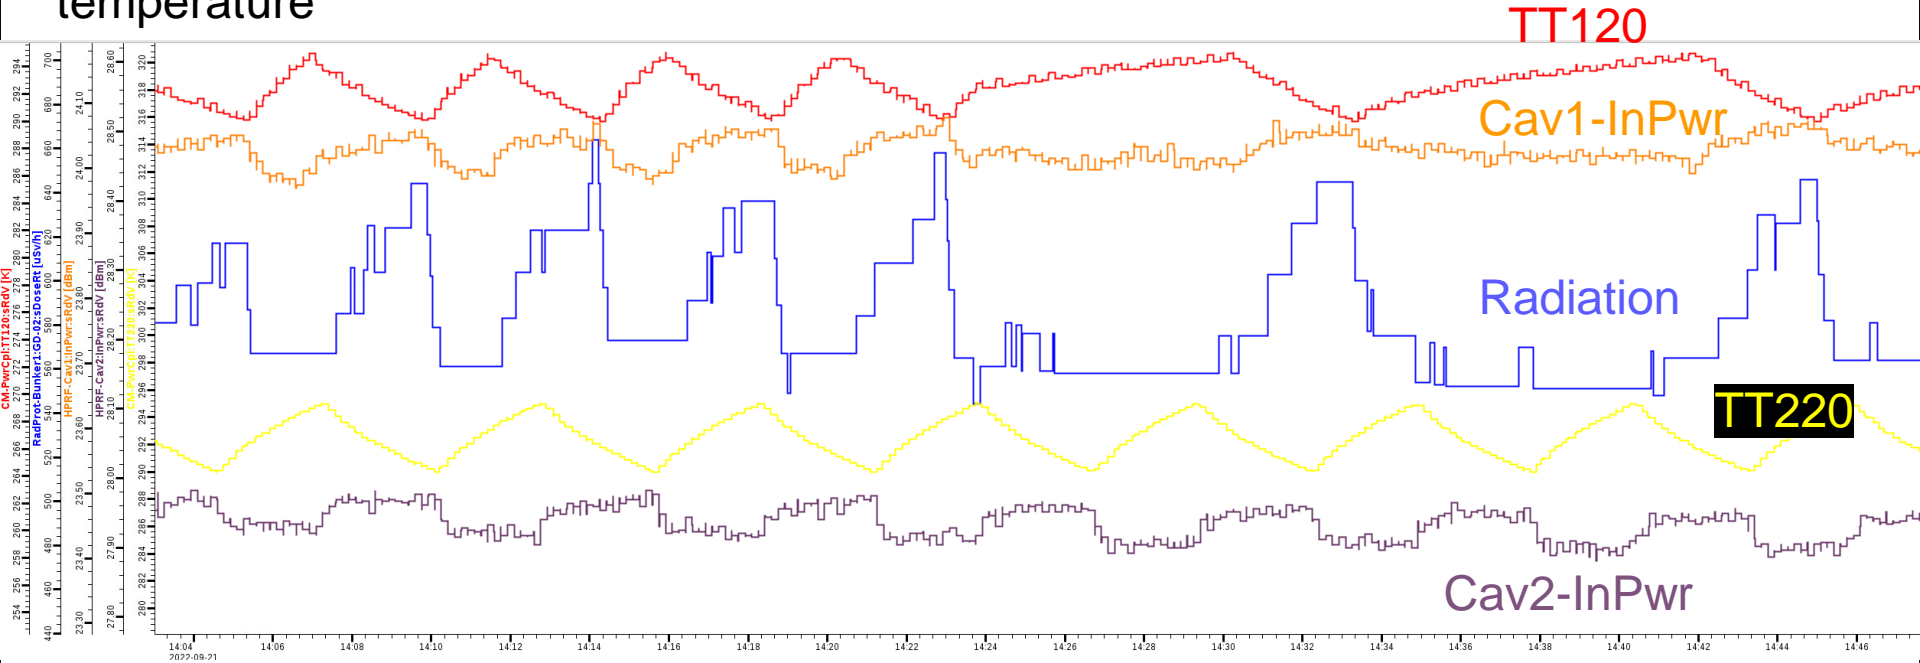
Cavities field modulation by DWT heater.

- In CM12 was found the cavities field modulation which correlate with ceramic windows temperature

- In this plot one can see that the field variation follows when the heater PID cycle in Cav1 is changed but not in Cav2

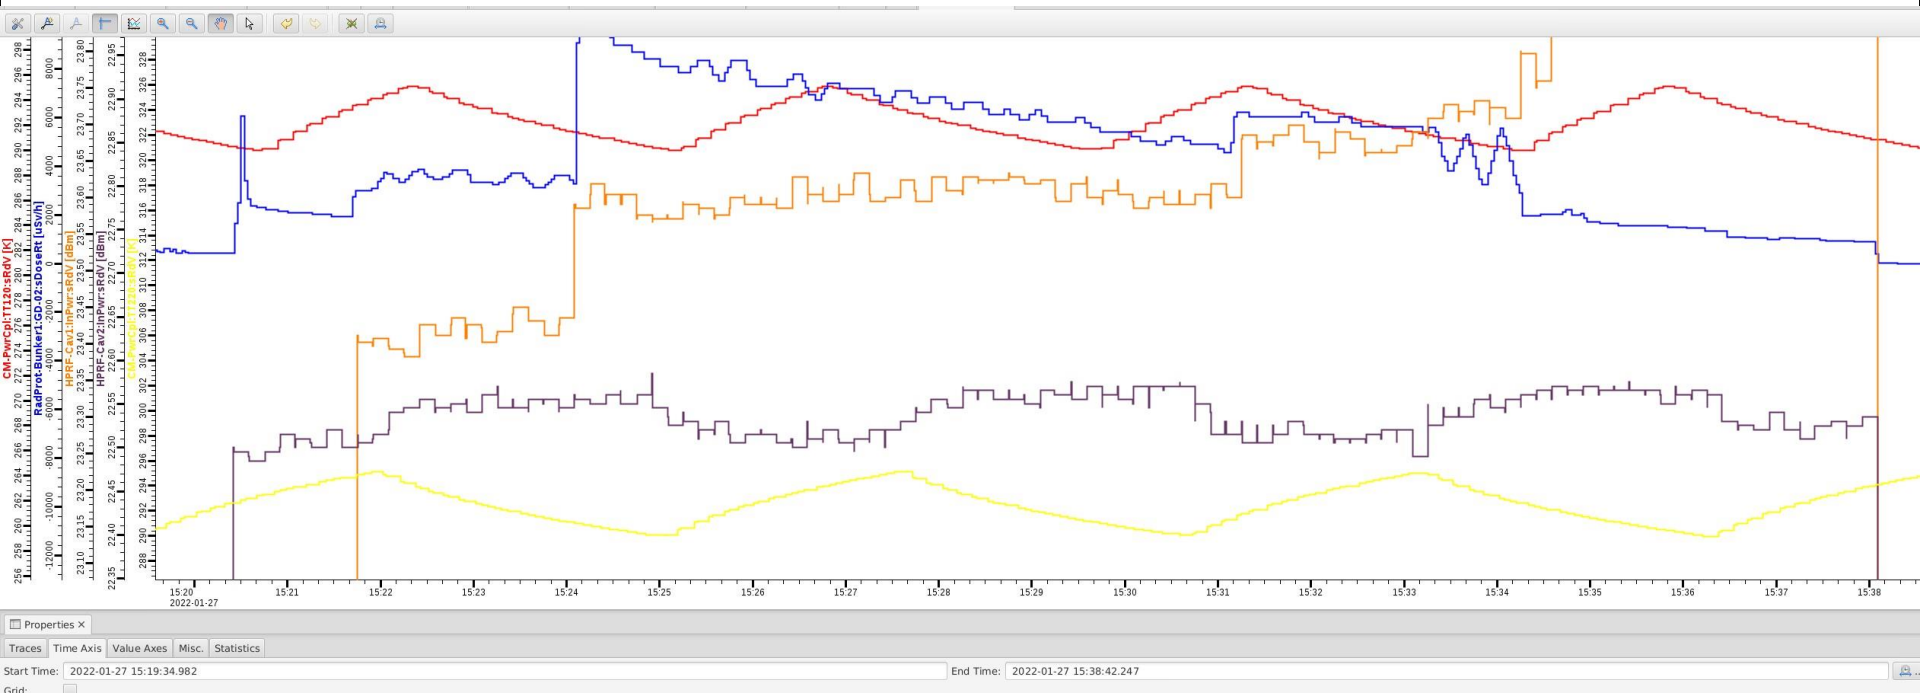
TT120 **TT220** Cav1-InPwr Cav2-InPwr Radiation

- CM07. Here one can see some correlation in CavOut but probably not in CavIn.
- Some other cavities were also checked but no good example was found.
