# Upgrade Scenarios for the Advanced Photon Source RF Power Sources

Doug Horan  
APS RF Group  
TIARA 2013  
June 17-19, 2013

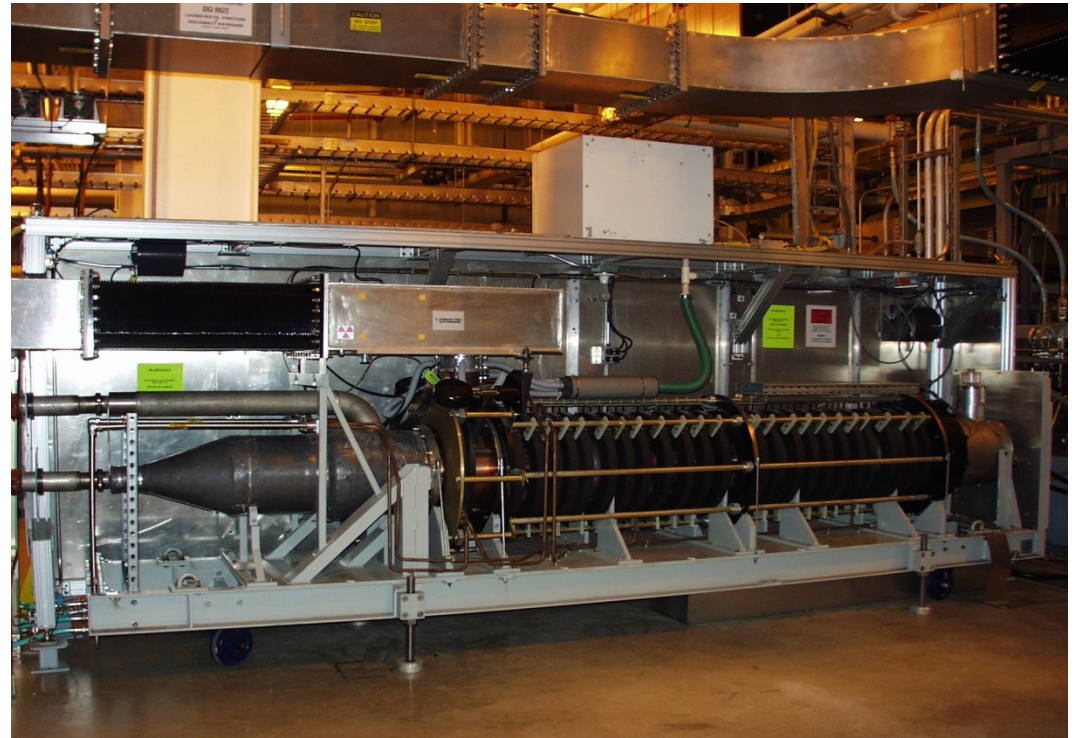
- **Five 1.1MW CW rf stations provide power to the APS accelerators:**
  - *Each rf station utilizes one klystron as a final amplifier*
  - *Each klystron requires a dc input power of  $\sim 88\text{kV}/14\text{A}$  dc to support  $102\text{mA}$  operation*
  - *Klystrons are cooled by 450 GPM of DI water at  $90^\circ\text{F}$  supply temperature*
  - *Typical rf output power for storage ring rf stations is  $\approx 675\text{kW}$  cw*

**352-MHz/1.1MW cw klystron  
inside radiation shield enclosure**

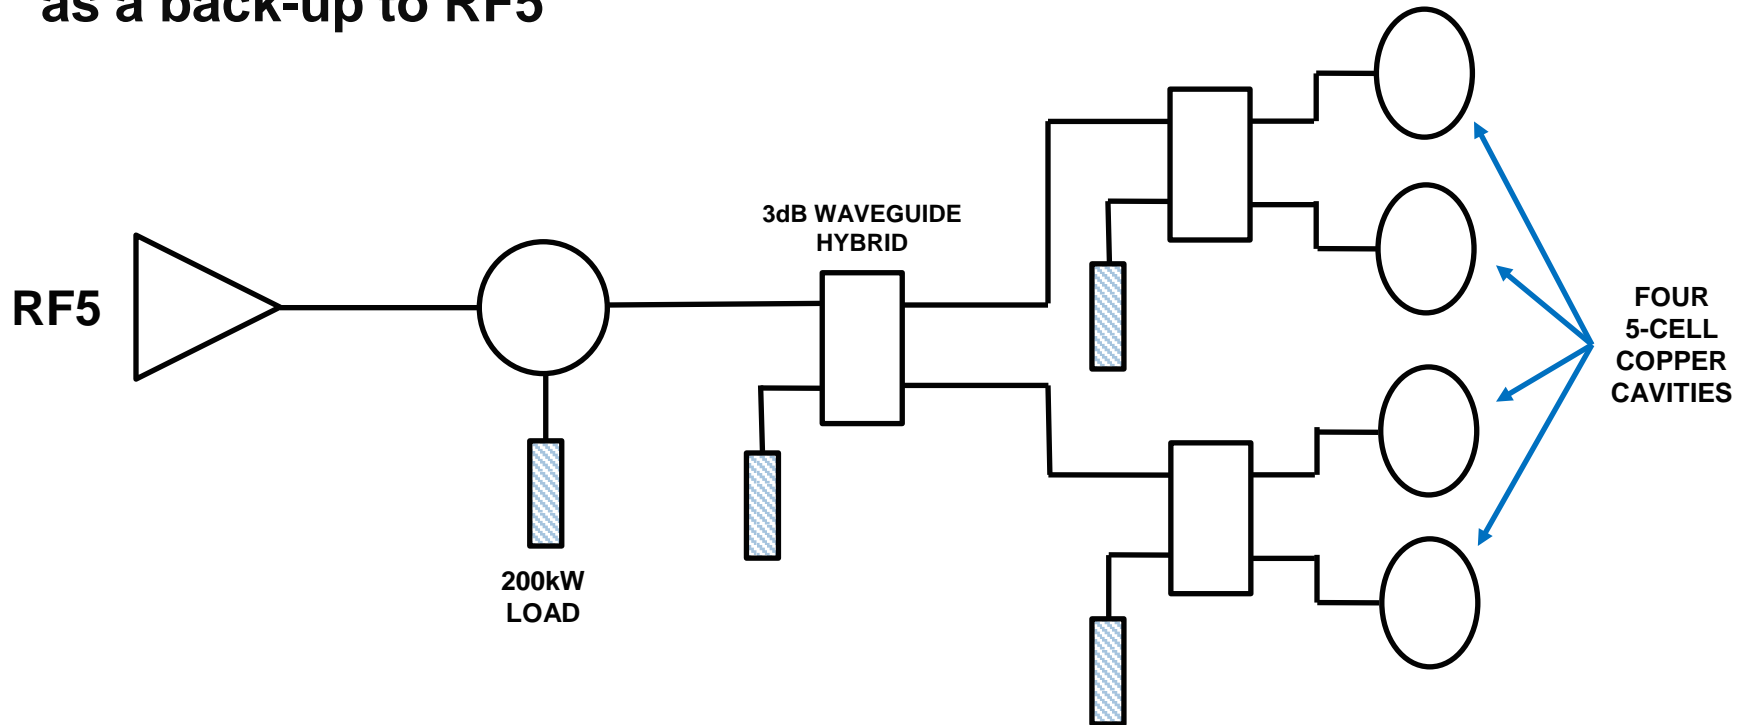
- Uses one 352-MHz/1-MW klystron (RF5) operating at 68kV/11.5A
- RF drive is 253ms ramp from 5kW to 400kW peak at 2Hz repetition rate → *400kW peak, ~ 120kW average power*
- Waveguide switching system allows storage ring station RF3 as a back-up to RF5

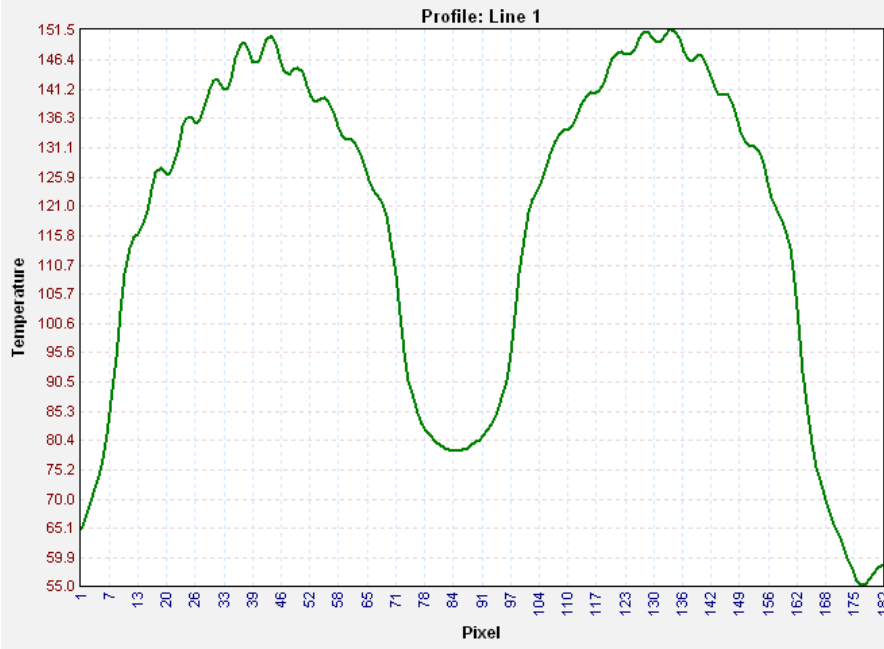
- Maximum die temperature at 1,010 watts output was 151.5°C
- 70% efficiency

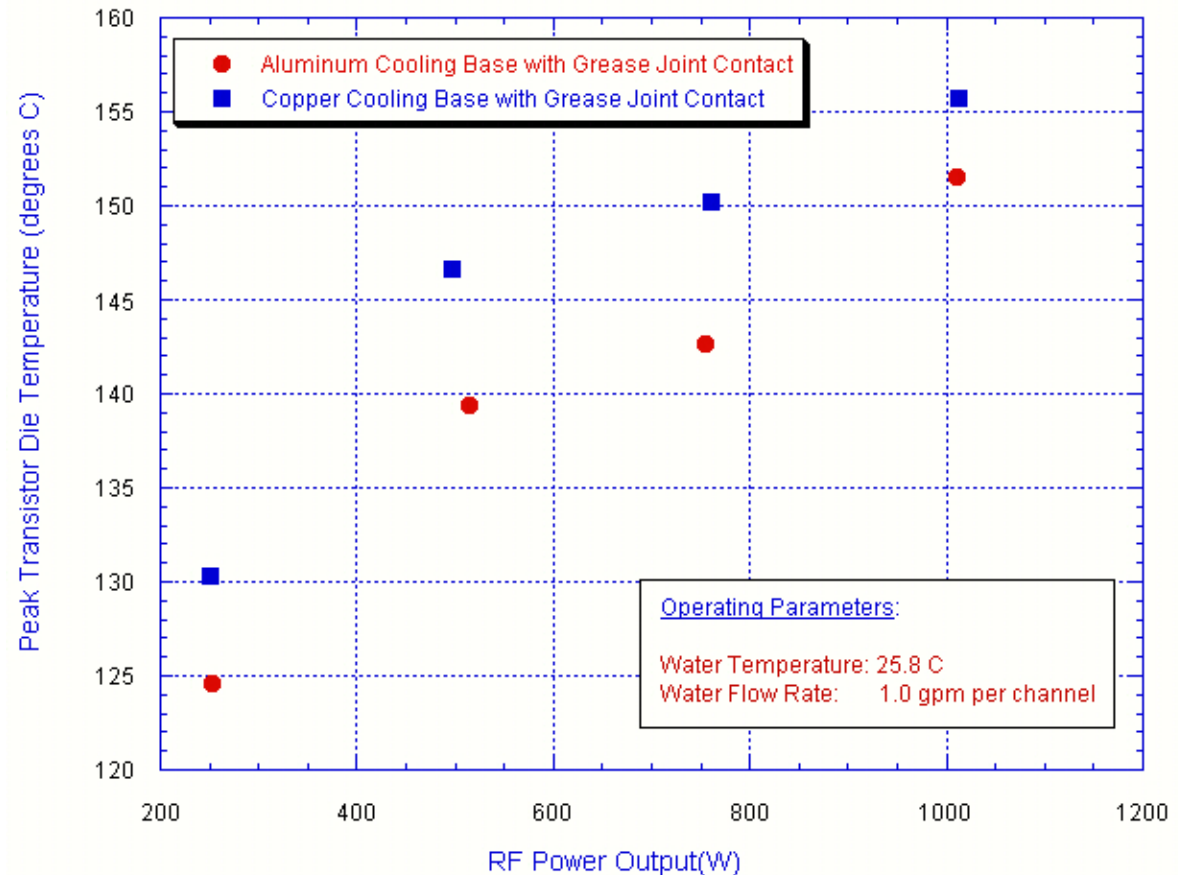
Aluminum & Copper Cooling Bases with Grease Joint Contact

- Aluminum cold plate seems to perform better
- Thermal analysis by Jeffery Collins, ANL

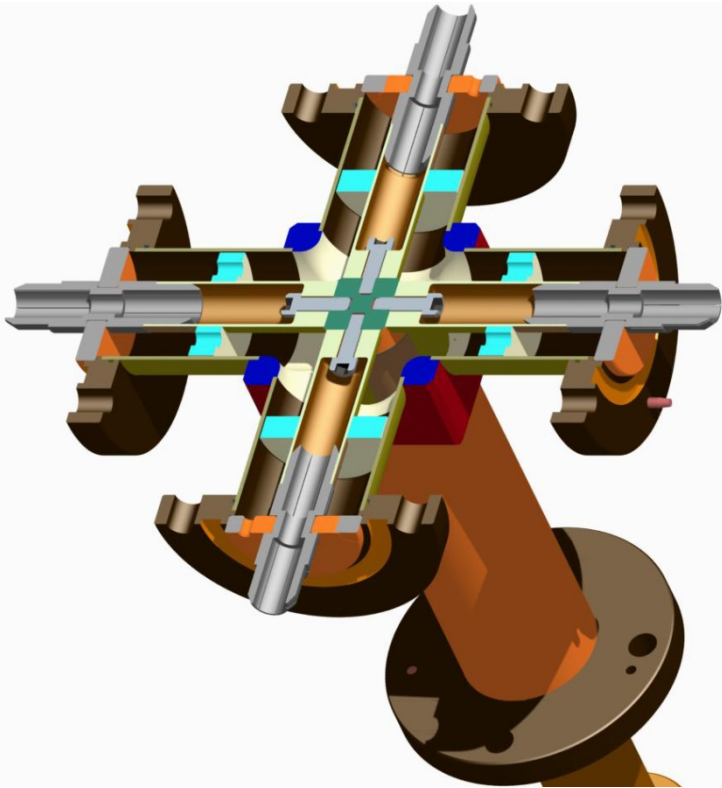
- **Constructed with 1-5/8" EIA standard coaxial components**
- **Utilizes sliding shorting plunger for tuning**

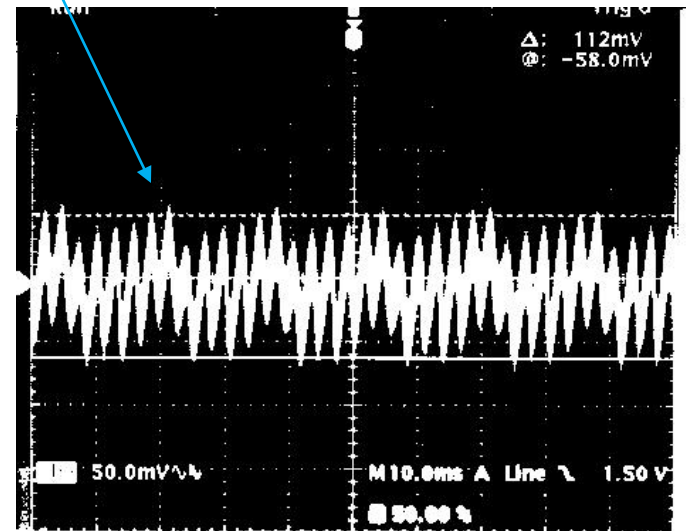
360-Hz HVPS RIPPLE, ~ 900v p-p

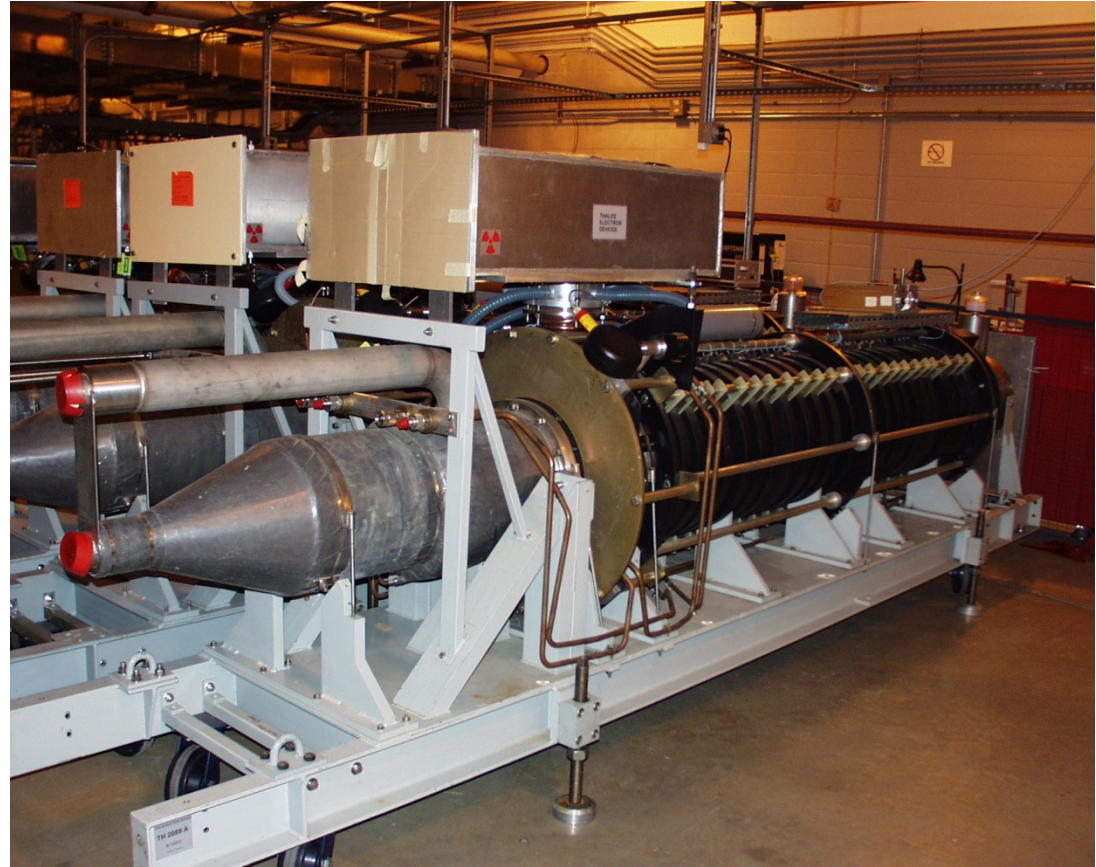
# 352-MHz/1MW CW Klystron Availability

- **Presently only one supplier with an existing design**
- **Cost per unit increased by  $\approx 300\%$  since 1992**
- **The number of operating sockets worldwide for these klystrons is shrinking**
- **Other capable suppliers exist, but NRE would be significant**

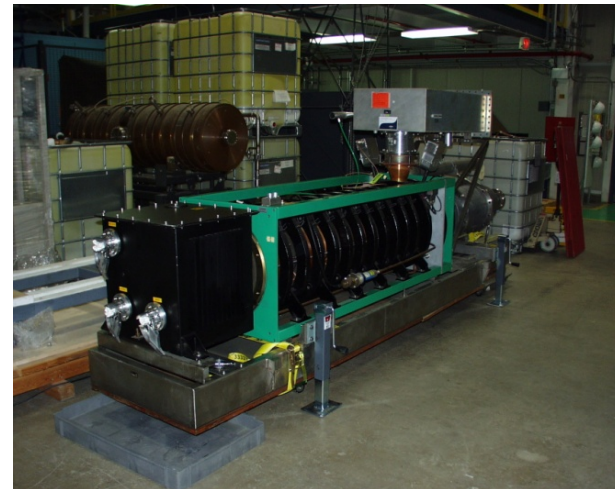
- **Average klystron lifetime at APS is  $\approx$  36k hours\***

**\* Includes all failures and end-of-life retirements since start of APS operation → 6,139 hrs (shortest) to 77,275 hrs (longest)**

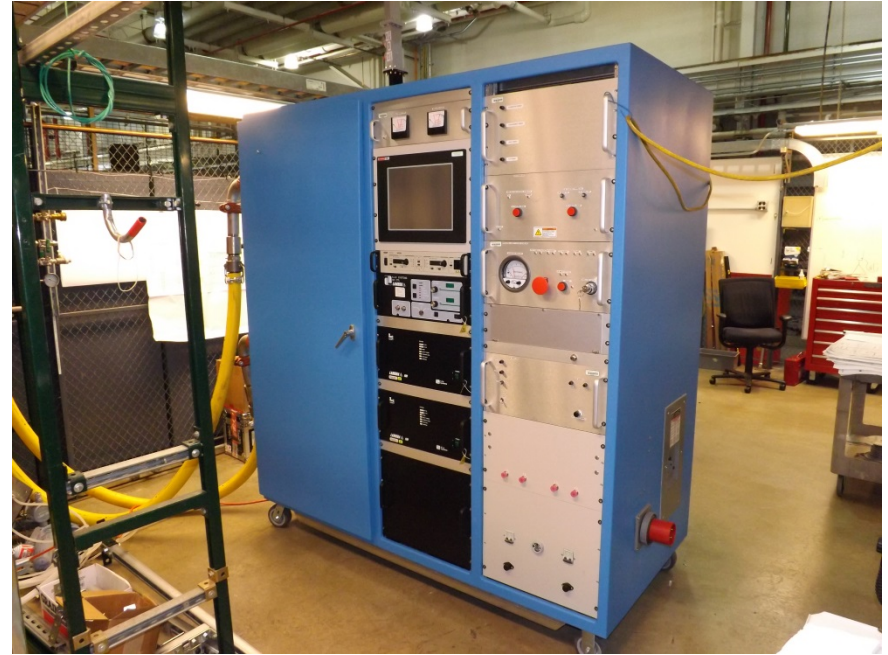
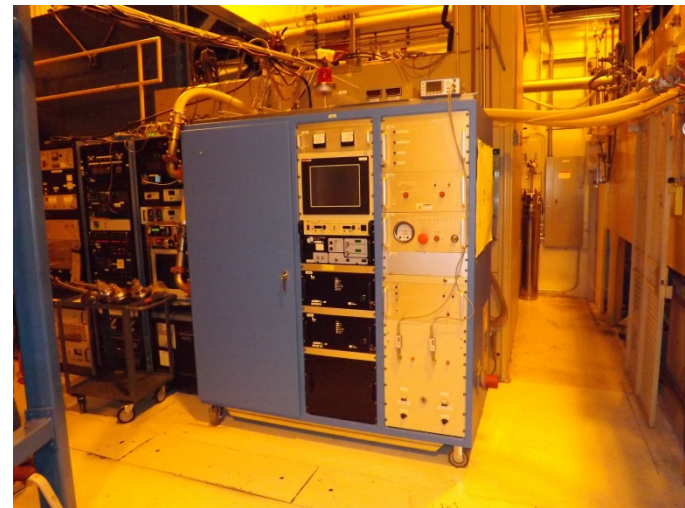
- Utilizes L-3 L4442 PM-focus klystron
- 50kW output isolator and internal RF test load
- Includes waveguide shutters between klystron and isolator input port
- Ultra-low ripple HVPS for minimal phase and amplitude noise on output

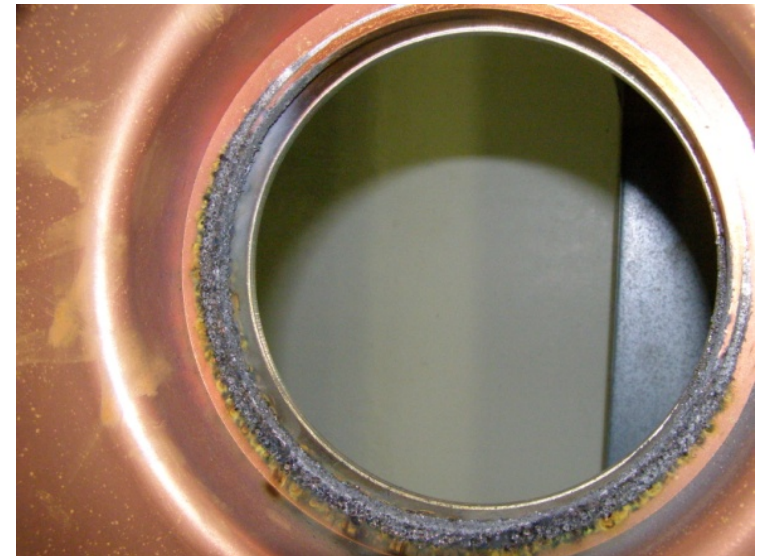
- Arcing at waveguide transition caused by degraded rf contact with waveguide transition matching post
- Coupler had to be replaced after 17 years of service!
- Same problem seen on one other coupler, but not as bad
- One coupler will be disassembled for inspection every shutdown from now on

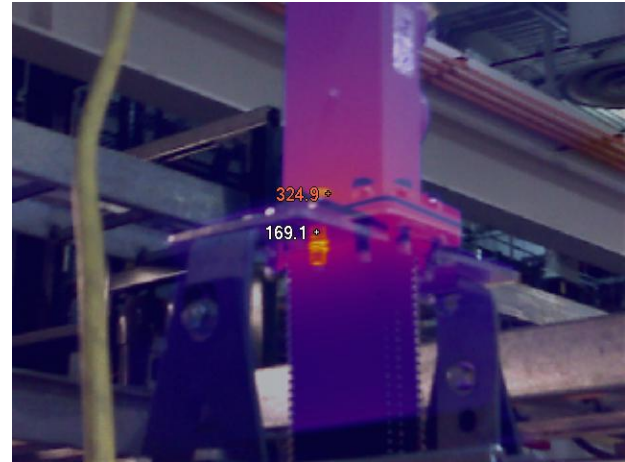
HOT FLANGE BOLT DUE TO IMPROPER TORQUE  
≈ 2kW cw

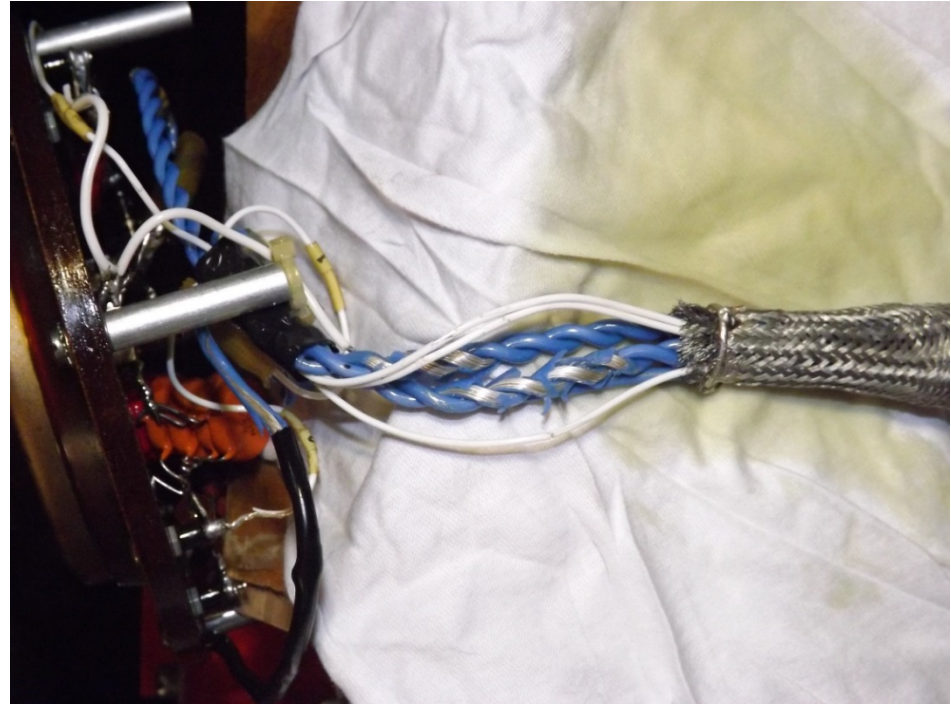
- **Caused intermittent drop-out of klystron mod-anode voltage due to shorts between frayed wiring and shield braid**
- **Long-term exposure to x-rays from tetrode tubes over 18 years of operation is suspected as root cause**
- **All tetrode socket wiring to be replaced**

**DAMAGED INSULATION ON WIRING  
LEADING TO TETRODE SOCKET**
