ESS spoke CM04/CM02 (2nd run)
weekly meeting
20210225
Han Li

- CM04 warm up
- CM04 leak test
- CM04 alignment test
- CM02 arrival
- Test plan

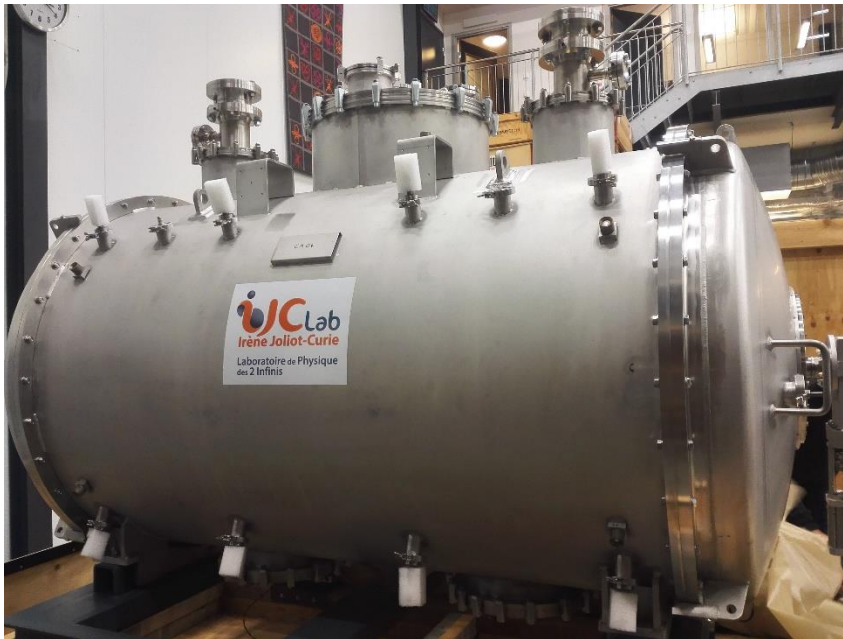
- CM04's warm-up took around 3 days
- Breaking insulation vacuum (by injecting N_2 gas) is effective to shorten the warming procedure

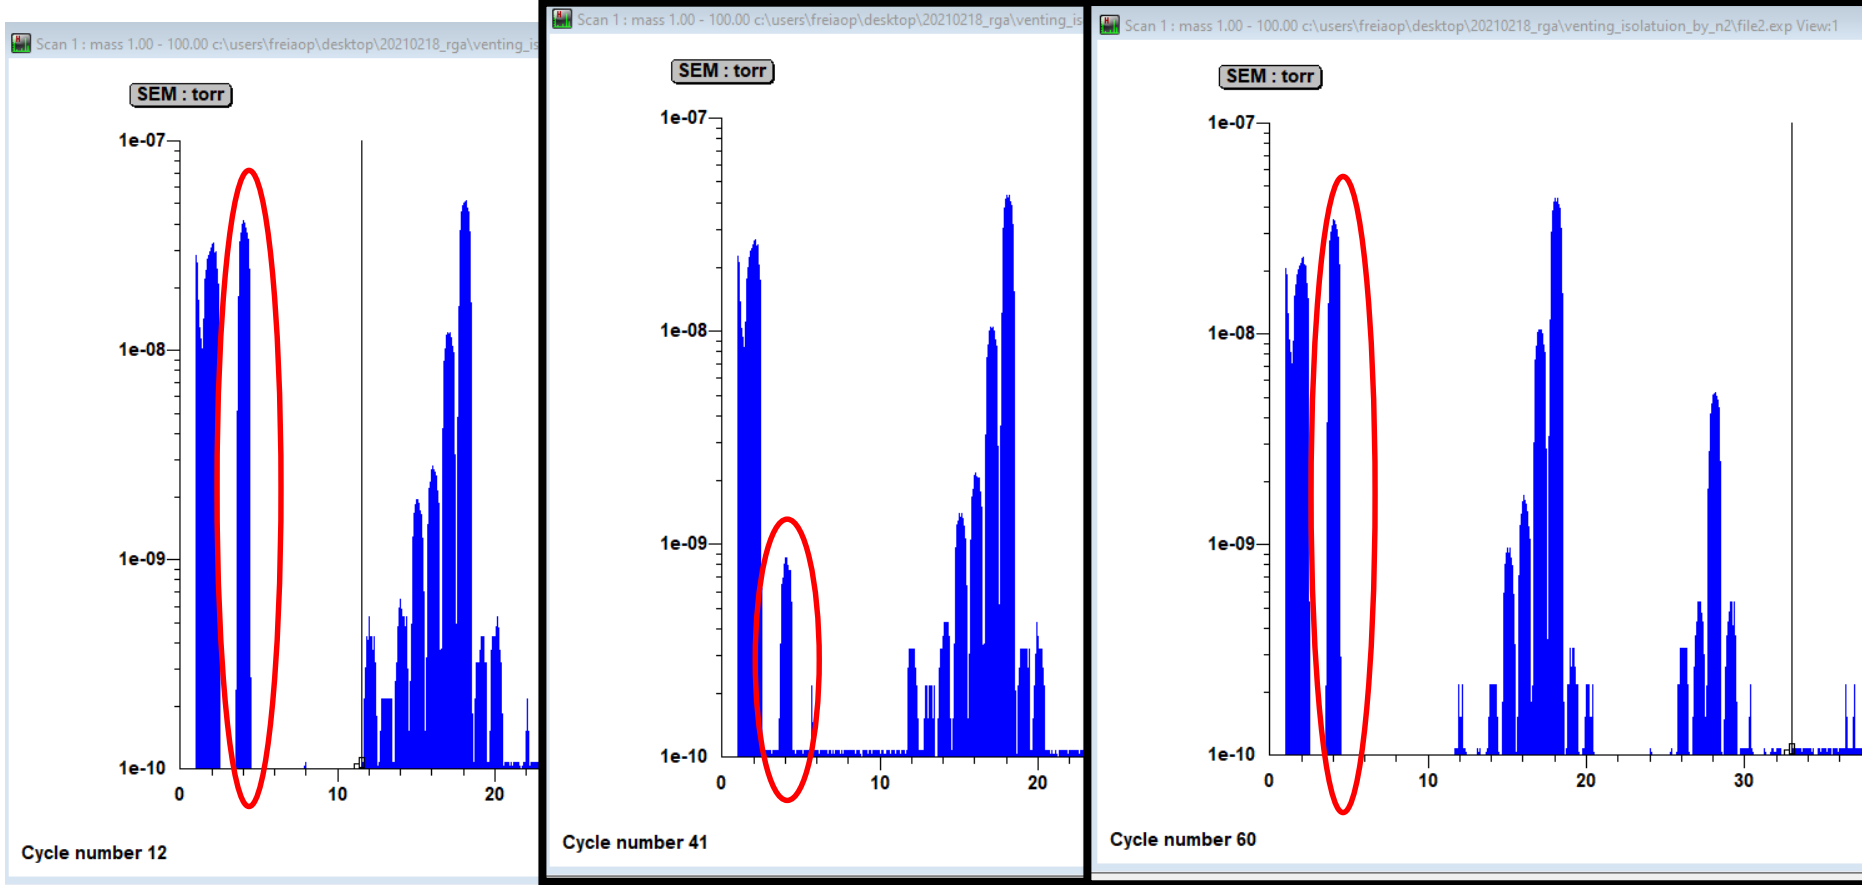
- 2nd run:
- ✓ Isolate the 4 K tank and the 2 K tank by closing relate valves (CV01, CV02, CV07, CV04 for the cryomodule)
- ✓ With RGA connected and angle-valve on
- ✓ Start purging procedure , pump down the 4 K tank(< 10 mbar) @ RT
- ✓ Monitor pressure in interested region:
 - Cavity helium vessel pressure (2 K tank , PT03)
 - FPC supercritical helium line pressure (4 K tank , PT01)
- ✓ Refill the helium circuit with helium gas to 1 atm

Purpose: localize the leaking position

the pressure is only pumping down in the 4 K tank (including the supercritical helium line)

the 2 K tank pressure(including cavity vessels) are constant (PT03 around 1025 mbar)

supercritical helium line pressure ↓ Helium peak ↓

supercritical helium line pressure ↑ Helium peak ↑

- Leak test with purging system at warm
- **conclusion: the leak is in FPC line (the double wall tube of Cav_OUT?)**

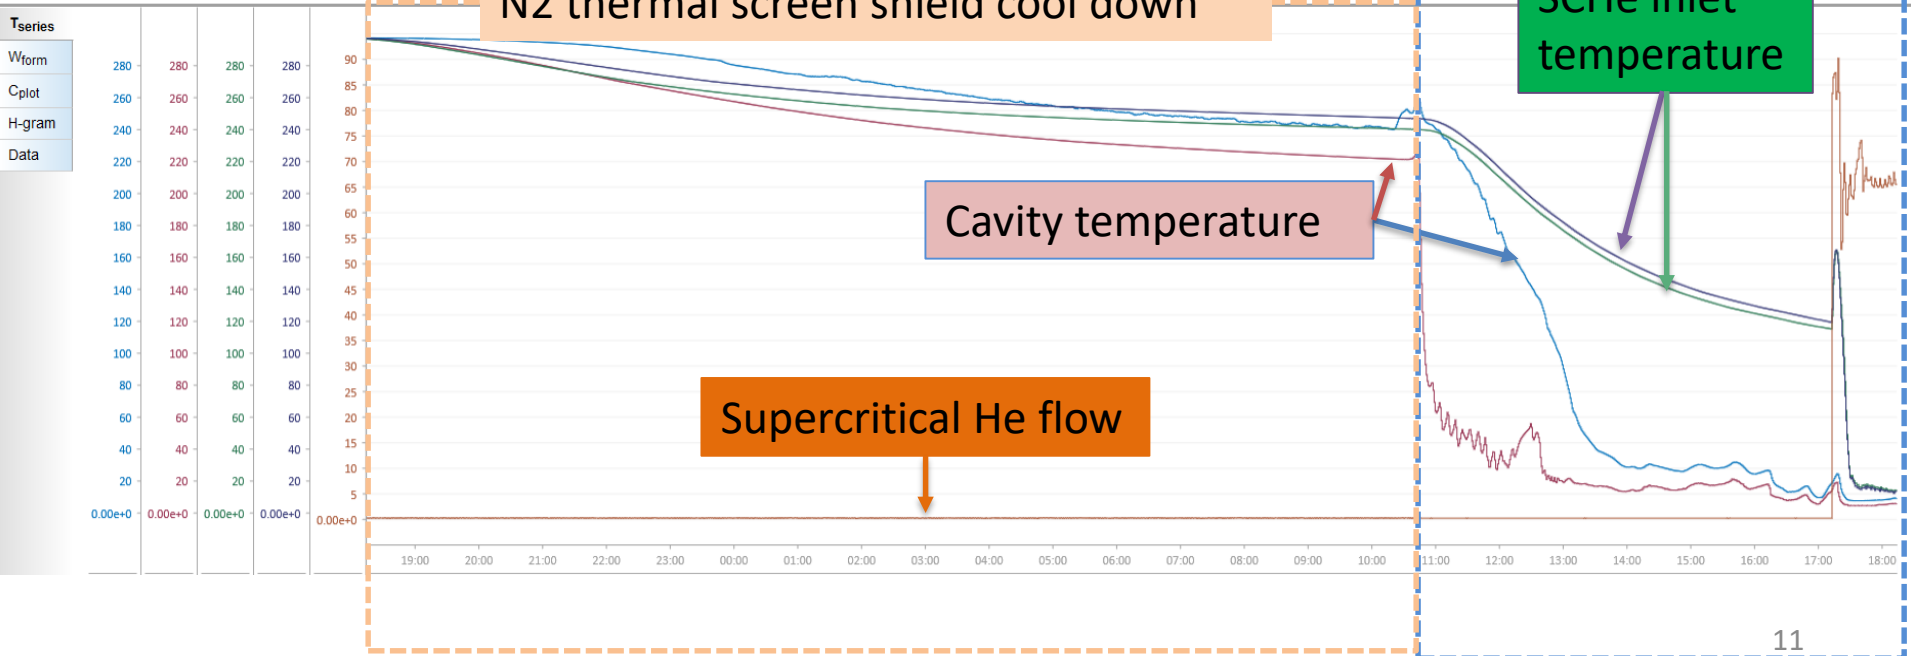
- FPC cooldown: from 240 K -> 120 K within 6 hours **0.33K/min**
- from 120 K -> 15 K within 0.5 hours **3.5K/min**
- a temperature peak due to warm He gas from 120 -> 160 K
- from 160 K -> 15 K within 15 min **9.6K/min**

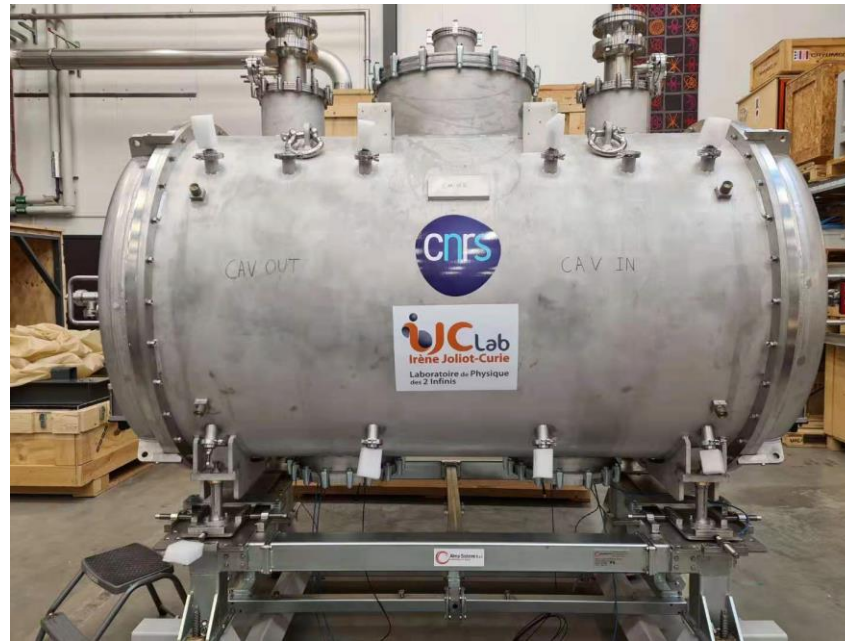
- CM02 arrival on 19th Feb.
- No big vibration has been logged during transportation
- Incoming test:
 - Electrical continuity check ✓
 - Cavity parameter check ✓

- Instrumentation cabling has been modified
- Similar result as previous test -> TT12 is malfunctional
