# ESS weekly meeting (W20)

A. Miyazaki et al.

# Summary: CM05's anomaly

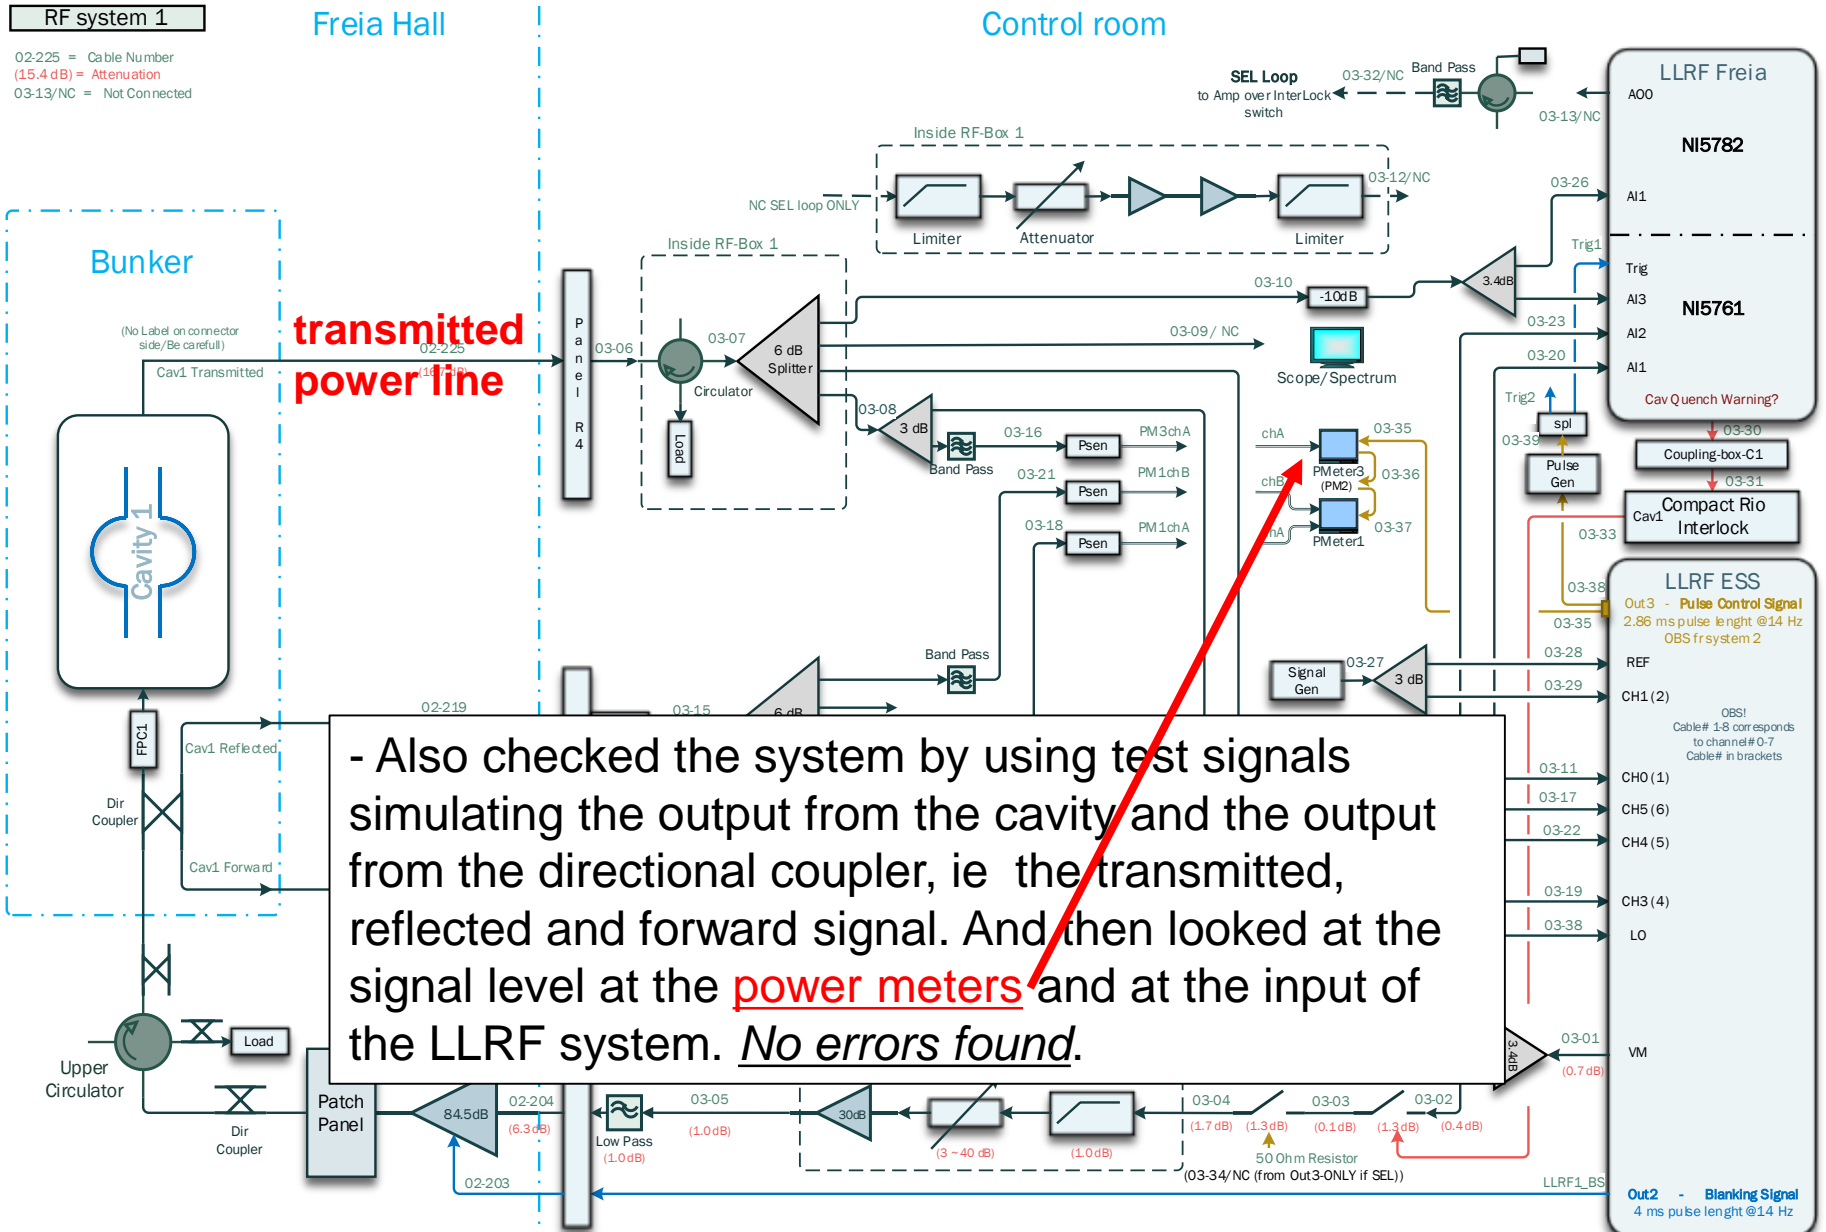
# Looking for errors in the power measurement.

- Also checked the system by using test signals simulating the output from the cavity and the output from the directional coupler, ie the transmitted, reflected and forward signal. And then looked at the signal level at the power meters and at the input of the LLRF system. No errors found.

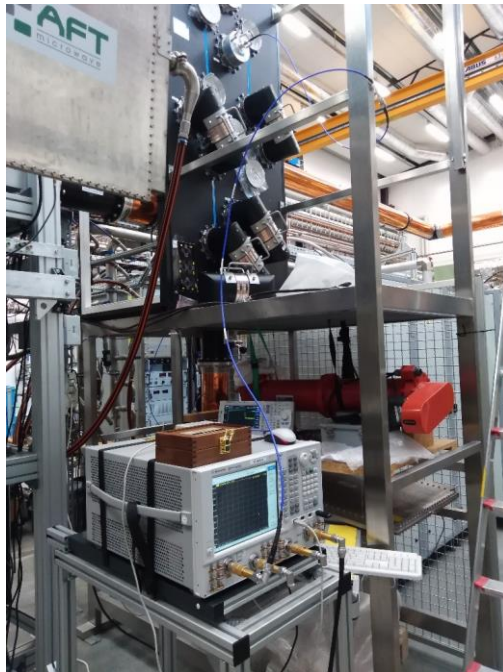
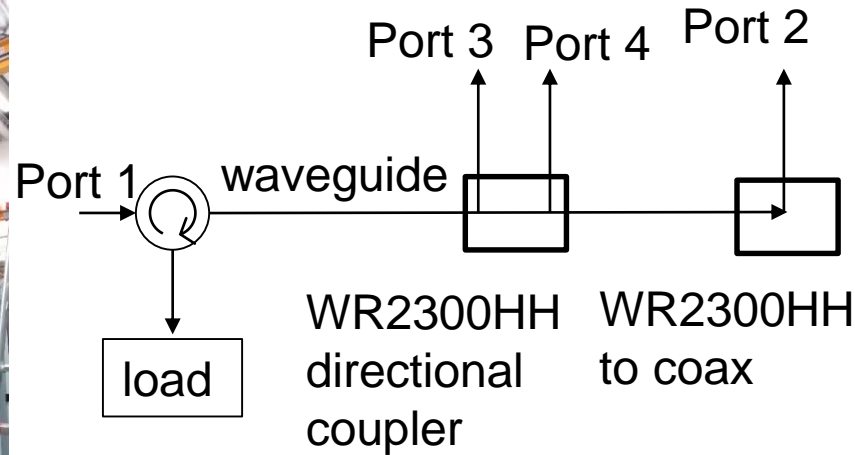
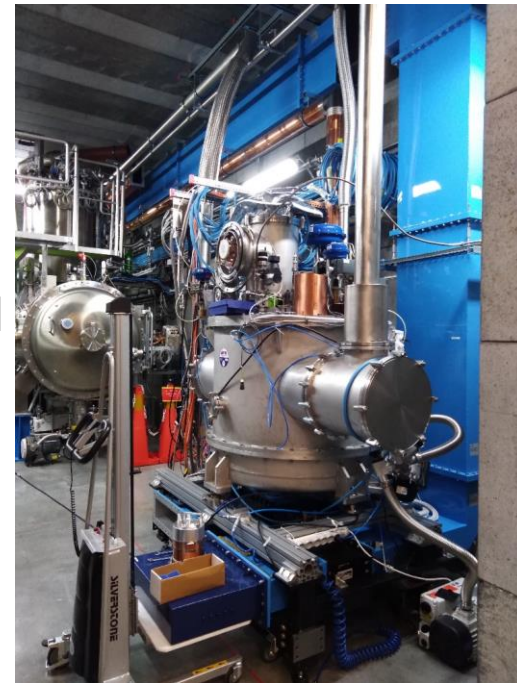
# Measure WR2300HH waveguide

Long (~20m) RF cable was calibrated and connected to VNA's ports

- In reality, 2-port measurement was performed with matched or open condition at port 2
- Measurement around 352.21 MHz +/- 1MHz

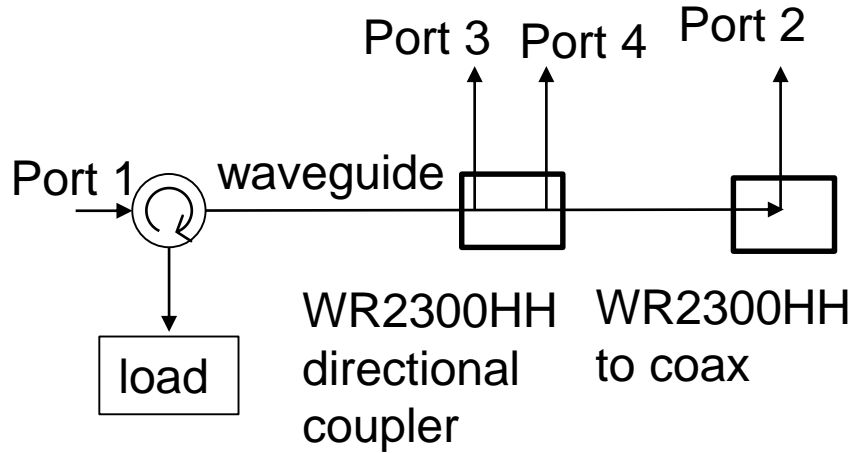
# Measure WR2300HH waveguide

- The cavity powering is performed under a strongly over coupling condition
- The relevant impedance condition to generate identical standing wave of cavity measurement is tricky
- The conservative guess is to compare short and open condition ( $\lambda/4$  shifts in standing wave)

S-parameter	value [dB]	coupling
S21	-0.09	
S31 w port 2 50 W	-49.67	-49.58
S31 w port 2 open	-49.49	-49.40
S31 w port 2 short	-50.13	-50.04
S41 w port 2 50 W	-74.72	
S41 w port 2 open	-49.03	
S41 w port 2 open	-49.72

We have used manufactured value 50 dB but the real value seems **0.5 dB** lower except for the short case

S-parameter	value [dB]	coupling
S21	-0.28	
S31 w port 2 50 W	-49.85	-49.57
S31 w port 2 open	-48.70	-48.42
S31 w port 2 short	-51.08	-50.80
S41 w port 2 50 W	-77.00	
S41 w port 2 short	-51.25	
S41 w port 2 open	-49.22

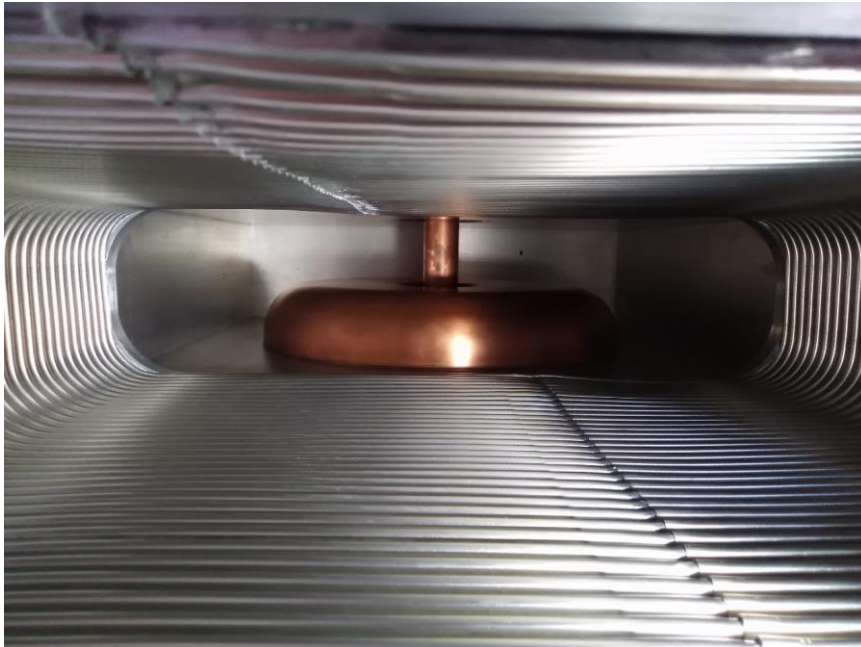
# Visual inspection of doorknob

CAV IN

CAV OUT

**Nothing special**

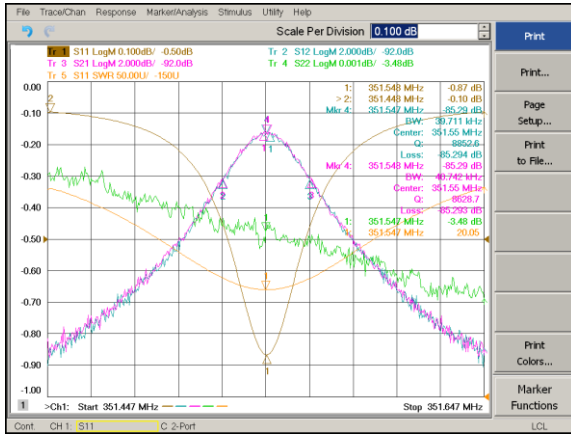
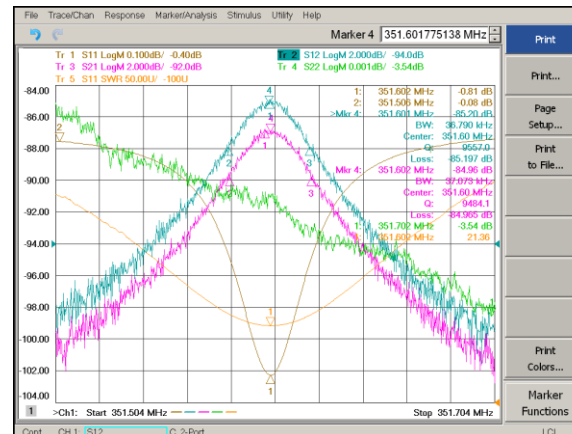
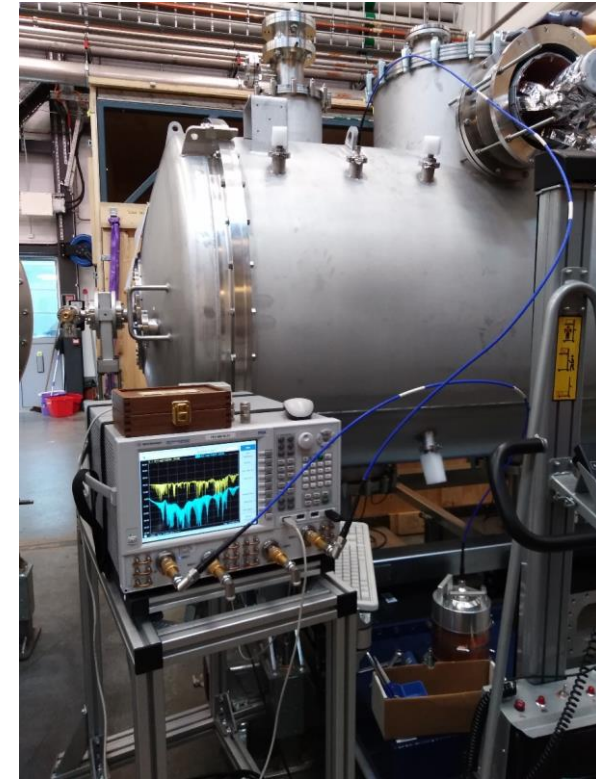
# Cavity measurement through doorknob

**Nothing special**

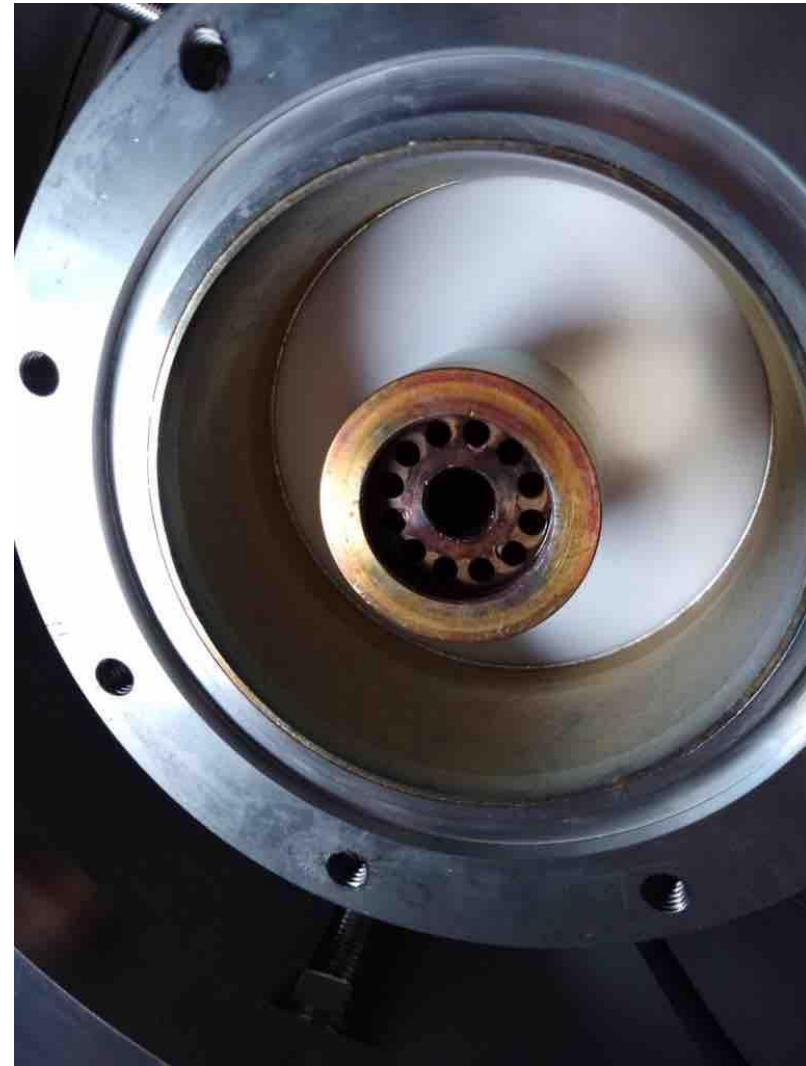
# CM05: Doorknob dismounting

- Doorknob is black (from the beginning) → does it affect?
- Nothing in the ceramic window

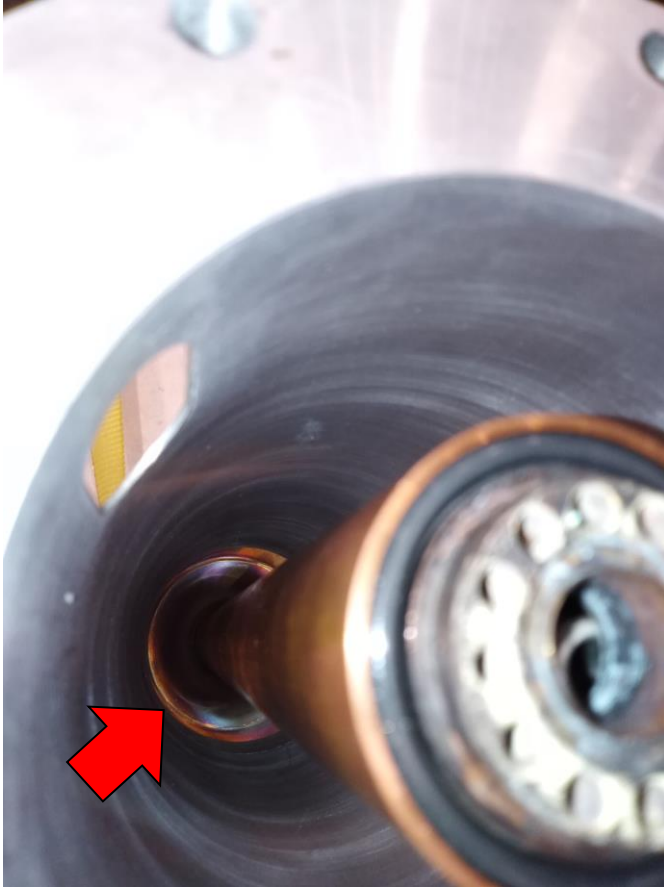
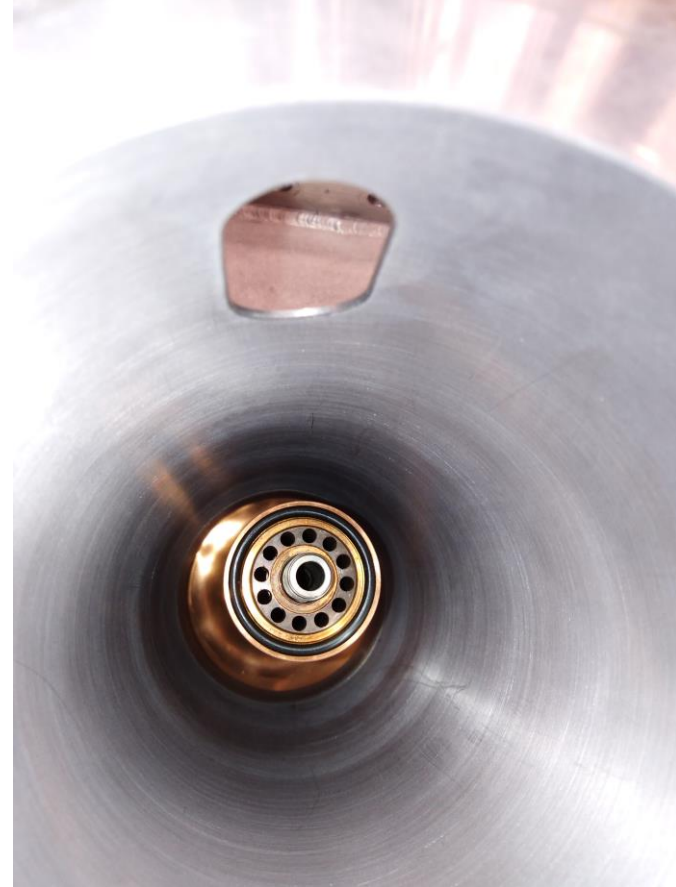
# Cf. doorknobs in December 2020

- It was already black → no major change is visible
- CAV IN's arc detector at the doorknob tripped a lot in CM02 and CM04 but it was very calm during CM05 testing

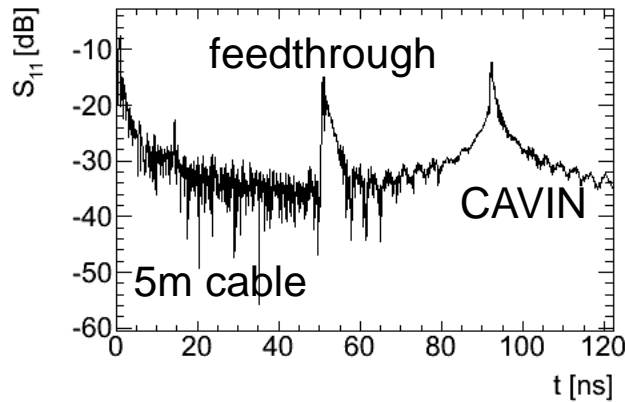
## TDR: pick-up cable

CAV IN			CAV OUT		
	Before cold test	after cold test w doorknob	after cold test w/o doorknob	Before cold test	after cold test w doorknob	after cold test w/o doorknob
$f_0$ [MHz]	351.542	351.548	351.552	351.602	351.603	351.607
$Q_L$	9061	8628	8931	9484	8857	9095
$S_{21}(f_0)$ [dB]	-85.37	-85.29	-85.35	-85.97	-84.91	-85.27
$S_{11}(f_0)$ [dB]	-0.84	-0.87	-0.79	-0.81	-0.83	-0.81
$S_{11}(f_0-\Delta f)$ [dB]	-0.08	-0.10	-0.05	-0.08	-0.05	-0.07
$S_{22}(f_0)$ [dB]	-3.48	-3.48	-3.49	-3.54	-3.58	-3.58

- Nothing explains the anomalous 2.5 dB from cavity measurement
- The VNA measurement at warm is not precise but hypothetical damage for 2.5 dB must be visible if such a thing exists

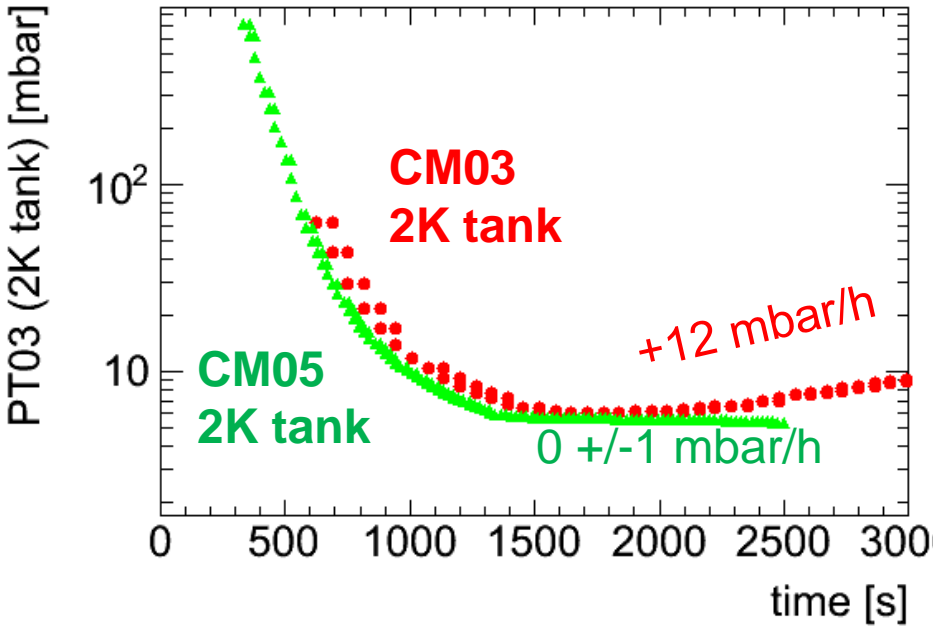
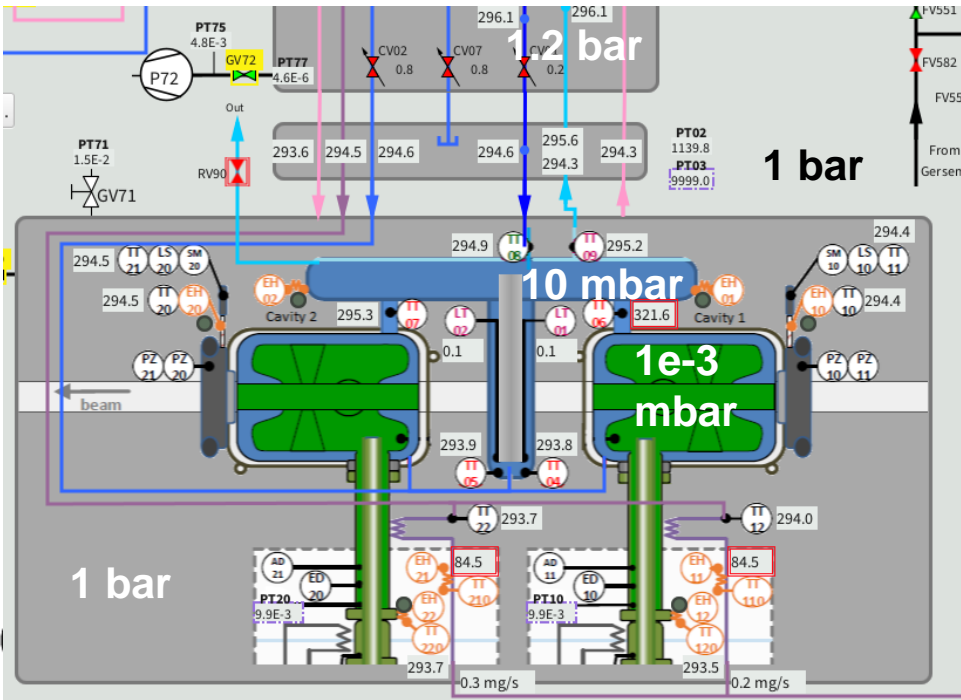
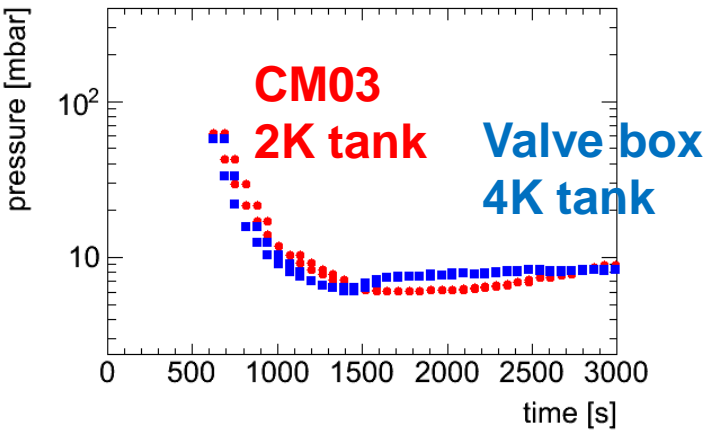
# Leak test in the He circuit (under pressure)

The He tank inside isolated CM03 seems leaky

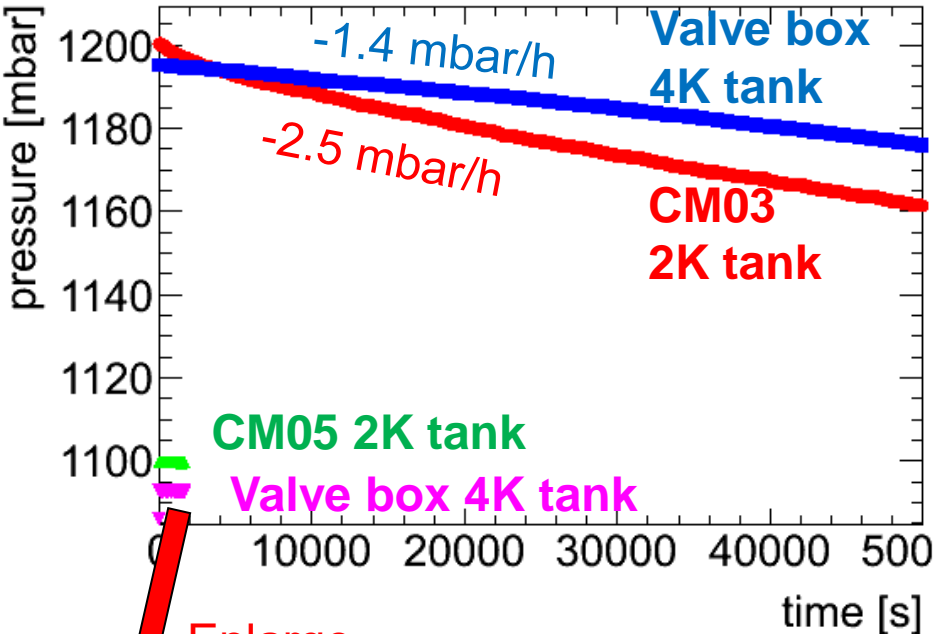
# Leak test in the He circuit (over pressure)

It looks like a leak through 1 bar

Leak rate  $Q_L$  vs differential pressure  $\Delta P$

$\Delta P \sim 1000$  mbar:  $Q_L \sim + 12$  mbar/h

$\Delta P \sim - 200$  mbar:  $Q_L \sim - 2.5$  mbar/h

$\rightarrow Q_L \sim 1.2 \times 10^{-2} \Delta P$

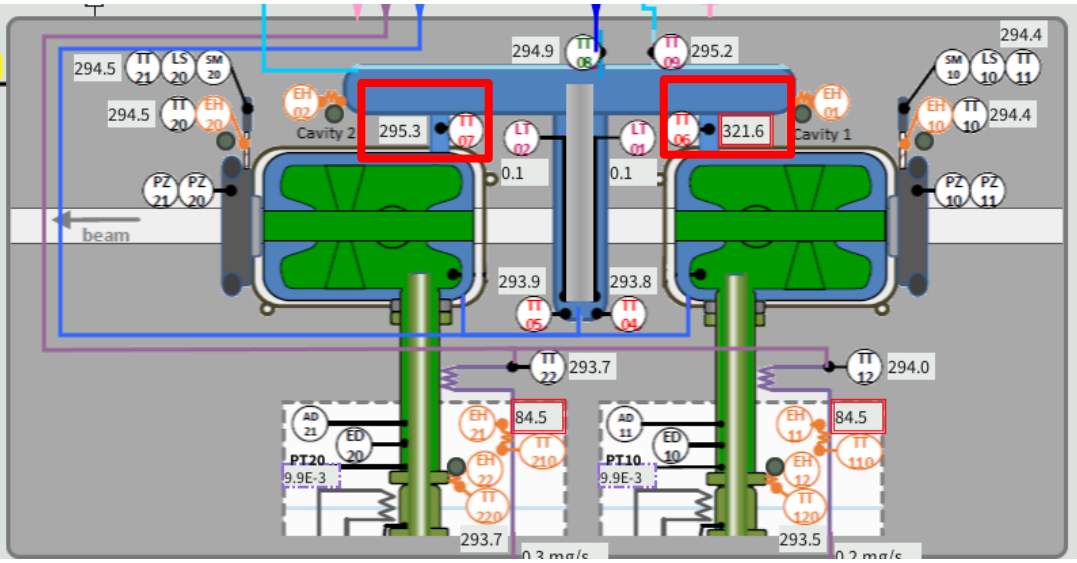
# Doubt on temperature sensors

TT04:	● ●	295.426 K	66.149 Ω
TT05:	● ●	295.552 K	66.277 Ω
TT06:	● ●	321.878 K	65.866 Ω
TT07:	● ●	295.421 K	63.472 Ω
TT08:	● ●	295.565 K	62.376 Ω
TT09:	●	295.786 K	71.024 Ω

- Two **crucial sensors** for cryogenic regulation are suspicious
  - TT06 (X138025)
  - TT07 (X138026)
- They seem swapped between Orsay's document and our measurement at reception
- Swapped calibration curves for "TT07" (X138025) works but "TT06" (X138026) still does not work

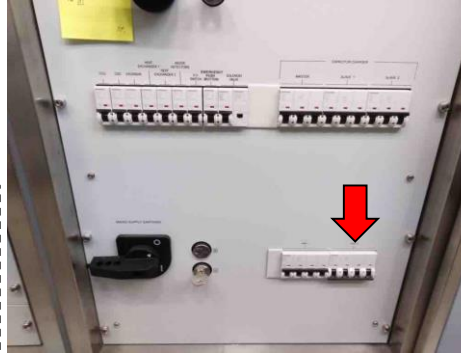
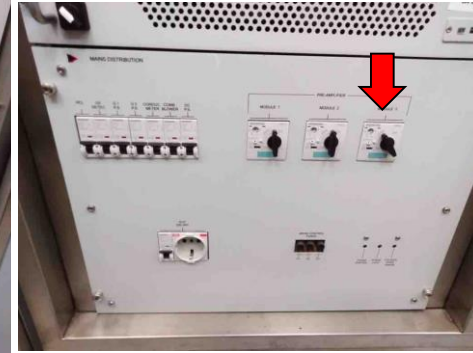
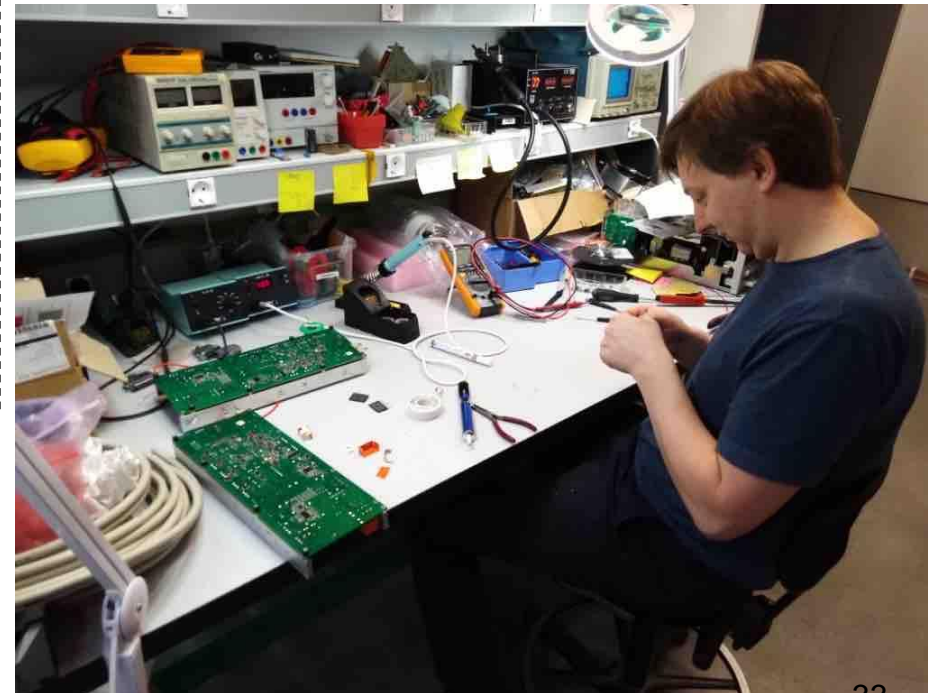
# Electrosys → broken power supply fixed

Issue found in W15

(This error does not trip interlock)

Spare PSs around middle of May are also coming
