ESS weekly meeting (W23)

A. Miyazaki et al.

W23 progress

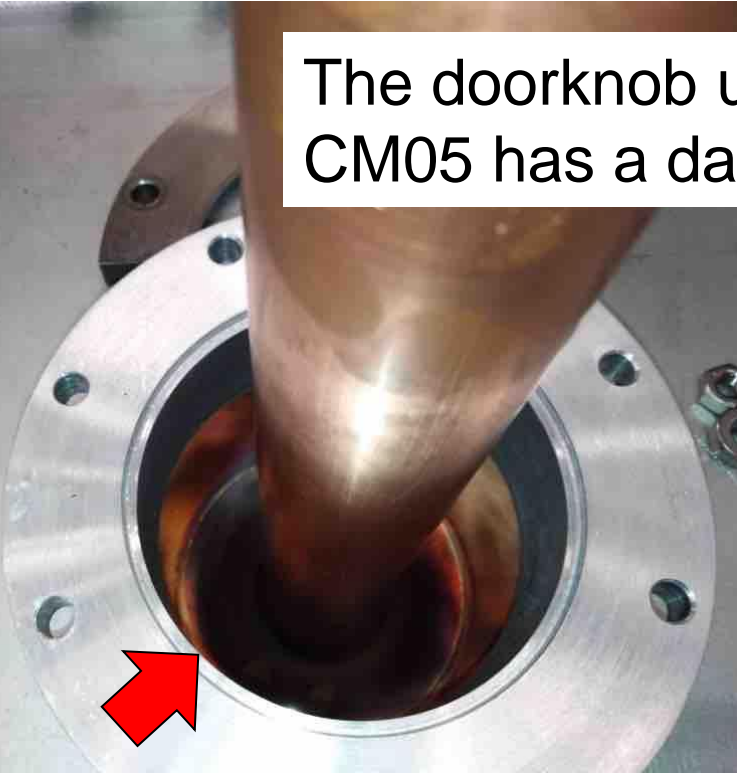
Thermocouple to monitor doorknob

The doorknob used for CAV IN CM05 has a dark surface

Anomaly in power or field for CM05 CAV IN might be due to heating?

Monitor temperature from the other side

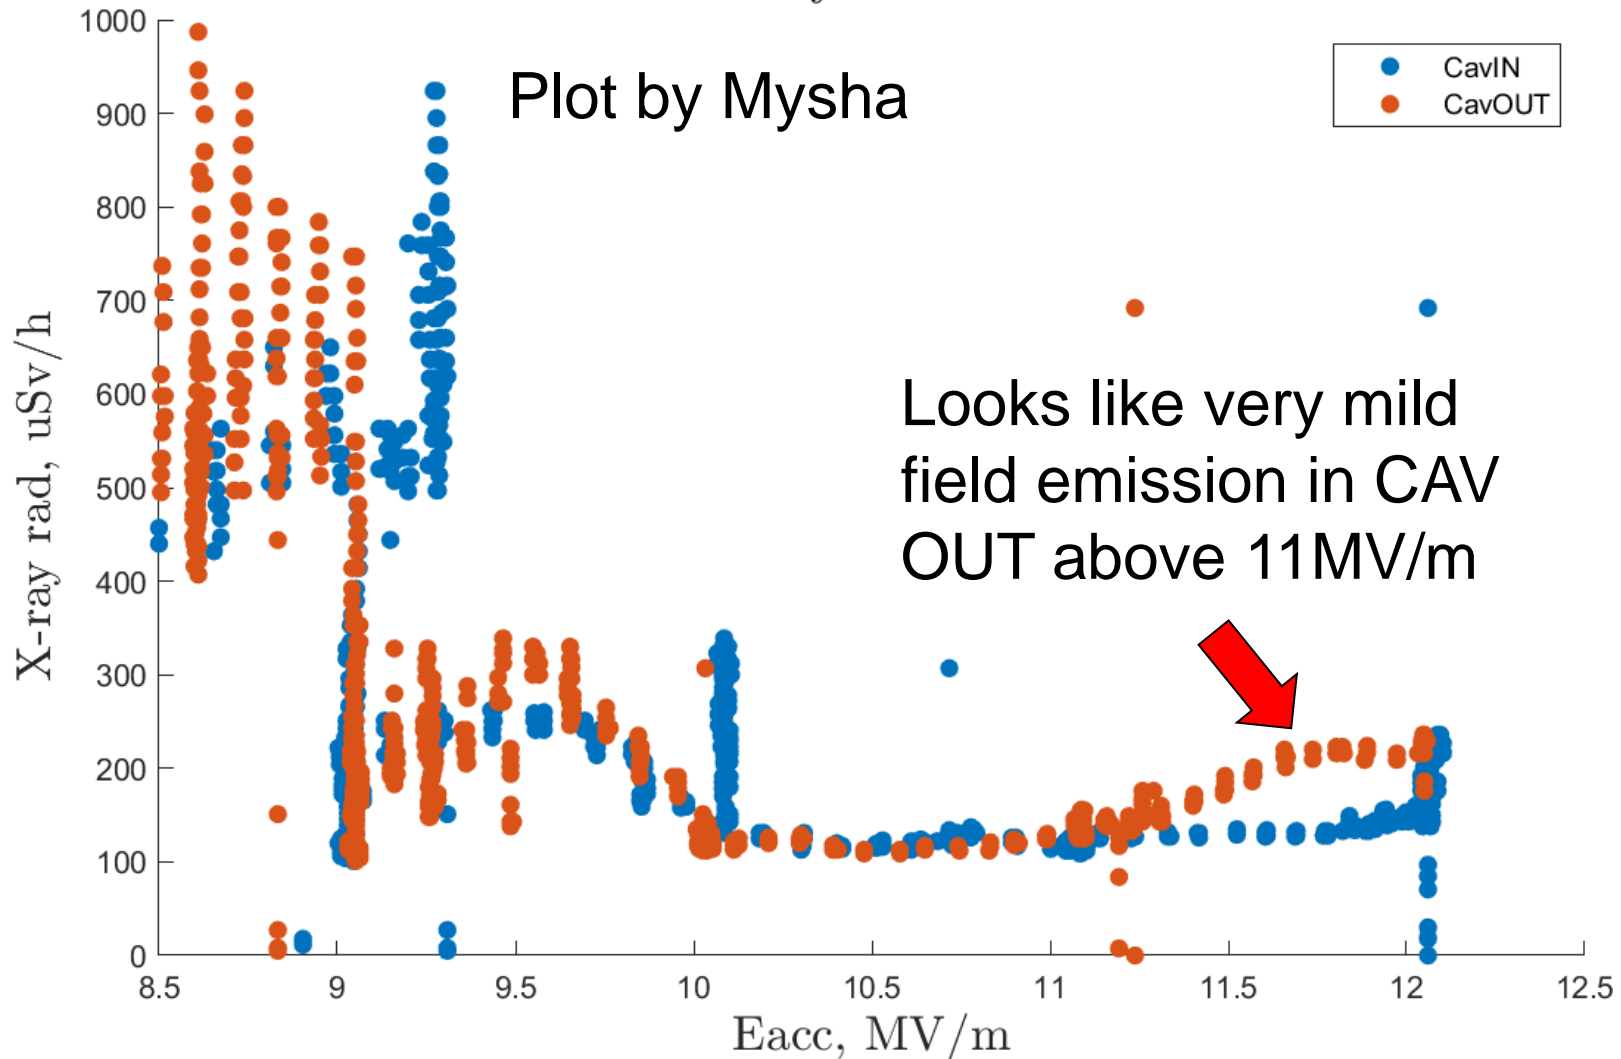
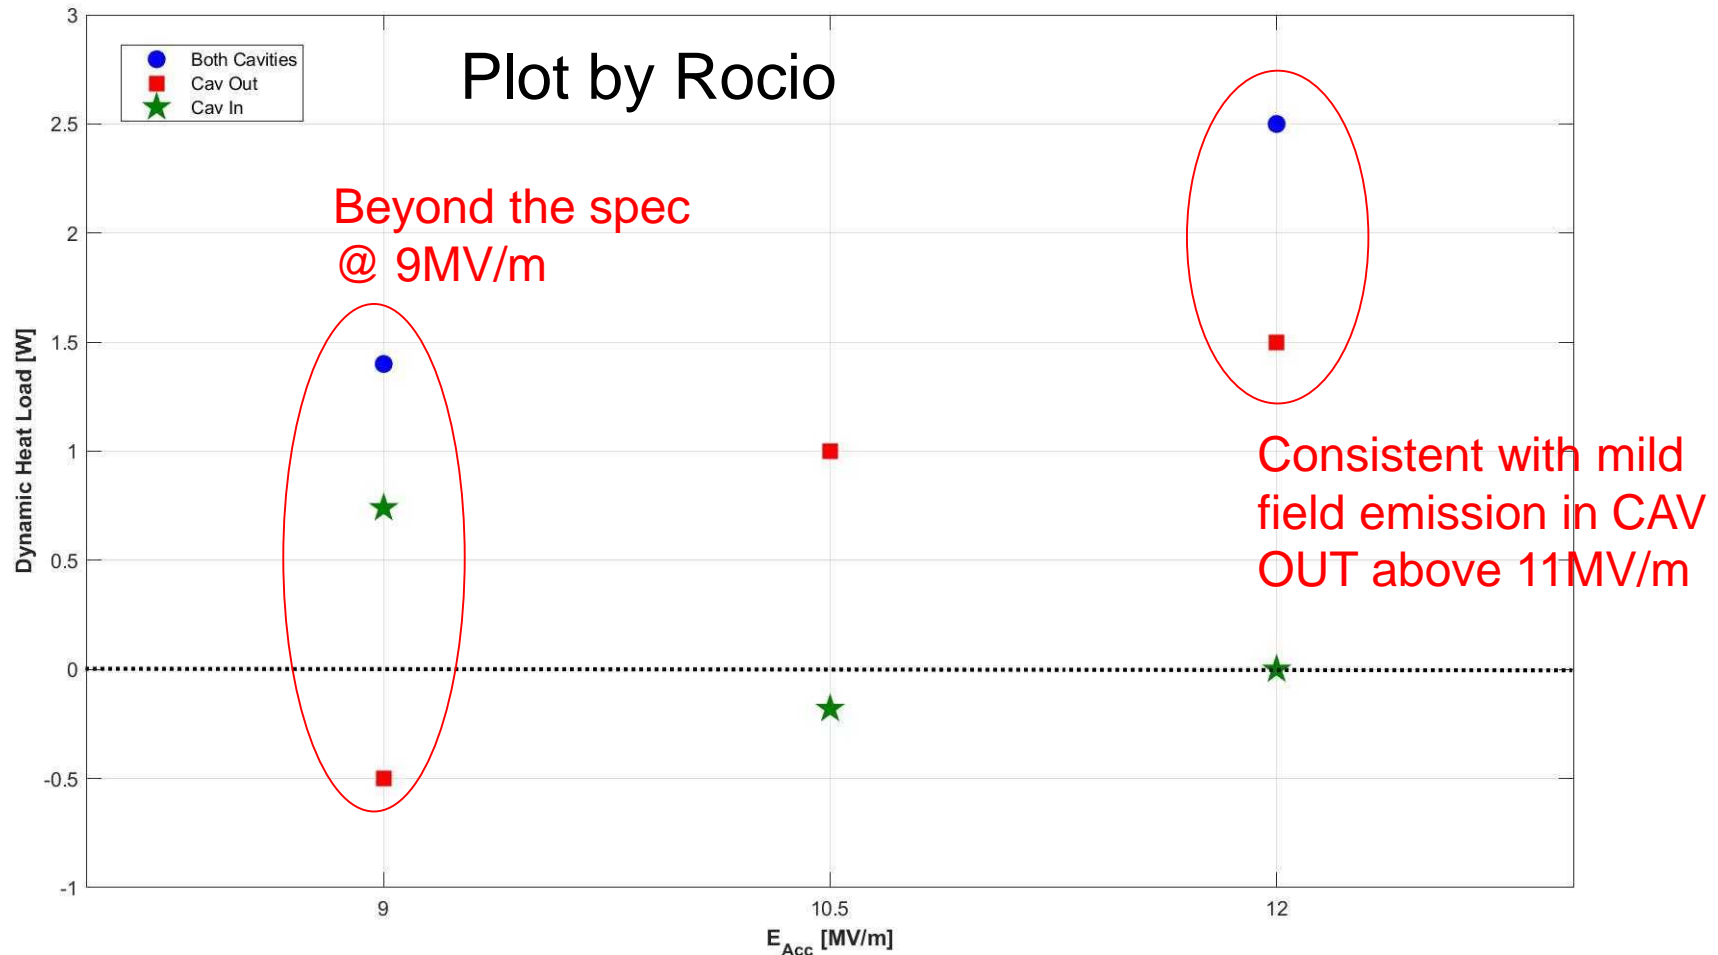
X-ray vs Eacc

We plan to improve the measurement accuracy in coming tests.
(For example, calibration and RF measurement within on pressure rise cycle)

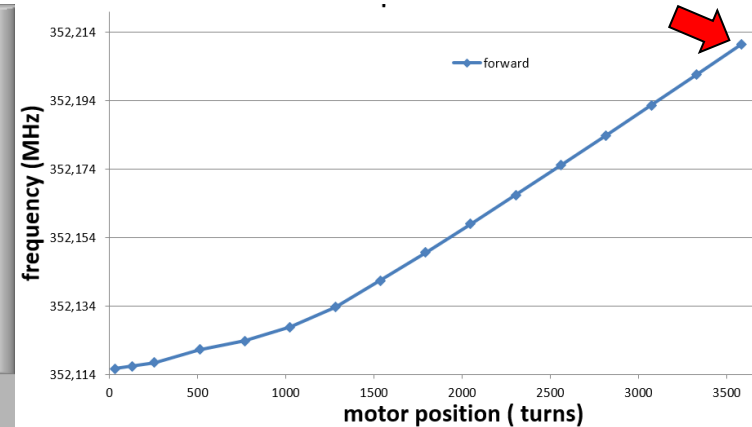
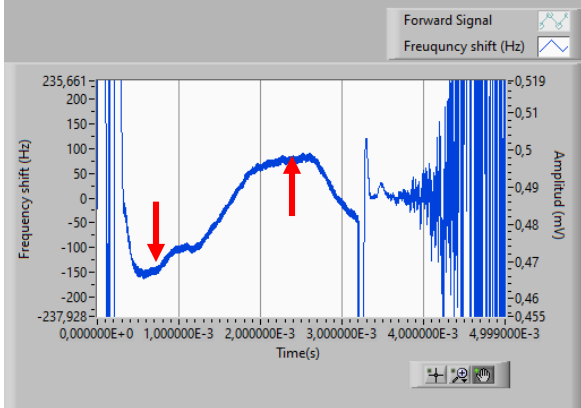
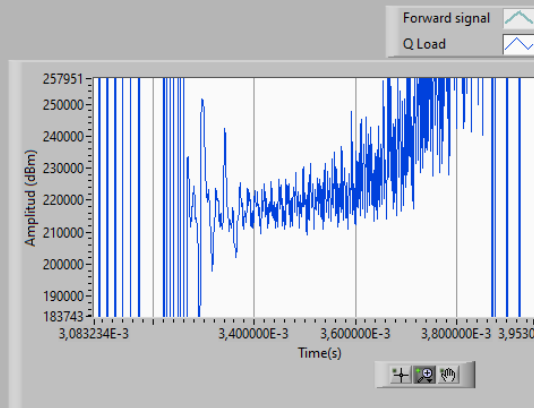
Lorentz force detuning at 9MV/m CAV OUT

-150 Hz / + 100 Hz → 250 Hz @ 9MV/m

Relevant position of CTS2 at 352.21 MHz

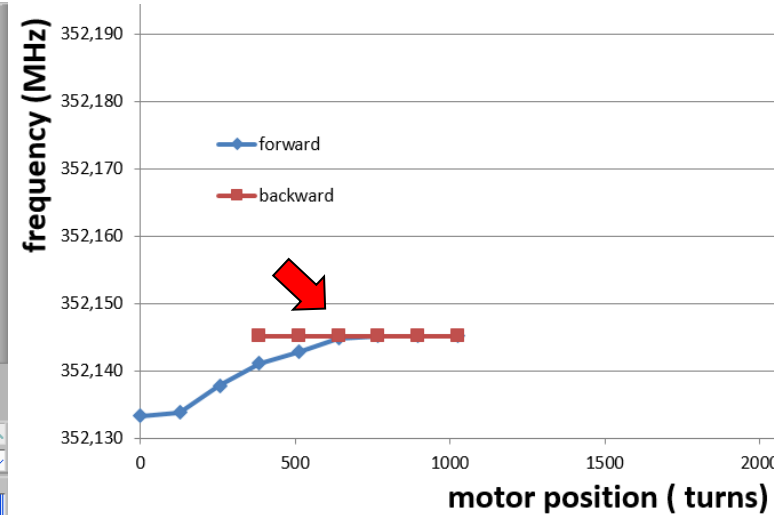
-150 Hz / + 75 Hz → 225 Hz @ 9MV/m

Irrelevant position of CTS1 at 352.145 MHz

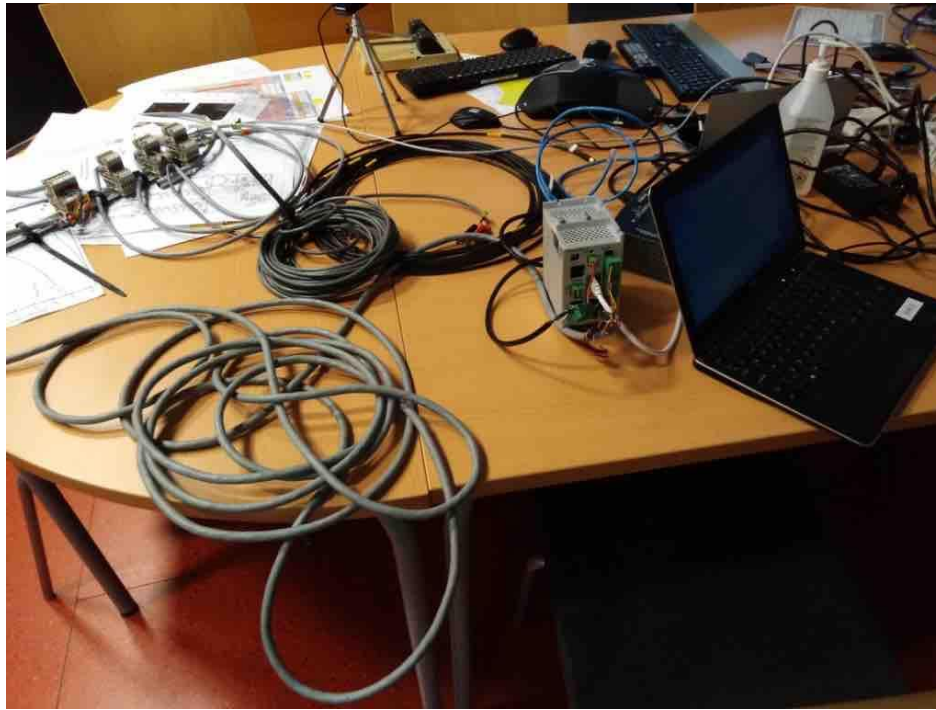
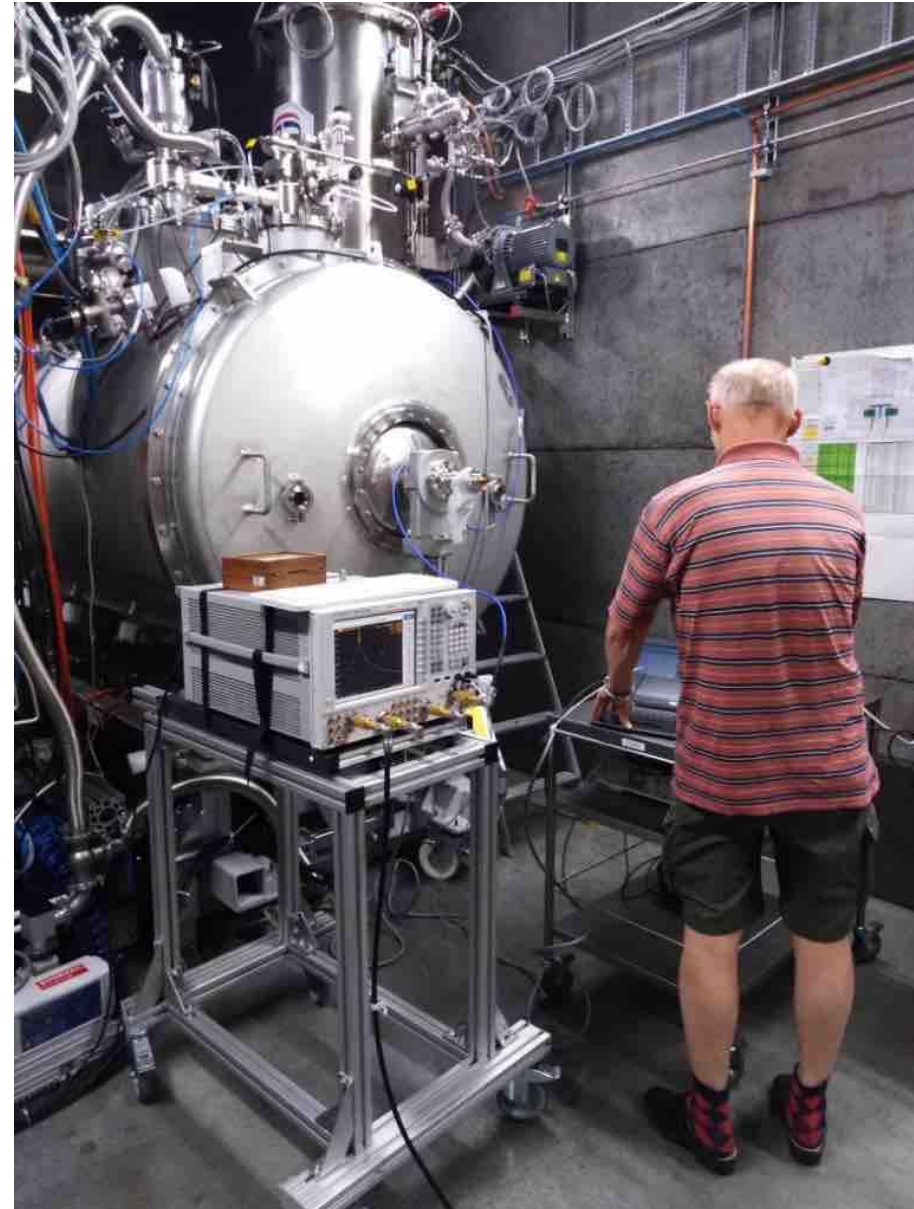
Another driver from Orsay

- This is the driver that was used to qualify the tuners at Orsay
- CTS1 was OK in the outgoing test at Orsay

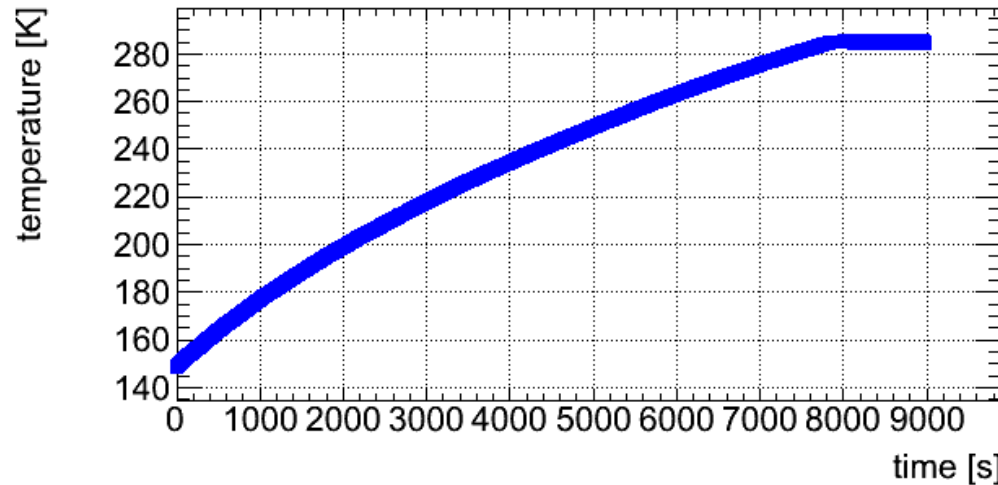
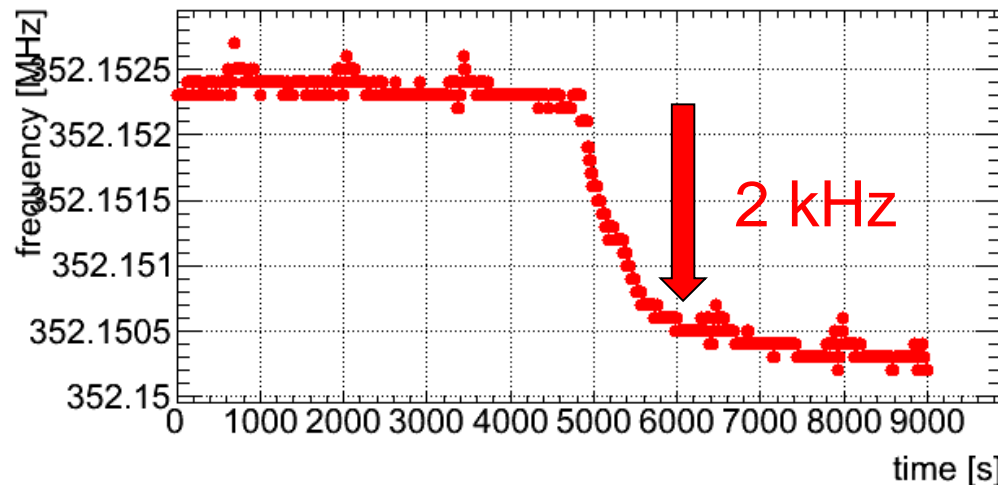
Disengage system again

We tried to move the stepper motor backward after disengagement
 → We could **NOT find the limit switch even at -5888 turns** (-23 turns) from the stuck position

- The stepper motor seems not moving even though we release the possible mechanical stress from the cavity by using the disengage system
- The other driver from Orsay certainly sends more current than what we have now at Uppsala (→ feedback to ESS) but it still does not move CTS1
- We need to warm up the module and investigate inside the vacuum vessel
- Question: where to open the vessel?

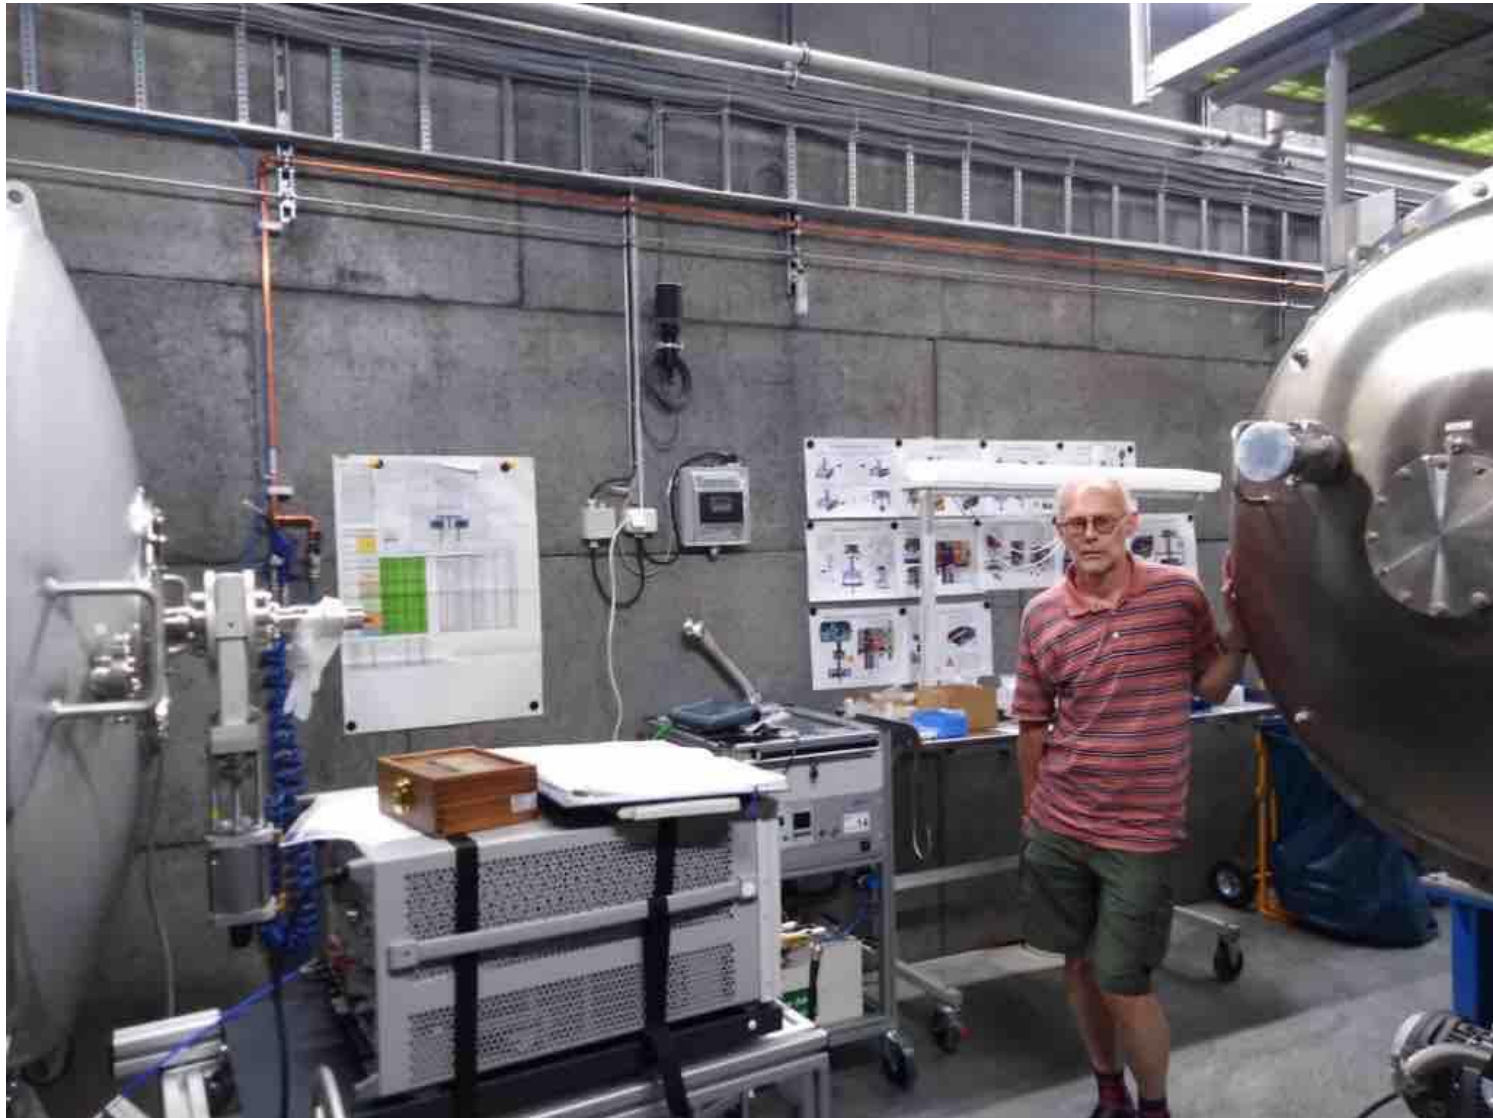
Accessibility at the bunker

2.7 m to HNOSS from CAV OUT side

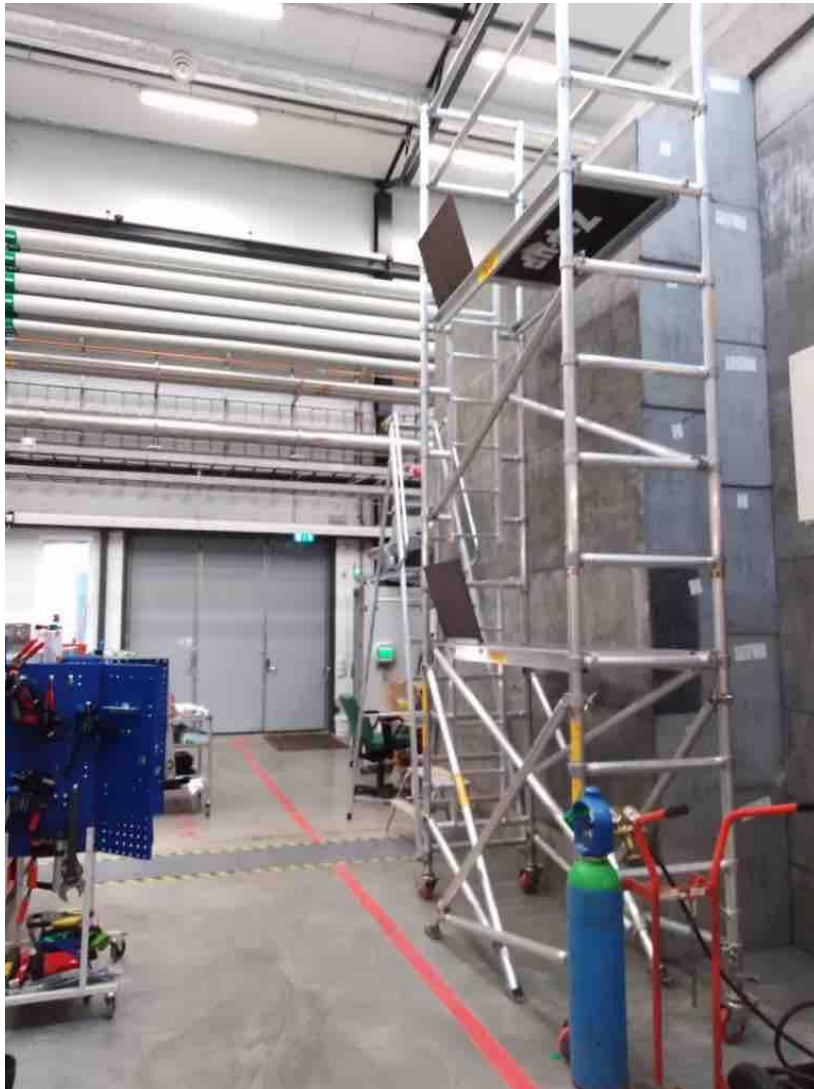
Open the wall

→ >3m space from CAV IN
