# 1. Visual inspection from TL012 upper bellow into VB

### **OUTCOME of TESTS**

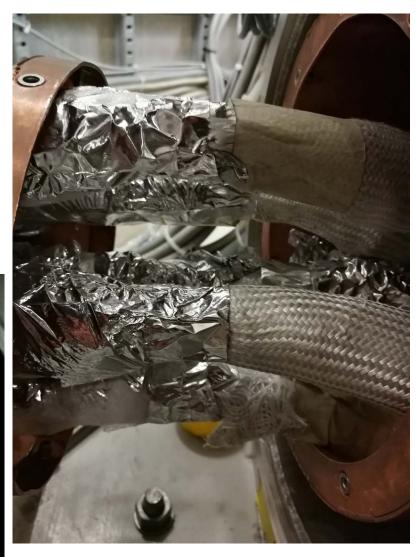
#### 7. Blow hot air (ca. 50C) through bayonnet and let air out after TL016 outlet in VB (see graph next page)

- Pumping circuit at 347 K
- Other LHe circuit at 303 K
- 4K tank at 297 K
- LN2 shield TTs at 300 K
- LN2 piping at 301 K

VB, VCS and TL012 UNDER vacuum
