Issues in DB station and TH595A

A. Miyazaki, M. Zhovner, T. Peterson and R. Wedberg

Issues in DB station

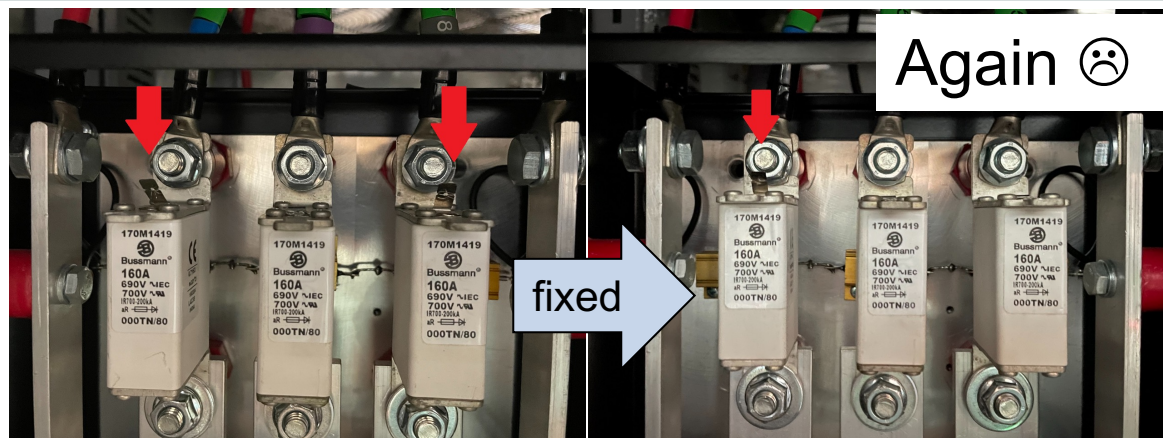
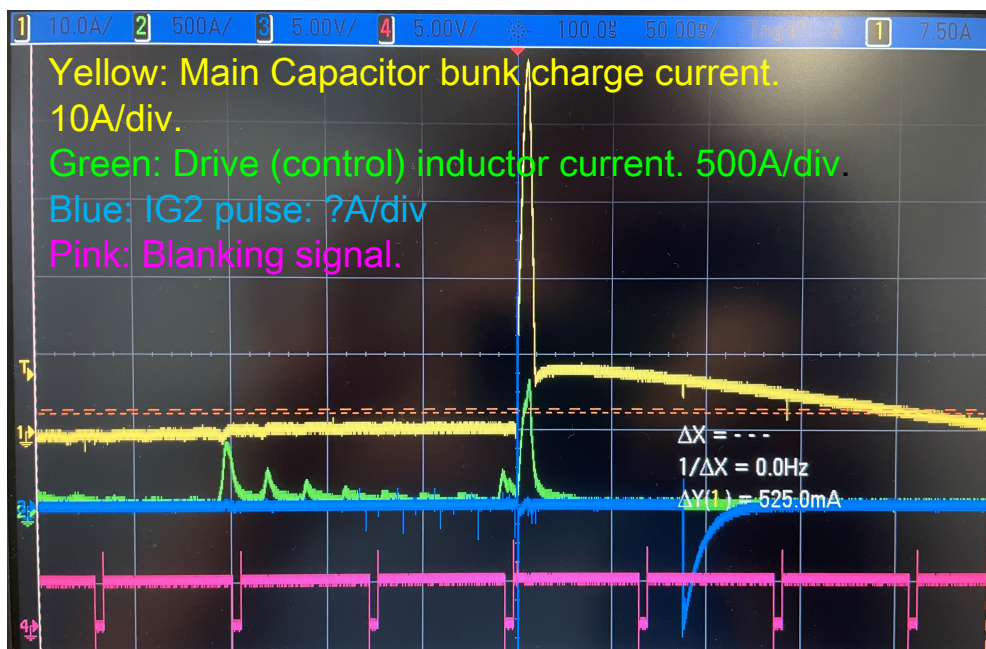
- A lot of “Crowbar IN” of DB-B in past months
- This time, fuses were damaged and happen again and again even if it is fixed
- Disconnect the HV line from the tube → no problem

→ tube or cavity of tetrode was doubted

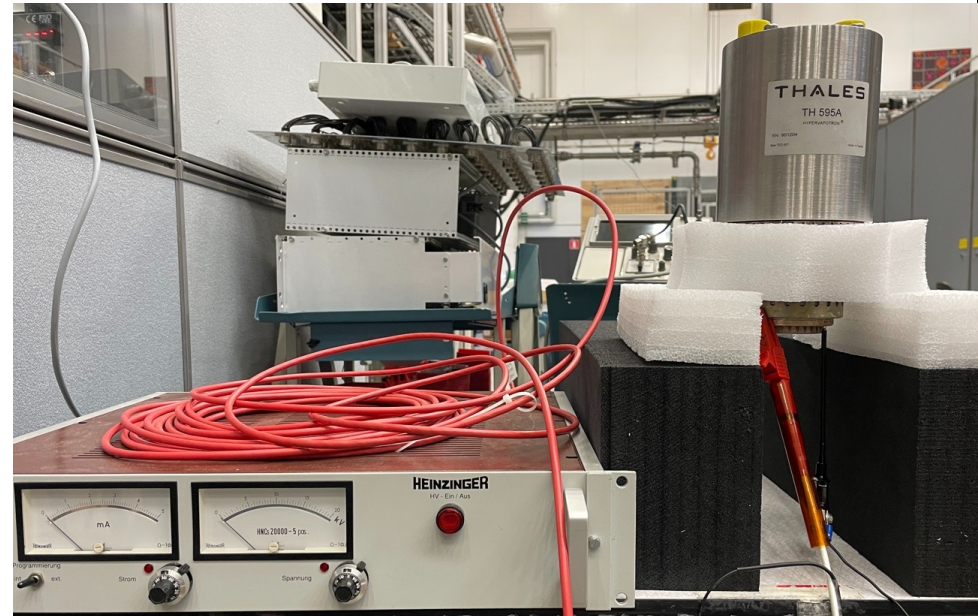
The tube under debate: 595A 901204

Tube did NOT

- Start operation on September 2019
- The first 595A type tube
- Total service (filament ON) time: **4800 hours** (0.5 years)
- ESS project requirements :> 20,000 hours (2 years)
- No short-circuit or low capacitance at room temperature between any grids and/or cathode

HV test **at room temperature** without filament ON (*preliminary*)

→ Cathode-G1:2kV OK, Anode-G2:20kV OK,

→ **G1-G2**: 750-1000V discharge << 1500V with 6uA (spec.)

→ It was mitigated after “conditioning” at some voltage for several hours

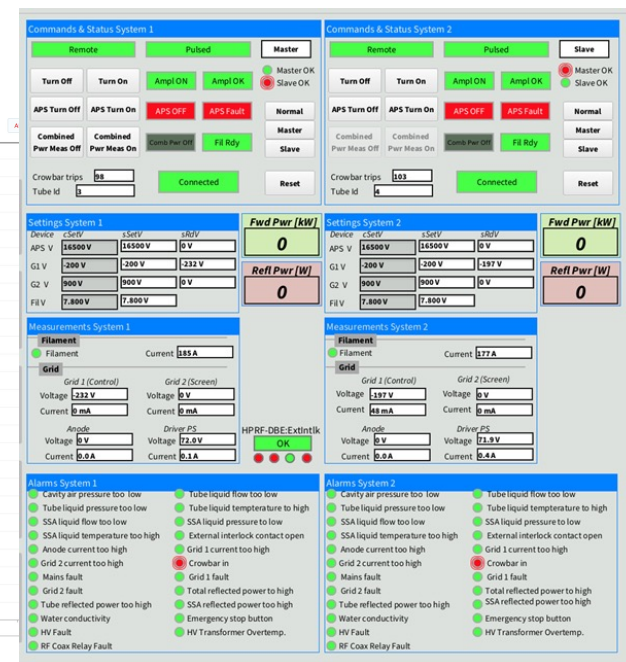
Section A 120kW

Section B 120kW

Tripped before taking
data point above 120kW

- The tube 595A 901204 was replaced to a **virgin new spare 912223**
- The new filament was flushed over one night
- OK with HV test **without RF**
- RF test with a dummy load was performed
 - Up to 120kW in section A & 120kW in section B (total 240kW)
- CROWBAR IN above 240kW
 - Not clear yet if it is from section A (with TH595A S/N907196; filament 4800 hours since 2020 March 6th) or B
 - **The issue could be from section A** → to be tested more

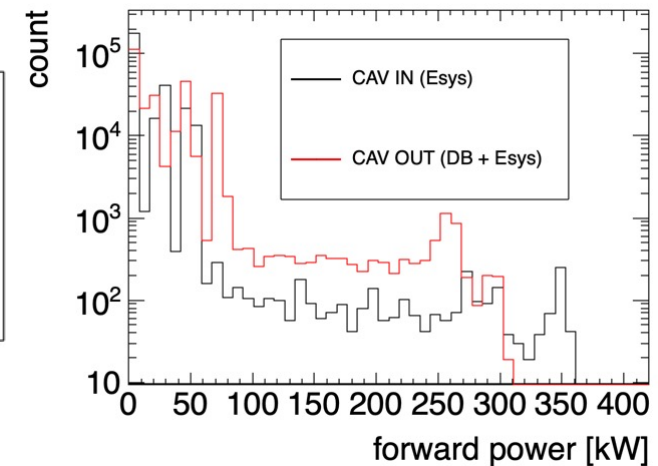
Histogram of required power during coupler conditioning

- ✓ Most demanding test at Uppsala is coupler conditioning
- ✓ Power requirement is low still the stations often trip
- ✓ Uppala needs to continue this test for another year
